Date:	09/20/2021	Weather:		Coding:	<b>PACP 7.0</b>
Pipe Length (ft):	180.0	Owner:	City of Hobart	Pre Clea	in: Heavy Cleaning
P.O.#:	YES502259	Surveyor:	S. Bucklin	PSR:	P-503-023-022
Customer:	City of Hobart	Clean Date:	09/04/2021	Shape:	С
Street:	West 39th Avenue		Flow Control:	Not Con	trolled
City:	Hobart, IN		Year Renewed:		
Location:	Alley		Tape/Media #:		
Purpose:	Routine Assessment		Dia/Height:	10"	
Use:	Sanitary Sewage Pipe	1	Material:	VCP	
Drain Area:			Lining:	None	
Category:	NA				
Comment:					
Location Details	:		Direction of Surv	vey: Downst	eam
US MH:	M-503-022	DS MH:	M-503-023	Total Length Surve	yed (ft): <b>30.7</b>
0&M Index:	2.15	O&M Quick:	413	<sup>3</sup> O&M Ratin	g: 28.00
tructural Index:	2.50	Structural Qu	uck: 312		
Overall Index:	2.20		413

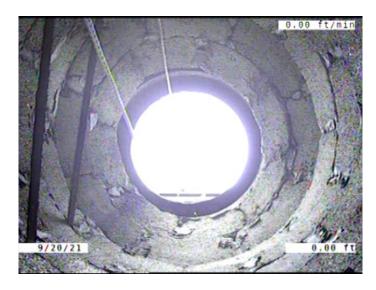
Code:	АМН
Description:	Manhole
Distance (ft):	.0
Structural Grade:	0
O&M Grade:	0
Clock Start/From:	
Clock To:	
1st Value:	
2nd Value:	
Value Percent:	
Continuous Index:	
Within 8" of Joint:	NO
Remarks:	M-503-022
