Profile/Photo Observation Report

Date:	09/20/2021	Weather:		Coding:	PACP 7.0
Pipe Length (ft):	175.6	Owner:	City of Hobart	Pre Clean:	Heavy Cleaning
P.O.#:	YES502259	Surveyor:	S. Bucklin	PSR:	P-503-024-023
Customer:	City of Hobart	Clean Date:	09/04/2021	Shape:	C

Street:	West 39th Avenue	Flow Control:	Not Controlled
City:	Hobart, IN	Year Renewed:	
Location:	Alley	Tape/Media #:	
Purpose:	Routine Assessment	Dia/Height:	10"
Use:	Sanitary Sewage Pipe	Material:	VCP
Drain Area:		Lining:	None
Category:	NA		
Comment:			
Location Details:		Direction of Survey:	Upstream
US MH:	M-503-023	DS MH:	M-503-024
		Total Length Surveyed (ft):	175.6

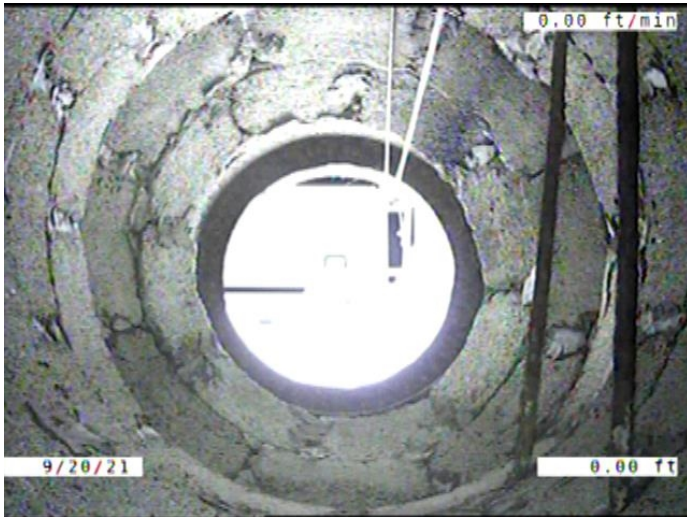
Code: **AMH**
Description: **Manhole**

Distance (ft): **.0**
Structural Grade: **0**
O&M Grade: **0**
Clock Start/From:
Clock To:
1st Value:
2nd Value:
Value Percent:
Continuous Index:
Within 8" of Joint: **NO**
Remarks: **M-503-024**

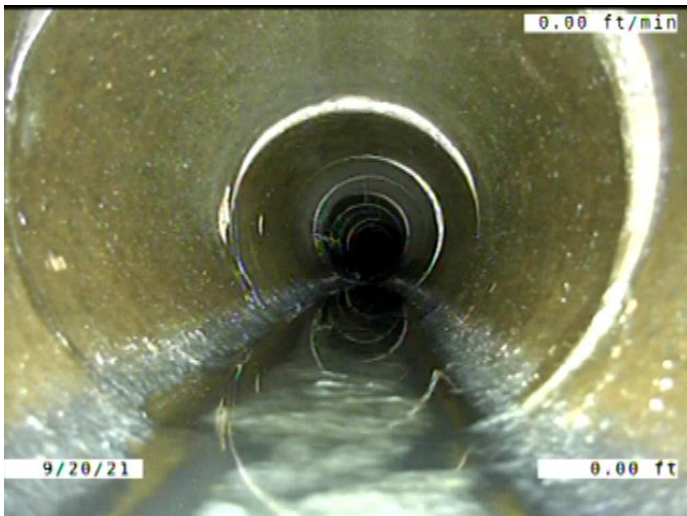
Code: **MWL**
Description: **Miscellaneous Water Level**

Distance (ft): **.0**
Structural Grade: **0**
O&M Grade: **0**
Clock Start/From:
Clock To:
1st Value:
2nd Value:
Value Percent: **5.000**
Continuous Index:
Within 8" of Joint: **NO**
Remarks:

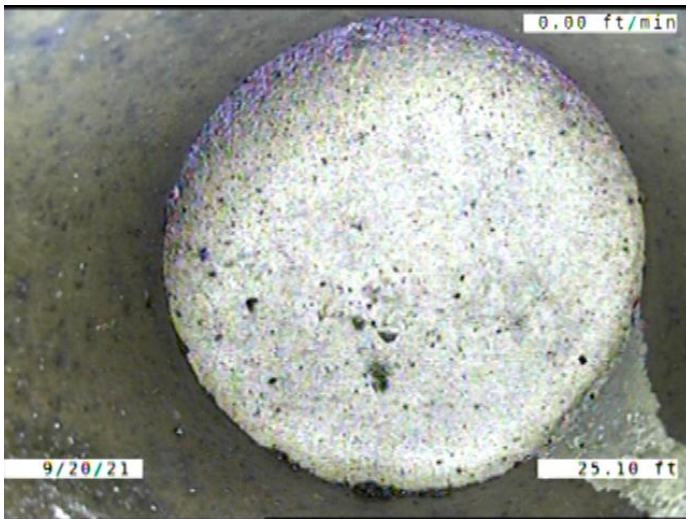
Code:	TFC
Description:	Tap Factory Capped
Distance (ft):	25.1
Structural Grade:	0
O&M Grade:	0
Clock Start/From:	1
Clock To:	
1st Value:	4.000
2nd Value:	
Value Percent:	
Continuous Index:	
Within 8" of Joint:	YES
Remarks:

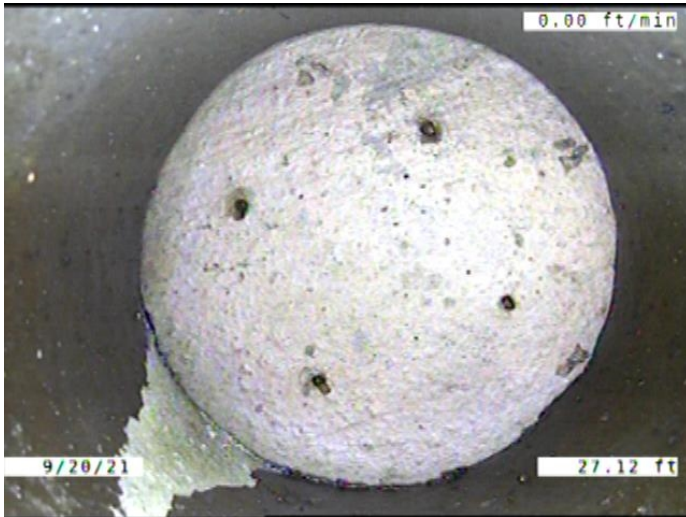
Code: **TFC**
 Description: **Tap Factory Capped**

Distance (ft): **27.1**
 Structural Grade: **0**
 O&M Grade: **0**
 Clock Start/From: **11**
 Clock To:
 1st Value: **4.000**
 2nd Value:
 Value Percent:
 Continuous Index:
 Within 8" of Joint: **YES**
 Remarks:

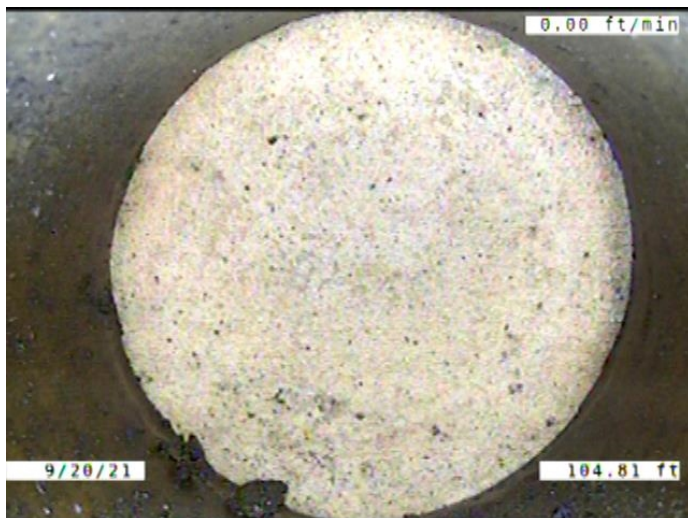
Code: **TFC**
 Description: **Tap Factory Capped**

Distance (ft): **104.8**
 Structural Grade: **0**
 O&M Grade: **0**
 Clock Start/From: **1**
 Clock To:
 1st Value: **4.000**
 2nd Value:
 Value Percent:
 Continuous Index:
 Within 8" of Joint: **YES**
 Remarks:

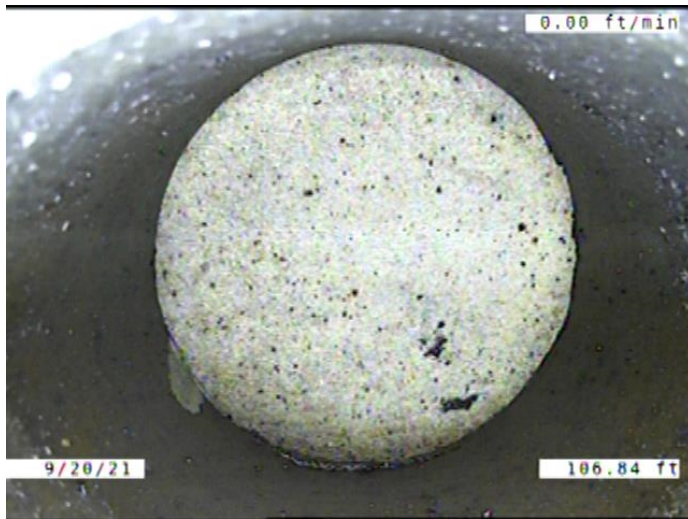
Code: **TFC**
Description: **Tap Factory Capped**

Distance (ft): **106.8**
Structural Grade: **0**
O&M Grade: **0**
Clock Start/From: **11**
Clock To:
1st Value: **4.000**
2nd Value:
Value Percent:
Continuous Index:
Within 8" of Joint: **YES**
Remarks:

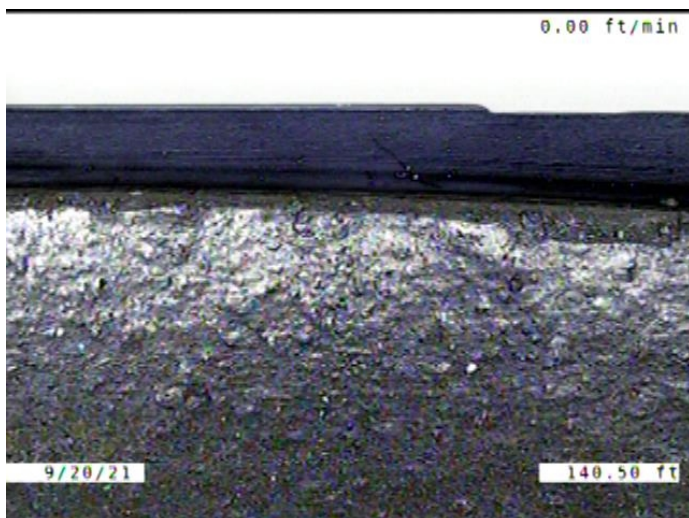
Code: **MMC**
Description: **Miscellaneous Material Change**

Distance (ft): **140.5**
Structural Grade: **0**
O&M Grade: **0**
Clock Start/From:
Clock To:
1st Value:
2nd Value:
Value Percent:
Continuous Index:
Within 8" of Joint: **NO**
Remarks: **PVC TO VCP**

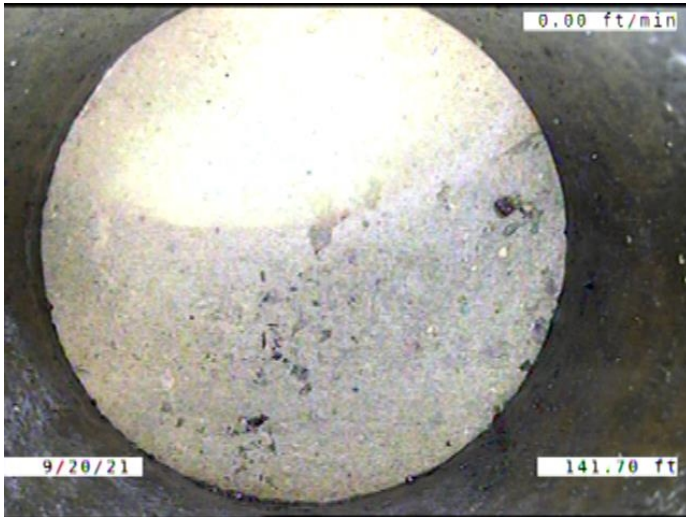
Code: **TFC**
 Description: **Tap Factory Capped**

Distance (ft): **141.7**
 Structural Grade: **0**
 O&M Grade: **0**
 Clock Start/From: **2**
 Clock To:
 1st Value: **4.000**
 2nd Value:
 Value Percent:
 Continuous Index:
 Within 8" of Joint: **YES**
 Remarks:
