Profile/Photo Observation Report

Date:	09/20/2021	Weather:		Coding:	PACP 7.0
Pipe Length (ft):	175.6	Owner:	City of Hobart	Pre Clean:	Heavy Cleaning
P.O.#:	YES502259	Surveyor:	S. Bucklin	PSR:	P-503-024-023
Customer:	City of Hobart	Clean Date:	09/04/2021	Shape:	C

Street:	West 39th Avenue	Flow Control:	Not Controlled
City:	Hobart, IN	Year Renewed:	
Location:	Alley	Tape/Media #:	
Purpose:	Routine Assessment	Dia/Height:	10"
Use:	Sanitary Sewage Pipe	Material:	VCP
Drain Area:		Lining:	None
Category:	NA		
Comment:			
Location Details:		Direction of Survey:	Upstream
US MH:	M-503-023	DS MH:	M-503-024
		Total Length Surveyed (ft):	175.6

O&M Index:	1.62	O&M Quick:	5131	O&M Rating:	115.00
Structural Index:	2.76	Structural Quick:	4A38	Structural Rating:	102.00
Overall Index:	2.01	Overall Quick:	514A	Overall Rating:	217.00

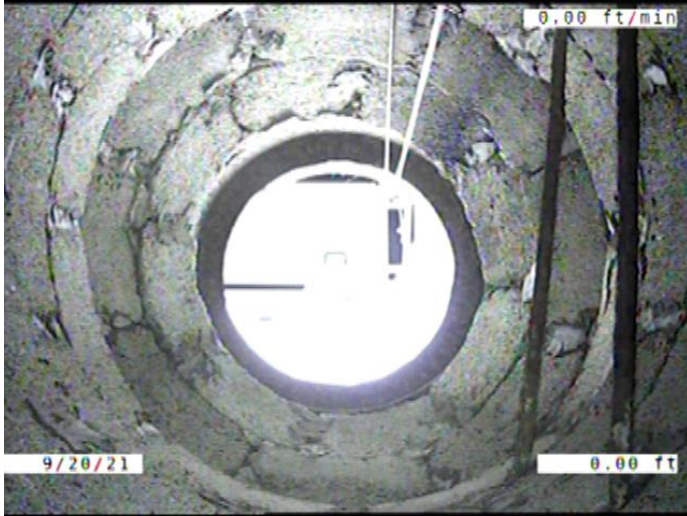
Code: **AMH**
Description: **Manhole**

Distance (ft): **.0**
Structural Grade: **0**
O&M Grade: **0**
Clock Start/From:
Clock To:
1st Value:
2nd Value:
Value Percent:
Continuous Index:
Within 8" of Joint: **NO**
Remarks: **M-503-024**

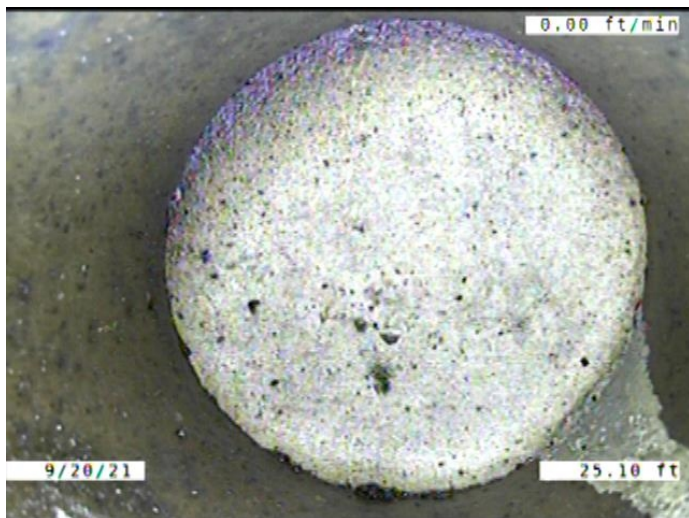
Code:	TFC
Description:	Tap Factory Capped
Distance (ft):	25.1
Structural Grade:	0
O&M Grade:	0
Clock Start/From:	1
Clock To:	
1st Value:	4.000
2nd Value:	
Value Percent:	
Continuous Index:	
Within 8" of Joint:	YES
Remarks:

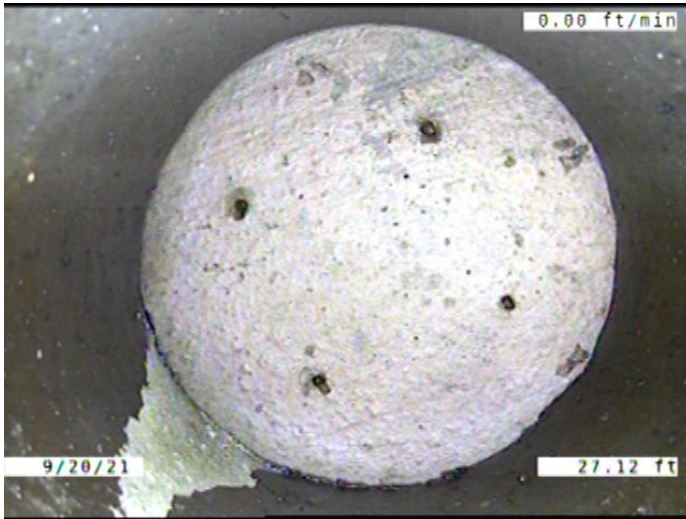
Code: **TFC**
 Description: **Tap Factory Capped**

Distance (ft): **27.1**
 Structural Grade: **0**
 O&M Grade: **0**
 Clock Start/From: **11**
 Clock To:
 1st Value: **4.000**
 2nd Value:
 Value Percent:
 Continuous Index:
 Within 8" of Joint: **YES**
 Remarks:

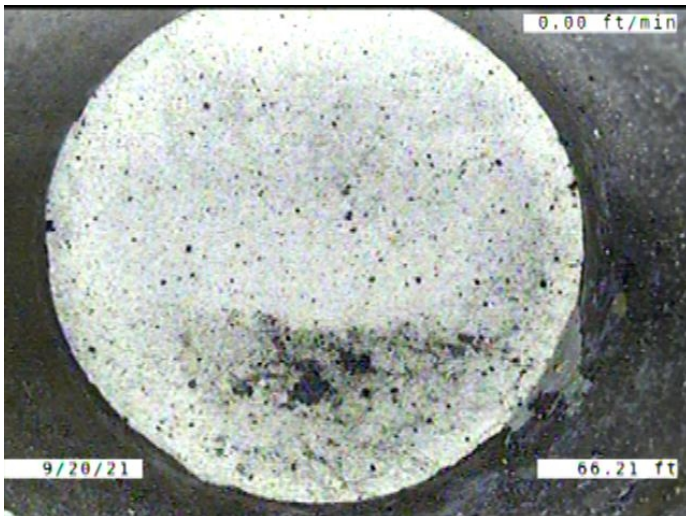
Code: **TFC**
 Description: **Tap Factory Capped**

Distance (ft): **66.2**
 Structural Grade: **0**
 O&M Grade: **0**
 Clock Start/From: **1**
 Clock To:
 1st Value: **4.000**
 2nd Value:
 Value Percent:
 Continuous Index:
 Within 8" of Joint: **YES**
 Remarks:

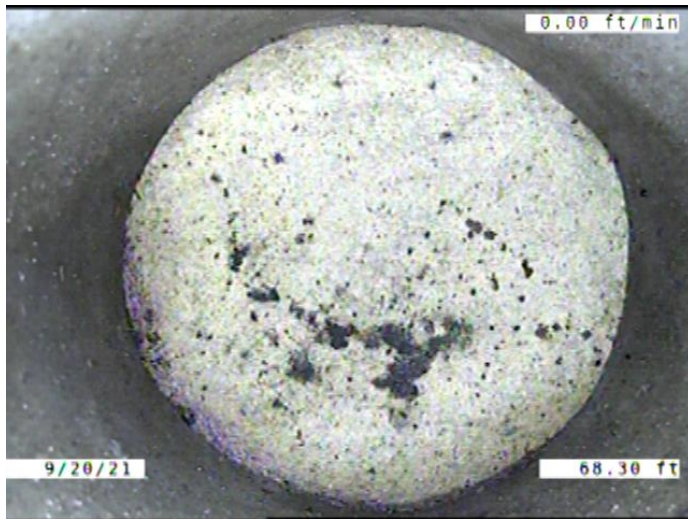
Code: **TFC**
 Description: **Tap Factory Capped**

Distance (ft): **68.3**
 Structural Grade: **0**
 O&M Grade: **0**
 Clock Start/From: **11**
 Clock To:
 1st Value: **4.000**
 2nd Value:
 Value Percent:
 Continuous Index:
 Within 8" of Joint: **YES**
 Remarks:

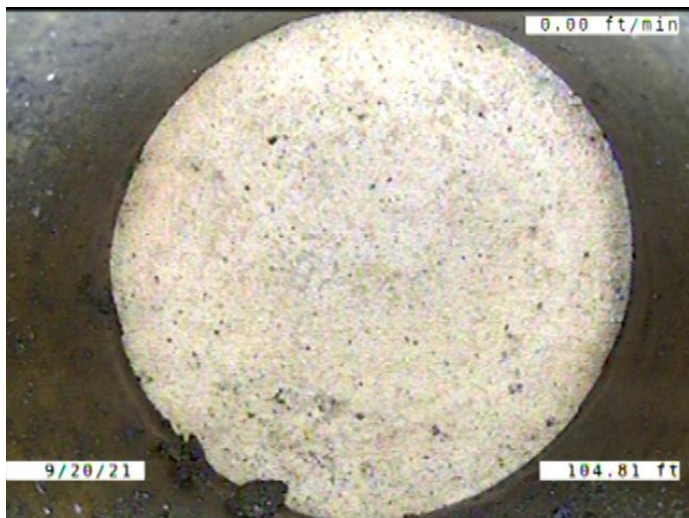
Code: **TFC**
 Description: **Tap Factory Capped**

Distance (ft): **104.8**
 Structural Grade: **0**
 O&M Grade: **0**
 Clock Start/From: **1**
 Clock To:
 1st Value: **4.000**
 2nd Value:
 Value Percent:
 Continuous Index:
 Within 8" of Joint: **YES**
 Remarks:

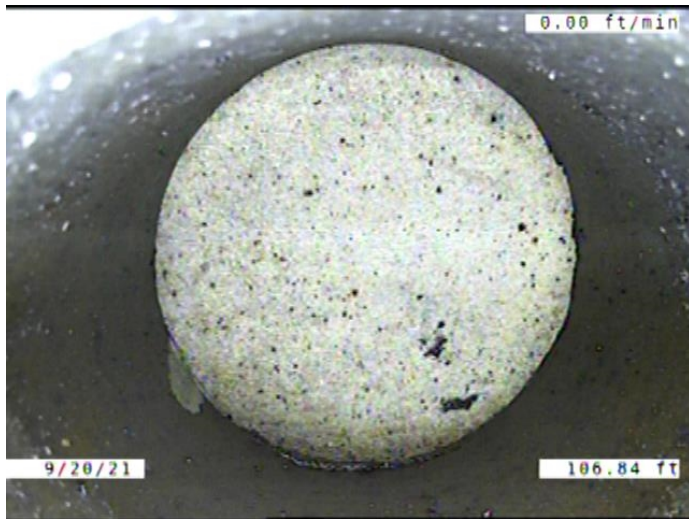
Code: **TFC**
Description: **Tap Factory Capped**

Distance (ft): **106.8**
Structural Grade: **0**
O&M Grade: **0**
Clock Start/From: **11**
Clock To:
1st Value: **4.000**
2nd Value:
Value Percent:
Continuous Index:
Within 8" of Joint: **YES**
Remarks:

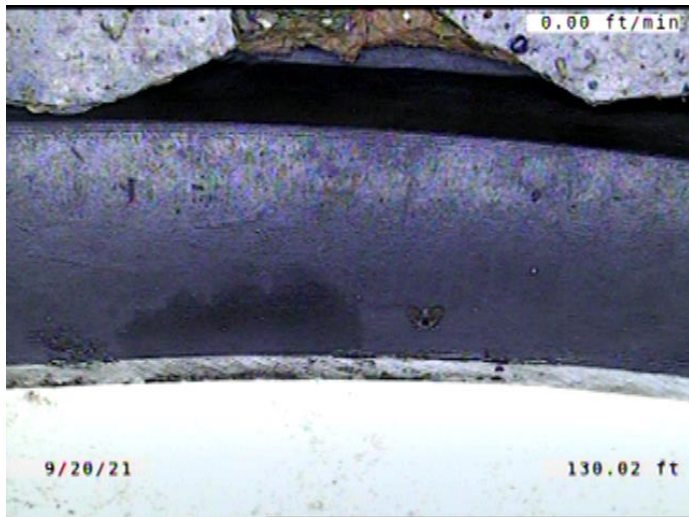
Code: **MMC**
 Description: **Miscellaneous Material Change**

Distance (ft): **130.0**
 Structural Grade: **0**
 O&M Grade: **0**
 Clock Start/From:
 Clock To:
 1st Value:
 2nd Value:
 Value Percent:
 Continuous Index:
 Within 8" of Joint: **NO**
 Remarks: **VCP TO PVC**

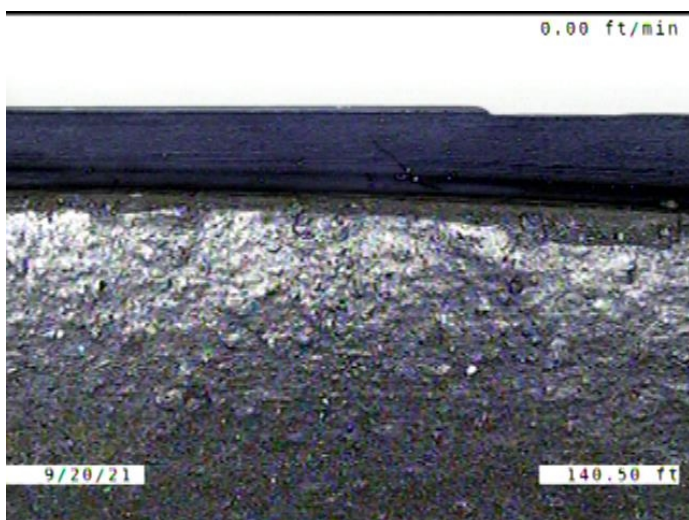
Code: **MMC**
 Description: **Miscellaneous Material Change**

Distance (ft): **140.5**
 Structural Grade: **0**
 O&M Grade: **0**
 Clock Start/From:
 Clock To:
 1st Value:
 2nd Value:
 Value Percent:
 Continuous Index:
 Within 8" of Joint: **NO**
 Remarks: **PVC TO VCP**

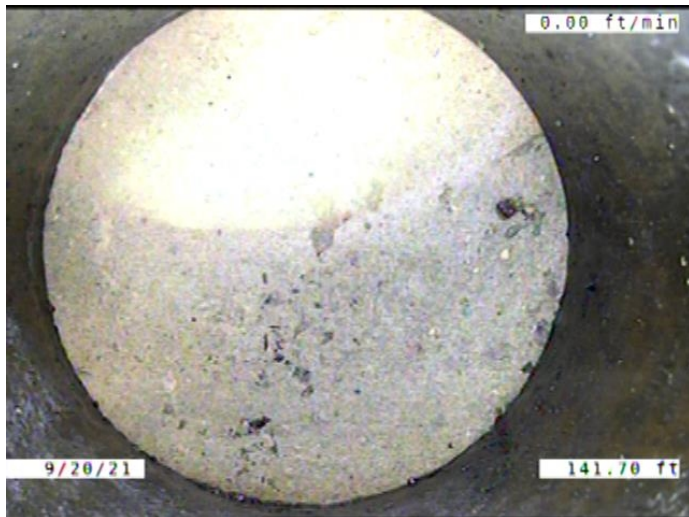
Code: **TFC**
 Description: **Tap Factory Capped**

Distance (ft): **141.7**
 Structural Grade: **0**
 O&M Grade: **0**
 Clock Start/From: **2**
 Clock To:
 1st Value: **4.000**
 2nd Value:
 Value Percent:
 Continuous Index:
 Within 8" of Joint: **YES**
 Remarks:

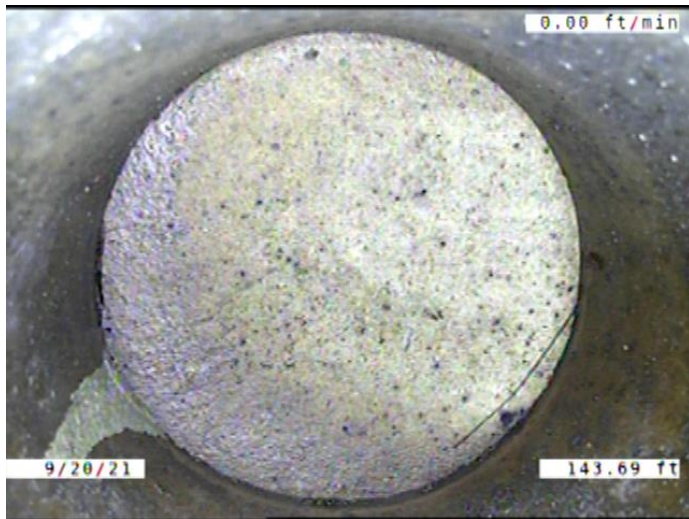
Code: **TFC**
 Description: **Tap Factory Capped**

Distance (ft): **143.7**
 Structural Grade: **0**
 O&M Grade: **0**
 Clock Start/From: **11**
 Clock To:
 1st Value: **4.000**
 2nd Value:
 Value Percent:
 Continuous Index:
 Within 8" of Joint: **YES**
 Remarks:

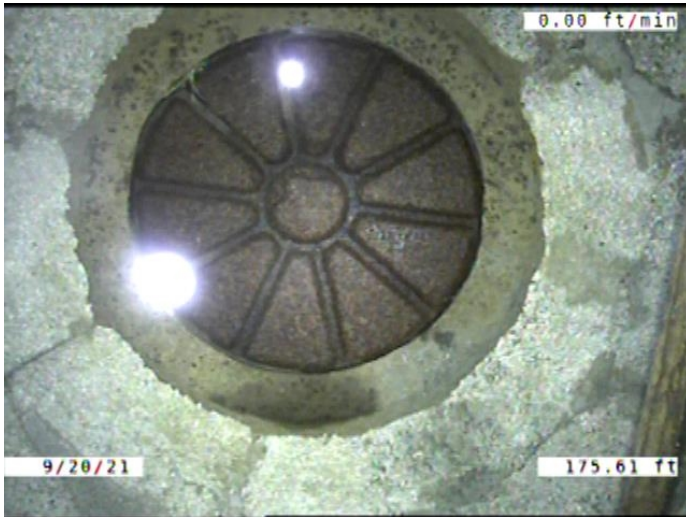
Code:	AMH
Description:	Manhole
Distance (ft):	175.6
Structural Grade:	0
O&M Grade:	0
Clock Start/From:	
Clock To:	
1st Value:	
2nd Value:	
Value Percent:	
Continuous Index:	
Within 8" of Joint:	NO
Remarks:	M-503-023
