Profile/Photo Observation Report

Date:	09/20/2021	Weather:		Coding:	PACP 7.0
Pipe Length (ft):	157.2	Owner:	City of Hobart	Pre Clean:	Light Cleaning
P.O.#:	YES502259	Surveyor:	S. Bucklin	PSR:	P-503-026-090
Customer:	City of Hobart	Clean Date:	08/28/2021	Shape:	C

Street:	West 41st Avenue	Flow Control:	Not Controlled
City:	Hobart, IN	Year Renewed:	
Location:	Local rural streets with light traffic, t	Tape/Media #:	
Purpose:	Routine Assessment	Dia/Height:	12"
Use:	Sanitary Sewage Pipe	Material:	VCP
Drain Area:		Lining:	None
Category:	NA		
Comment:			
Location Details:		Direction of Survey:	Downstream
US MH:	M-503-026	DS MH:	M-504-090
		Total Length Surveyed (ft):	157.2

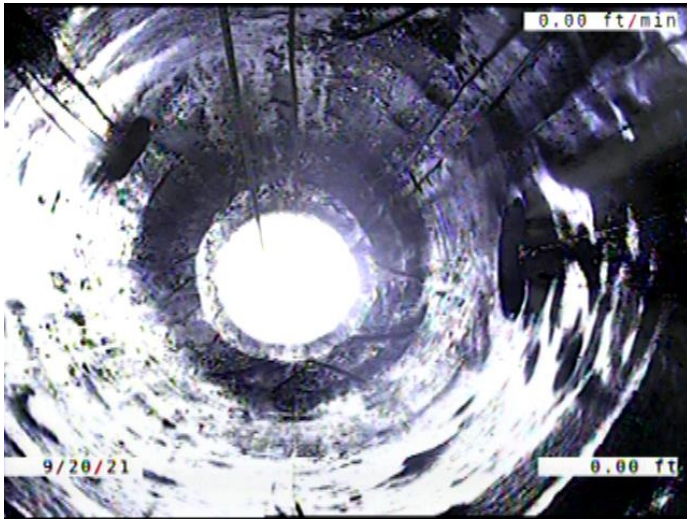
Code: **AMH**
Description: **Manhole**

Distance (ft): **.0**
Structural Grade: **0**
O&M Grade: **0**
Clock Start/From:
Clock To:
1st Value:
2nd Value:
Value Percent:
Continuous Index:
Within 8" of Joint: **NO**
Remarks: **M-503-026**

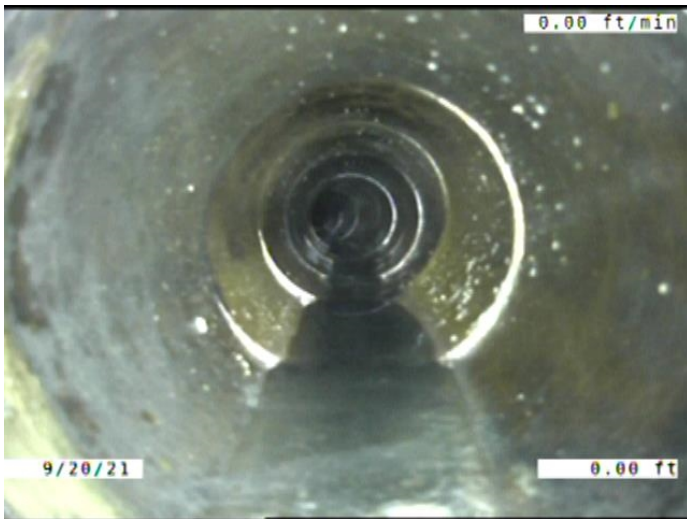
Code: **MWL**
Description: **Miscellaneous Water Level**

Distance (ft): **.0**
Structural Grade: **0**
O&M Grade: **0**
Clock Start/From:
Clock To:
1st Value:
2nd Value:
Value Percent: **5.000**
Continuous Index:
Within 8" of Joint: **NO**
Remarks:

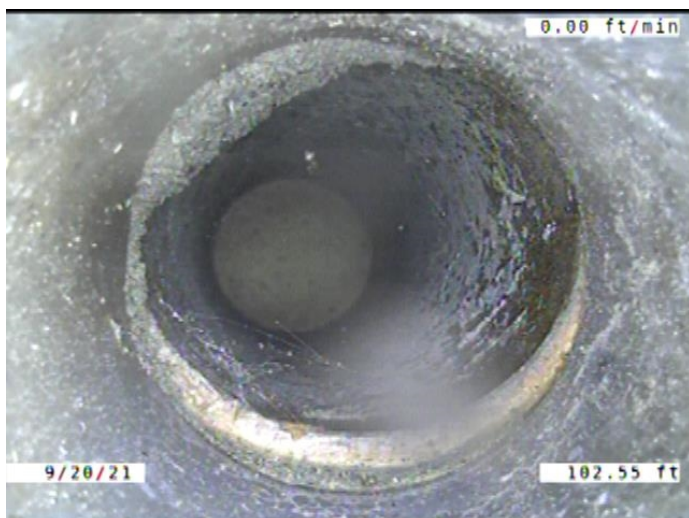
Code: **TF**
Description: **Tap Factory**

Distance (ft): **102.5**
Structural Grade: **0**
O&M Grade: **0**
Clock Start/From: **11**
Clock To:
1st Value: **4.000**
2nd Value:
Value Percent:
Continuous Index:
Within 8" of Joint: **YES**
Remarks: **LOOKS CAPPED**
