Profile/Photo Observation Report

Date:	04/09/2018	Weather:		Coding:	PACP 6.0
Pipe Length (ft):	218.3	Owner:	NA	Pre Clean:	Not Known
P.O.#:		Surveyor:	Byrd Fitzgerald	PSR:	P-503-027.5-027
Customer:		Clean Date:	01/01/1900	Shape:	C

Street:	W 40th ave	Flow Control:	Not Controlled
City:	Hobart, IN	Year Renewed:	
Location:	Other	Tape/Media #:	
Purpose:	Not Known	Dia/Height:	10"
Use:	Sanitary	Material:	VCP
Drain Area:	NA	Lining:	
Category:	NA		
Comment:

Location Details:		Direction of Survey:	Upstream
US MH:	M-503-027	DS MH:	M-503-027.5
		Total Length Surveyed (ft):	29.7

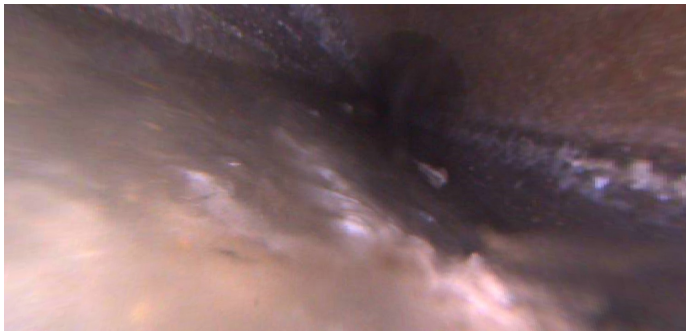
Code: **AMH**
Description: **Manhole**

Distance (ft): **.0**
Structural Grade: **0**
O&M Grade: **0**
Clock Start/From:
Clock To:
1st Value:
2nd Value:
Value Percent:
Continuous Index:
Within 8" of Joint: **NO**
Remarks: **M-503-027.5**

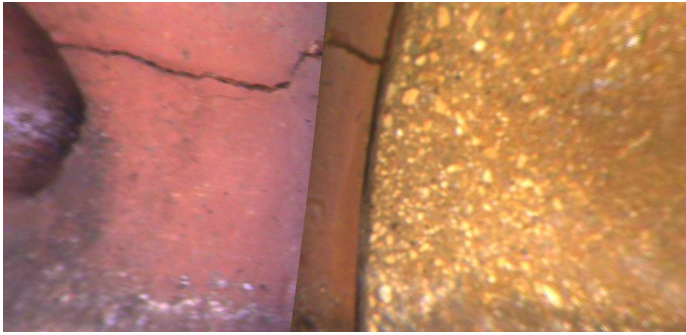
Code: **MMC**
Description: **Material Change**

Distance (ft): **21.1**
Structural Grade: **0**
O&M Grade: **0**
Clock Start/From:
Clock To:
1st Value:
2nd Value:
Value Percent:
Continuous Index:
Within 8" of Joint: **NO**
Remarks: **vcp**

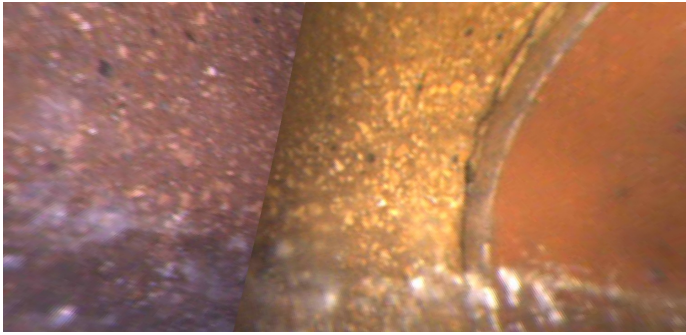
Code: **MMC**
Description: **Material Change**

Distance (ft): **27.5**
Structural Grade: **0**
O&M Grade: **0**
Clock Start/From:
Clock To:
1st Value:
2nd Value:
Value Percent:
Continuous Index:
Within 8" of Joint: **NO**
Remarks: **cp**
