Profile/Photo Observation Report

Date:	09/08/2021	Weather:		Coding:	PACP 7.0
Pipe Length (ft):	213.8	Owner:	City of Hobart	Pre Clean:	Light Cleaning
P.O.#:	YES502259	Surveyor:	S. Bucklin	PSR:	P-503-027.5-027
Customer:	City of Hobart	Clean Date:	08/28/2021	Shape:	C

Street:	North Virginia Street	Flow Control:	Not Controlled
City:	Hobart, IN	Year Renewed:	
Location:	Local rural streets with light traffic, t	Tape/Media #:	
Purpose:	Routine Assessment	Dia/Height:	10"
Use:	Sanitary Sewage Pipe	Material:	CP
Drain Area:		Lining:	None
Category:	NA		
Comment:			
Location Details:		Direction of Survey:	Upstream
US MH:	M-503-027	DS MH:	M-503-027.5
		Total Length Surveyed (ft):	213.8

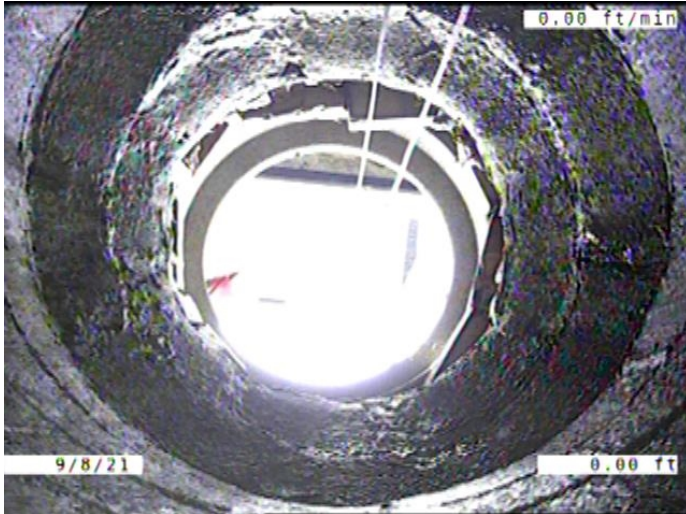
Code: **AMH**
 Description: **Manhole**

Distance (ft): **.0**
 Structural Grade: **0**
 O&M Grade: **0**
 Clock Start/From:
 Clock To:
 1st Value:
 2nd Value:
 Value Percent:
 Continuous Index:
 Within 8" of Joint: **NO**
 Remarks: **M-503-027.5**

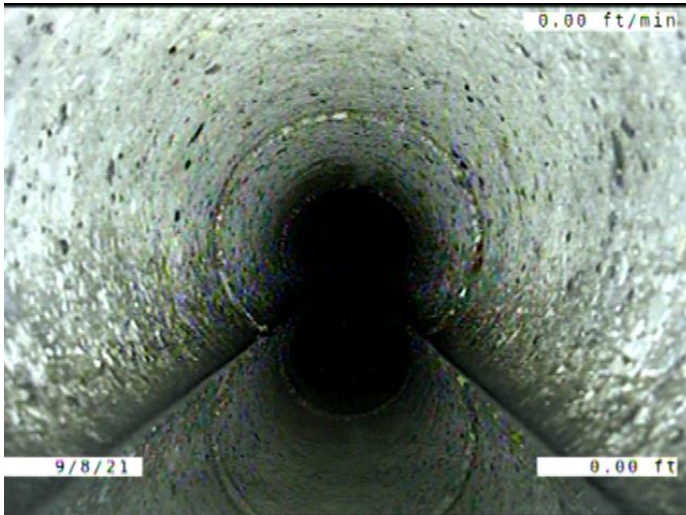
Code: **MWL**
 Description: **Miscellaneous Water Level**

Distance (ft): **.0**
 Structural Grade: **0**
 O&M Grade: **0**
 Clock Start/From:
 Clock To:
 1st Value:
 2nd Value:
 Value Percent: **5.000**
 Continuous Index:
 Within 8" of Joint: **NO**
 Remarks:

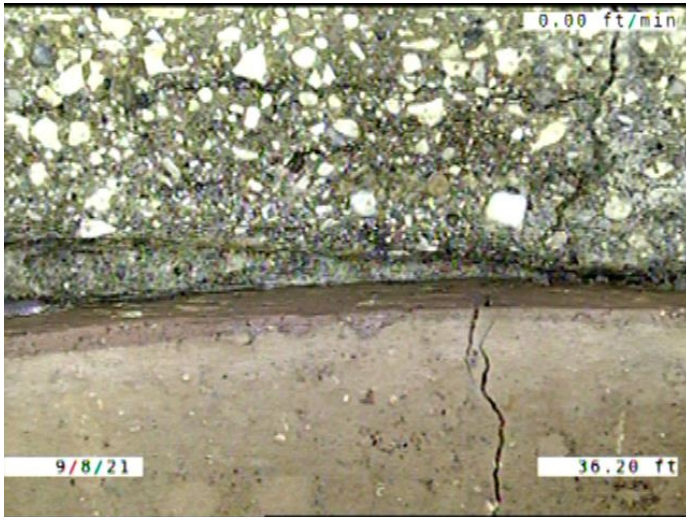
Code: **MMC**
 Description: **Miscellaneous Material Change**

Distance (ft): **36.2**
 Structural Grade: **0**
 O&M Grade: **0**
 Clock Start/From:
 Clock To:
 1st Value:
 2nd Value:
 Value Percent:
 Continuous Index:
 Within 8" of Joint: **NO**
 Remarks: **CONCRETE TO VCP**

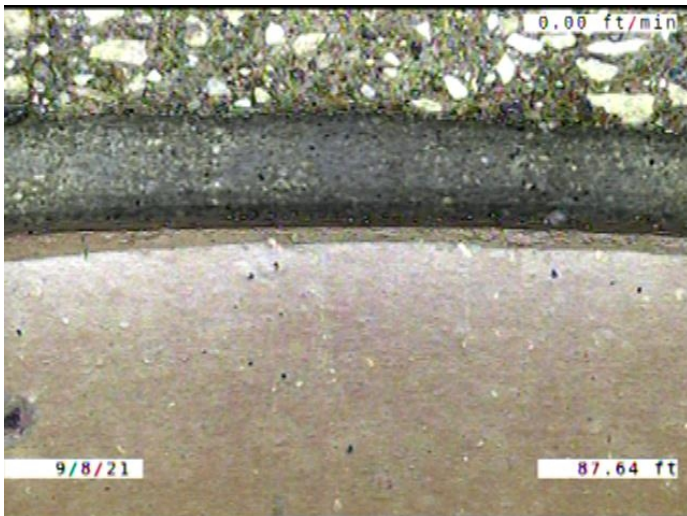
Code: **MMC**
 Description: **Miscellaneous Material Change**

Distance (ft): **87.6**
 Structural Grade: **0**
 O&M Grade: **0**
 Clock Start/From:
 Clock To:
 1st Value:
 2nd Value:
 Value Percent:
 Continuous Index:
 Within 8" of Joint: **NO**
 Remarks: **CONCRETE TO VCP**

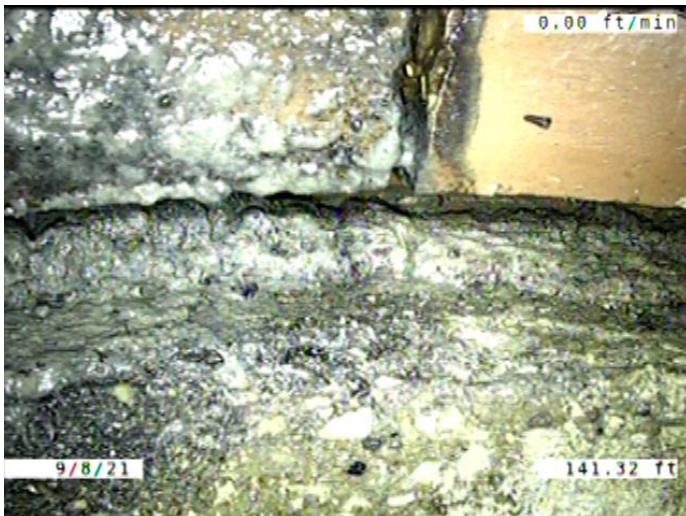
Code: **MMC**
 Description: **Miscellaneous Material Change**

Distance (ft): **141.3**
 Structural Grade: **0**
 O&M Grade: **0**
 Clock Start/From:
 Clock To:
 1st Value:
 2nd Value:
 Value Percent:
 Continuous Index:
 Within 8" of Joint: **NO**
 Remarks: **VCP TO CONCRETE**
