Profile/Photo Observation Report

Date:	04/09/2018	Weather:		Coding:	PACP 6.0
Pipe Length (ft):	230.8	Owner:	NA	Pre Clean:	Not Known
P.O.#:		Surveyor:	Mark Ruby	PSR:	P-504-028-027.5
Customer:		Clean Date:	01/01/1900	Shape:	C

Street:	N VIRGINIA ST	Flow Control:	Not Controlled
City:	Hobart, IN	Year Renewed:	
Location:	Other	Tape/Media #:	
Purpose:	Not Known	Dia/Height:	10"
Use:	Sanitary	Material:	VCP
Drain Area:	NA	Lining:	
Category:	NA		
Comment:			
Location Details:		Direction of Survey:	Upstream
US MH:	M-503-027.5	DS MH:	M-503-028
		Total Length Surveyed (ft):	207.4

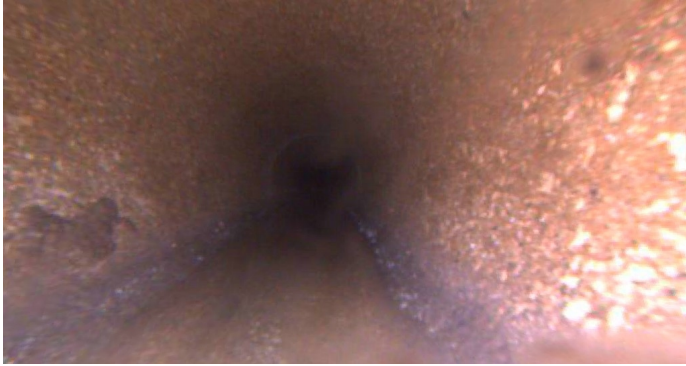
Code: **AMH**
Description: **Manhole**

Distance (ft): **.0**
Structural Grade: **0**
O&M Grade: **0**
Clock Start/From:
Clock To:
1st Value:
2nd Value:
Value Percent:
Continuous Index:
Within 8" of Joint: **NO**
Remarks: **M-503-028**

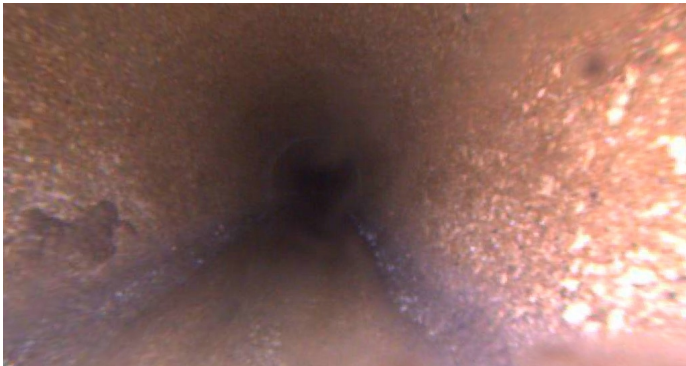
Code: **MWL**
Description: **Water Level**

Distance (ft): **.0**
Structural Grade: **0**
O&M Grade: **0**
Clock Start/From:
Clock To:
1st Value:
2nd Value:
Value Percent: **10.000**
Continuous Index:
Within 8" of Joint: **NO**
Remarks:

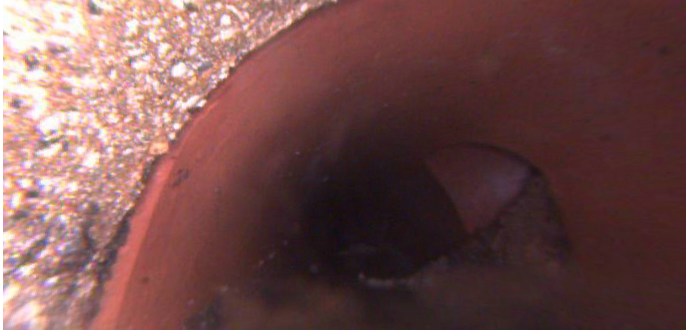
Code: **MMC**
Description: **Material Change**

Distance (ft): **36.7**
Structural Grade: **0**
O&M Grade: **0**
Clock Start/From:
Clock To:
1st Value:
2nd Value:
Value Percent:
Continuous Index:
Within 8" of Joint: **NO**
Remarks: **vcp**

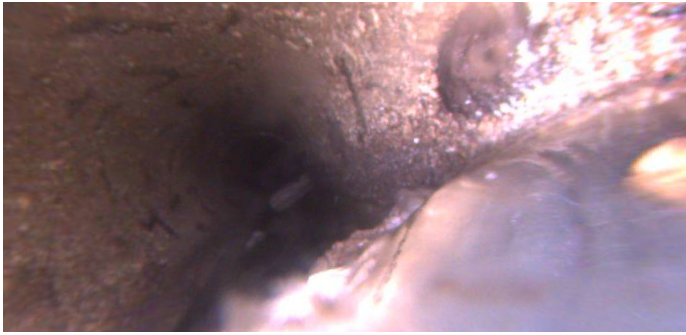
Code: **MMC**
Description: **Material Change**

Distance (ft): **39.9**
Structural Grade: **0**
O&M Grade: **0**
Clock Start/From:
Clock To:
1st Value:
2nd Value:
Value Percent:
Continuous Index:
Within 8" of Joint: **NO**
Remarks: **cp**

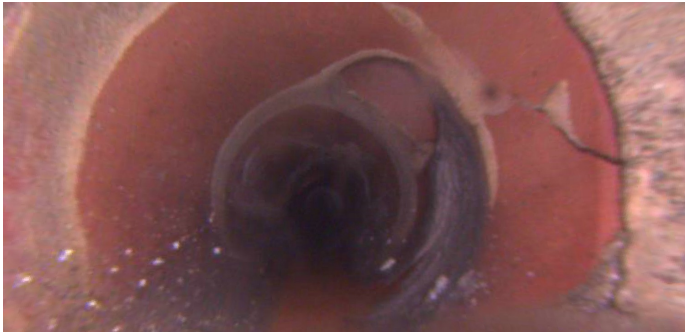
Code: **MMC**
Description: **Material Change**

Distance (ft): **81.1**
Structural Grade: **0**
O&M Grade: **0**
Clock Start/From:
Clock To:
1st Value:
2nd Value:
Value Percent:
Continuous Index:
Within 8" of Joint: **NO**
Remarks: **VCP**

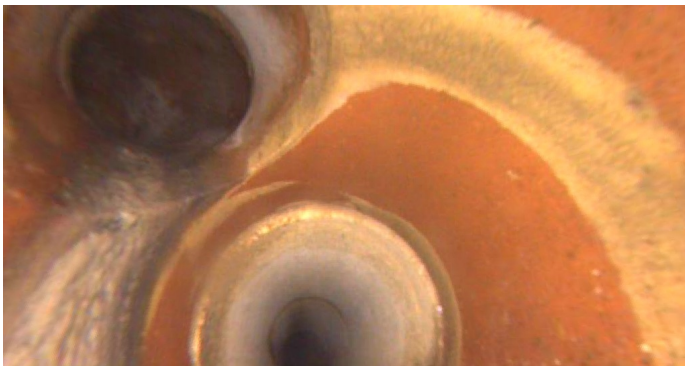
Code: **TF**
Description: **Tap Factory**

Distance (ft): **82.7**
Structural Grade: **0**
O&M Grade: **0**
Clock Start/From: **2**
Clock To:
1st Value: **4.000**
2nd Value:
Value Percent:
Continuous Index:
Within 8" of Joint:
Remarks: **Photo taken from rear camera.**

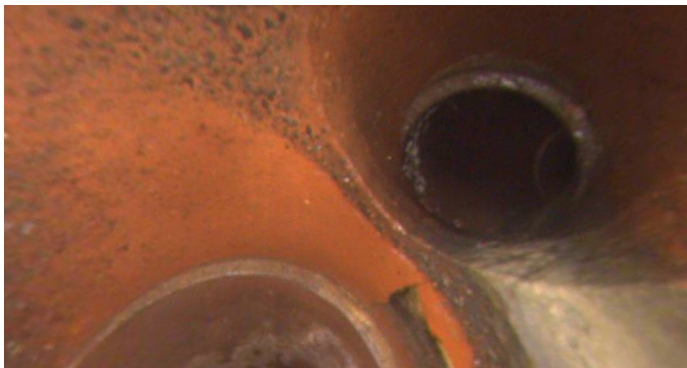
Code: **FM**
Description: **Fracture Multiple**

Distance (ft): **84.1**
Structural Grade: **4**
O&M Grade: **0**
Clock Start/From: **8**
Clock To: **10**
1st Value:
2nd Value:
Value Percent:
Continuous Index:
Within 8" of Joint: **YES**
Remarks:

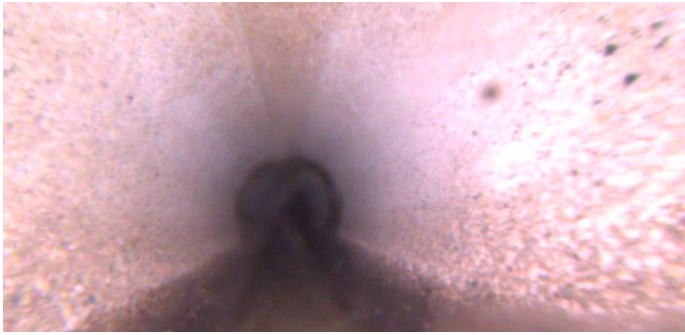
Code: **MMC**
Description: **Material Change**

Distance (ft): **87.4**
Structural Grade: **0**
O&M Grade: **0**
Clock Start/From:
Clock To:
1st Value:
2nd Value:
Value Percent:
Continuous Index:
Within 8" of Joint: **NO**
Remarks: **cp**

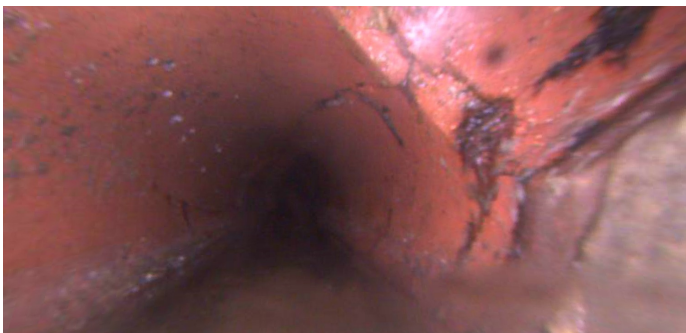
Code: **MMC**
Description: **Material Change**

Distance (ft): **132.4**
Structural Grade: **0**
O&M Grade: **0**
Clock Start/From:
Clock To:
1st Value:
2nd Value:
Value Percent:
Continuous Index:
Within 8" of Joint: **NO**
Remarks: **VCP**

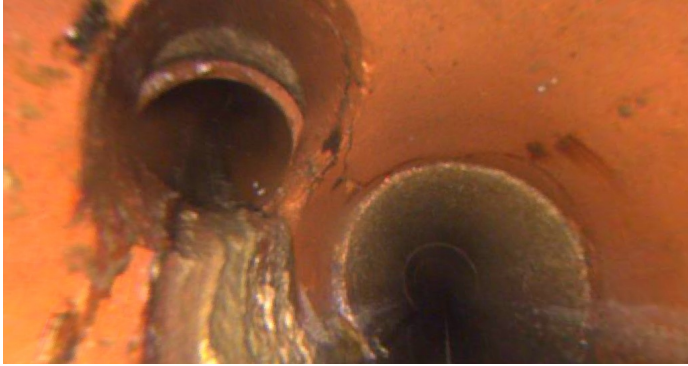
Code: **TF**
Description: **Tap Factory**

Distance (ft): **133.2**
Structural Grade: **0**
O&M Grade: **0**
Clock Start/From: **3**
Clock To:
1st Value: **4.000**
2nd Value:
Value Percent:
Continuous Index:
Within 8" of Joint:
Remarks: **Photo taken from rear camera.**

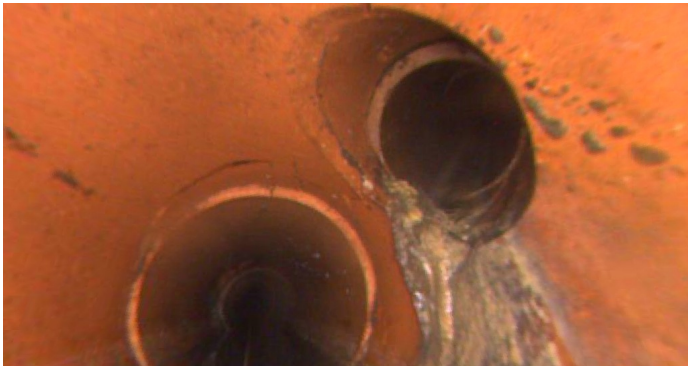
Code: **TF**
Description: **Tap Factory**

Distance (ft): **136.3**
Structural Grade: **0**
O&M Grade: **0**
Clock Start/From: **10**
Clock To:
1st Value: **4.000**
2nd Value:
Value Percent:
Continuous Index:
Within 8" of Joint:
Remarks: **Photo taken from rear camera.**

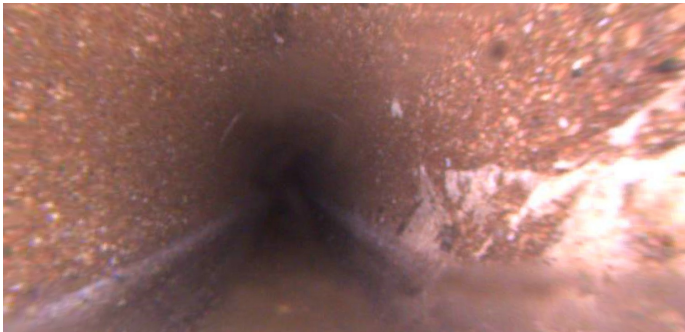
Code: **MMC**
Description: **Material Change**

Distance (ft): **137.9**
Structural Grade: **0**
O&M Grade: **0**
Clock Start/From:
Clock To:
1st Value:
2nd Value:
Value Percent:
Continuous Index:
Within 8" of Joint: **NO**
Remarks: **cp**

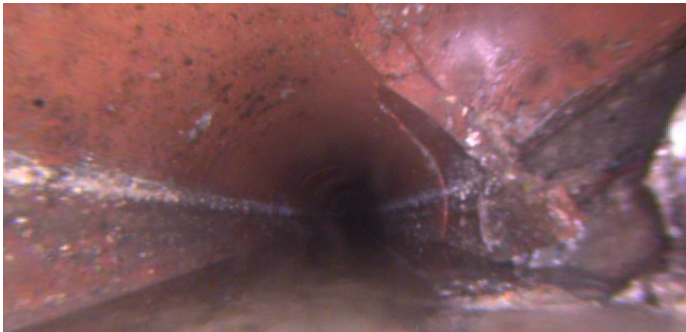
Code: **MMC**
Description: **Material Change**

Distance (ft): **179.7**
Structural Grade: **0**
O&M Grade: **0**
Clock Start/From:
Clock To:
1st Value:
2nd Value:
Value Percent:
Continuous Index:
Within 8" of Joint: **NO**
Remarks: **VC**

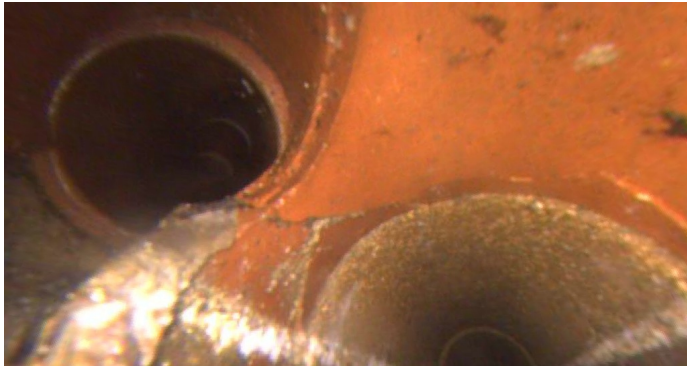
Code: **TF**
Description: **Tap Factory**

Distance (ft): **180.4**
Structural Grade: **0**
O&M Grade: **0**
Clock Start/From: **2**
Clock To:
1st Value: **4.000**
2nd Value:
Value Percent:
Continuous Index:
Within 8" of Joint:
Remarks: **Photo taken from rear camera.**

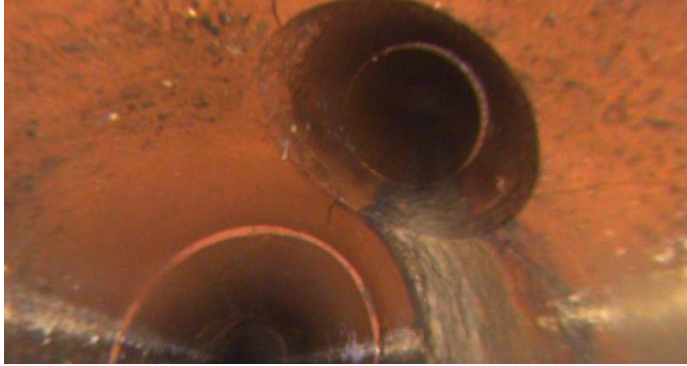
Code: **TF**
Description: **Tap Factory**

Distance (ft): **183.8**
Structural Grade: **0**
O&M Grade: **0**
Clock Start/From: **10**
Clock To:
1st Value: **4.000**
2nd Value:
Value Percent:
Continuous Index:
Within 8" of Joint:
Remarks: **Photo taken from rear camera.**

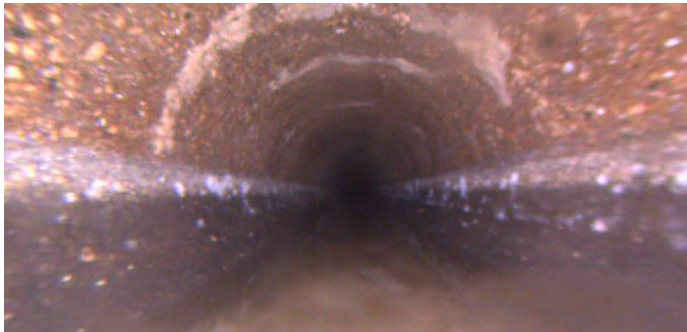
Code: **MMC**
Description: **Material Change**

Distance (ft): **185.6**
Structural Grade: **0**
O&M Grade: **0**
Clock Start/From:
Clock To:
1st Value:
2nd Value:
Value Percent:
Continuous Index:
Within 8" of Joint: **NO**
Remarks: **cp**

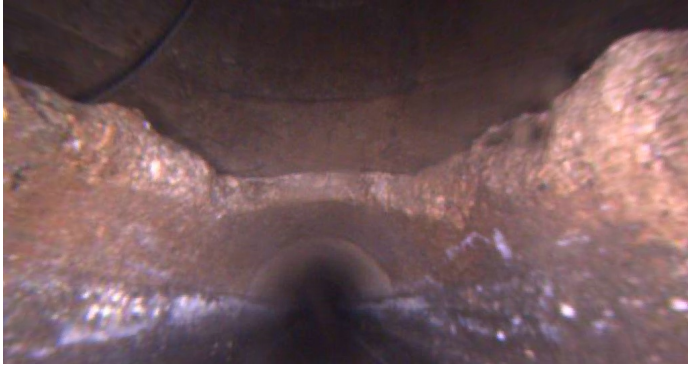
Code:	AMH
Description:	Manhole
Distance (ft):	207.4
Structural Grade:	0
O&M Grade:	0
Clock Start/From:	
Clock To:	
1st Value:	
2nd Value:	
Value Percent:	
Continuous Index:	
Within 8" of Joint:	NO
Remarks:	M-503-027.5
