RedZone
ROBOTICS

Street:	N DELAWARE ST		Flow Control:	Not Controlled	
City:	Hobart, IN		Year Renewed:		
Location:	Light Highway		Tape/Media #:		
Purpose:	Routine Assessment		Dia/Height:	10"	
Use:	Sanitary		Material:	CP	
Drain Area:	NA		Lining:	Other	
Category:	NA				
Comment:					
Location Details:			Direction of Survey:	Upstream	
US MH:	M-503-030	DS MH:	M-503-029	Total Length Surveyed (ft):	144.6

O&M Index:	<u>2.00</u>	O&M Quick:	312D	O&M Rating:	<u>54.00</u>
Structural Index:	<u>3.03</u>	Structural Quick:	5241	Structural Rating:	<u>109.00</u>
Overall Index:	<u>2.59</u>	Overall Quick:	5241	Overall Rating:	<u>163.00</u>

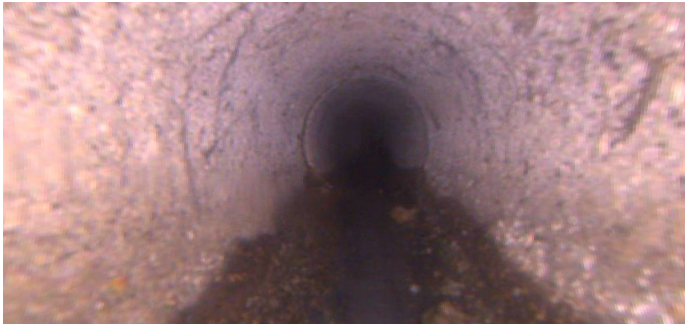
Code: **AMH**
Description: **Manhole**

Distance (ft): **.0**
Structural Grade: **0**
O&M Grade: **0**
Clock Start/From:
Clock To:
1st Value:
2nd Value:
Value Percent:
Continuous Index:
Within 8" of Joint: **NO**
Remarks: **M-503-029**

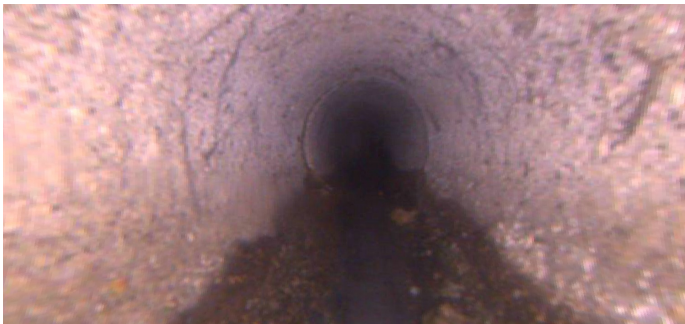
Code: **MWL**
Description: **Water Level**

Distance (ft): **.0**
Structural Grade: **0**
O&M Grade: **0**
Clock Start/From:
Clock To:
1st Value:
2nd Value:
Value Percent: **5.000**
Continuous Index:
Within 8" of Joint: **NO**
Remarks:

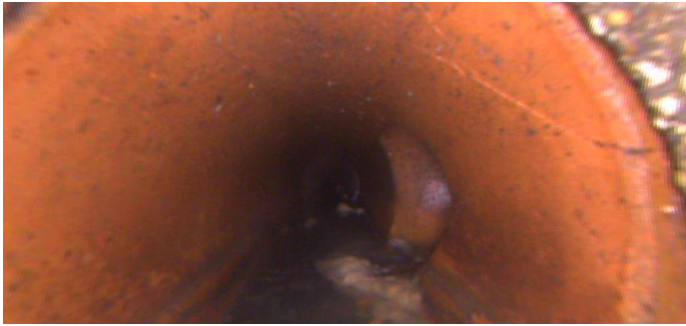
Code: **TF**
Description: **Tap Factory**

Distance (ft): **26.3**
Structural Grade: **0**
O&M Grade: **0**
Clock Start/From: **3**
Clock To:
1st Value: **4.000**
2nd Value:
Value Percent:
Continuous Index:
Within 8" of Joint:
Remarks:

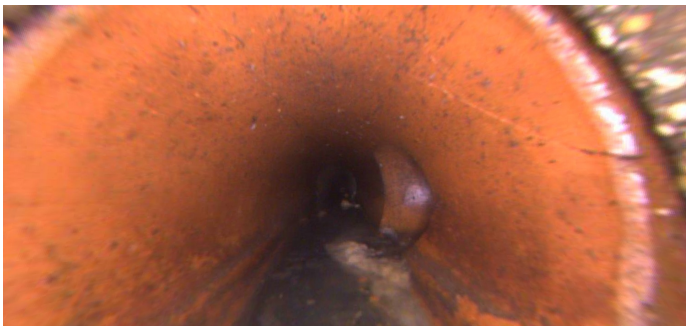
Code: **MMC**
Description: **Material Change**

Distance (ft): **26.3**
Structural Grade: **0**
O&M Grade: **0**
Clock Start/From:
Clock To:
1st Value:
2nd Value:
Value Percent:
Continuous Index:
Within 8" of Joint: **NO**
Remarks: **VCP**

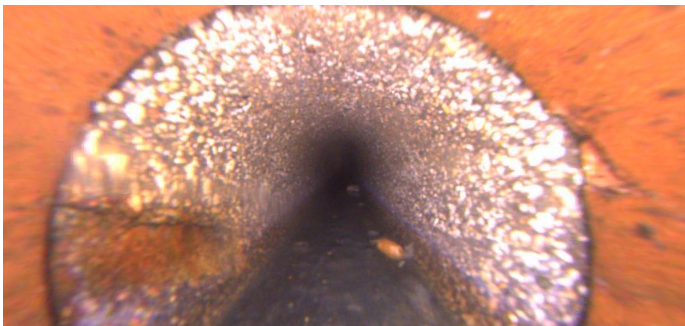
Code: **MMC**
Description: **Material Change**

Distance (ft): **29.3**
Structural Grade: **0**
O&M Grade: **0**
Clock Start/From:
Clock To:
1st Value:
2nd Value:
Value Percent:
Continuous Index:
Within 8" of Joint: **NO**
Remarks: **CP (non-reinforced)**

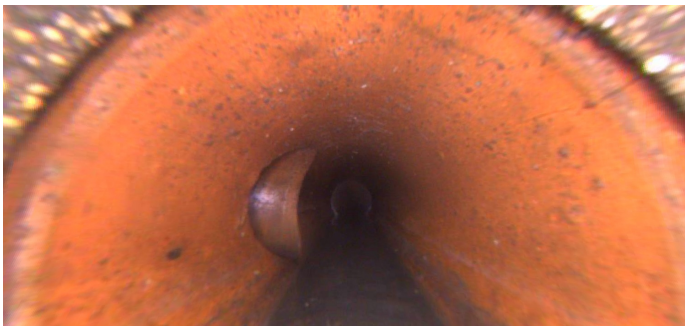
Code: **MMC**
Description: **Material Change**

Distance (ft): **44.4**
Structural Grade: **0**
O&M Grade: **0**
Clock Start/From:
Clock To:
1st Value:
2nd Value:
Value Percent:
Continuous Index:
Within 8" of Joint: **NO**
Remarks: **VCP**

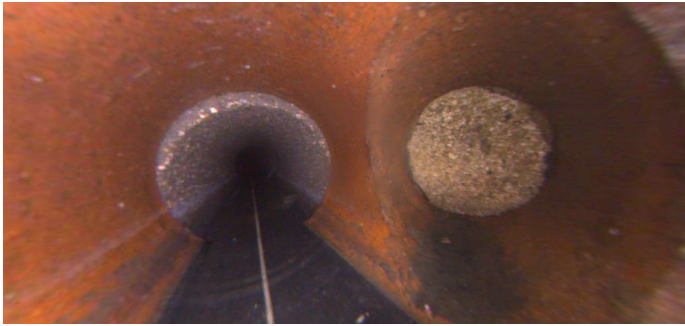
Code: **TFC**
Description: **Tap Factory Capped**

Distance (ft): **45.5**
Structural Grade: **0**
O&M Grade: **0**
Clock Start/From: **9**
Clock To:
1st Value: **4.000**
2nd Value:
Value Percent:
Continuous Index:
Within 8" of Joint:
Remarks:

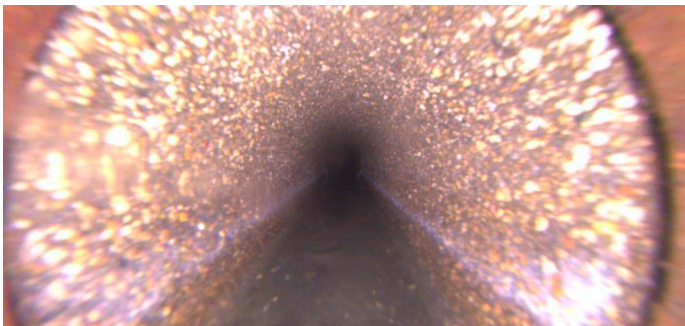
Code: **MMC**
Description: **Material Change**

Distance (ft): **47.4**
Structural Grade: **0**
O&M Grade: **0**
Clock Start/From:
Clock To:
1st Value:
2nd Value:
Value Percent:
Continuous Index:
Within 8" of Joint: **NO**
Remarks: **CP (non-reinforced)**

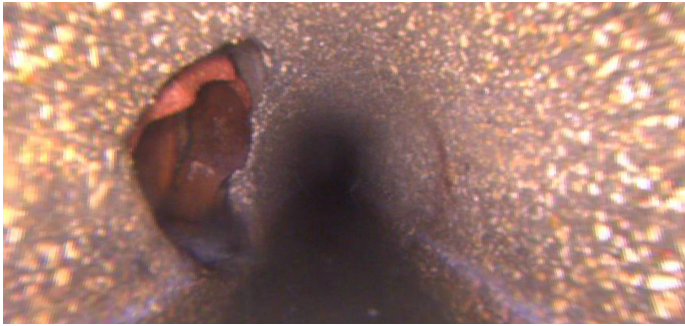
Code: **TB**
Description: **Tap Break-in**

Distance (ft): **56.9**
Structural Grade: **0**
O&M Grade: **0**
Clock Start/From: **9**
Clock To:
1st Value: **6.000**
2nd Value:
Value Percent:
Continuous Index:
Within 8" of Joint:
Remarks:

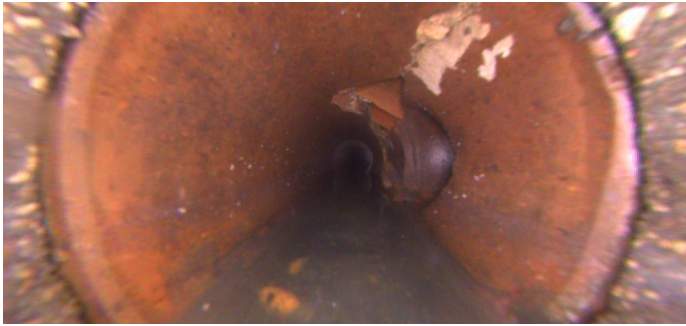
Code: **MMC**
Description: **Material Change**

Distance (ft): **80.6**
Structural Grade: **0**
O&M Grade: **0**
Clock Start/From:
Clock To:
1st Value:
2nd Value:
Value Percent:
Continuous Index:
Within 8" of Joint: **NO**
Remarks: **VCP**

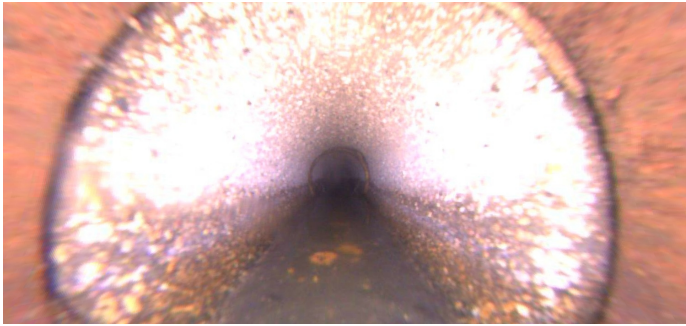
Code: **MMC**
Description: **Material Change**

Distance (ft): **83.5**
Structural Grade: **0**
O&M Grade: **0**
Clock Start/From:
Clock To:
1st Value:
2nd Value:
Value Percent:
Continuous Index:
Within 8" of Joint: **NO**
Remarks: **CP (non-reinforced)**

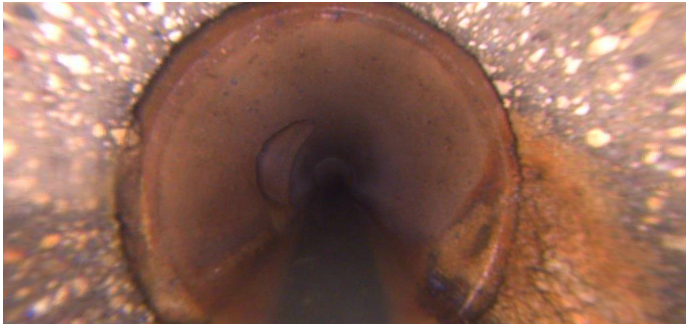
Code: **MMC**
Description: **Material Change**

Distance (ft): **98.7**
Structural Grade: **0**
O&M Grade: **0**
Clock Start/From:
Clock To:
1st Value:
2nd Value:
Value Percent:
Continuous Index:
Within 8" of Joint: **NO**
Remarks: **VCP**

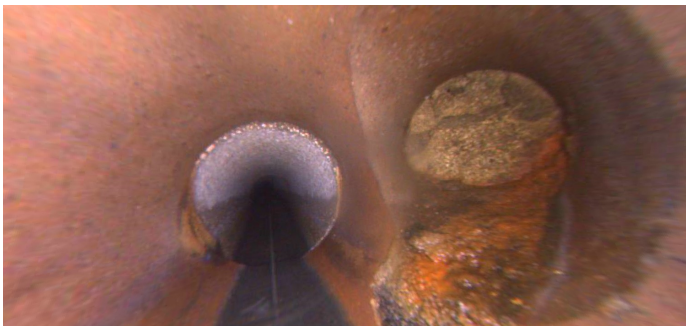
Code: **TFC**
Description: **Tap Factory Capped**

Distance (ft): **100.0**
Structural Grade: **0**
O&M Grade: **0**
Clock Start/From: **9**
Clock To:
1st Value: **6.000**
2nd Value:
Value Percent:
Continuous Index:
Within 8" of Joint:
Remarks:

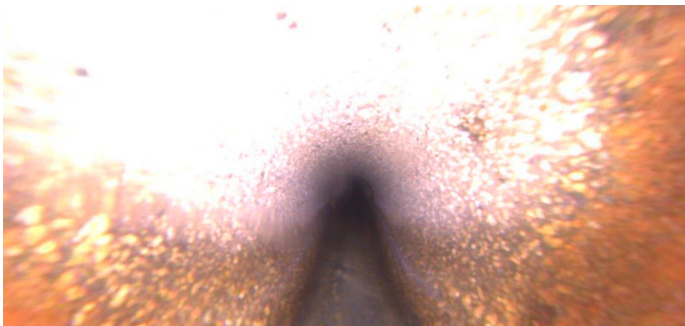
Code: **MMC**
Description: **Material Change**

Distance (ft): **101.9**
Structural Grade: **0**
O&M Grade: **0**
Clock Start/From:
Clock To:
1st Value:
2nd Value:
Value Percent:
Continuous Index:
Within 8" of Joint: **NO**
Remarks: **CP (non-reinforced)**

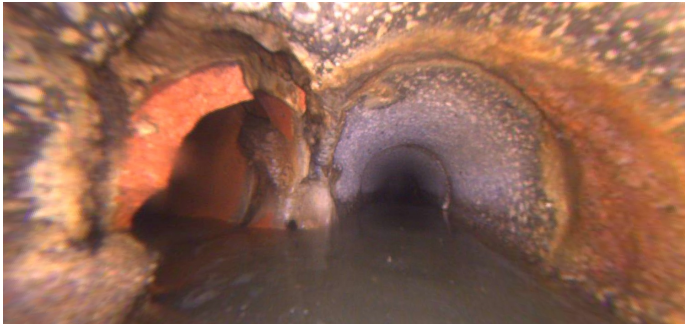
Code: **TB**
Description: **Tap Break-in**

Distance (ft): **115.5**
Structural Grade: **0**
O&M Grade: **0**
Clock Start/From: **9**
Clock To:
1st Value: **6.000**
2nd Value:
Value Percent:
Continuous Index:
Within 8" of Joint:
Remarks:

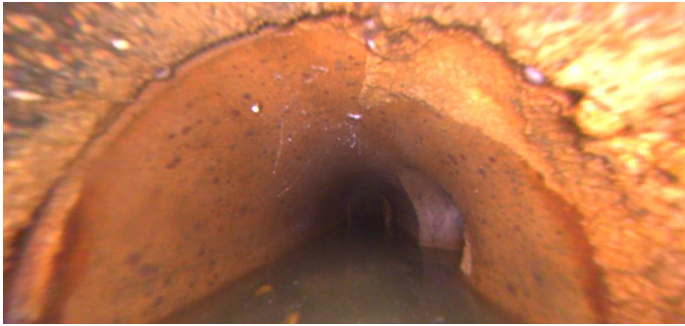
Code: **MMC**
Description: **Material Change**

Distance (ft): **135.0**
Structural Grade: **0**
O&M Grade: **0**
Clock Start/From:
Clock To:
1st Value:
2nd Value:
Value Percent:
Continuous Index:
Within 8" of Joint: **NO**
Remarks: **VCP**

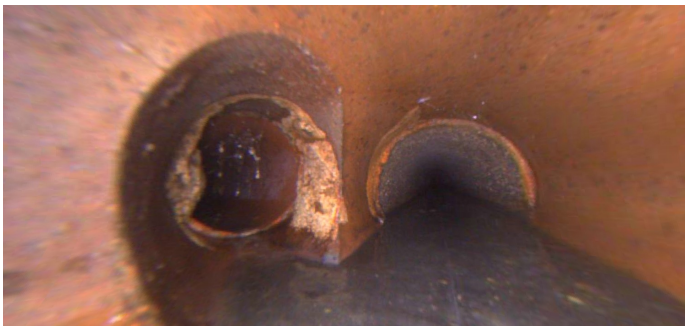
Code: **TF**
Description: **Tap Factory**

Distance (ft): **136.2**
Structural Grade: **0**
O&M Grade: **0**
Clock Start/From: **3**
Clock To:
1st Value: **6.000**
2nd Value:
Value Percent:
Continuous Index:
Within 8" of Joint:
Remarks:

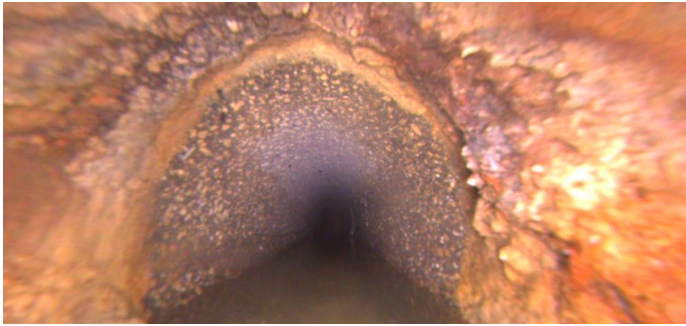
Code: **MMC**
Description: **Material Change**

Distance (ft): **138.3**
Structural Grade: **0**
O&M Grade: **0**
Clock Start/From:
Clock To:
1st Value:
2nd Value:
Value Percent:
Continuous Index:
Within 8" of Joint: **NO**
Remarks: **CP (non-reinforced)**

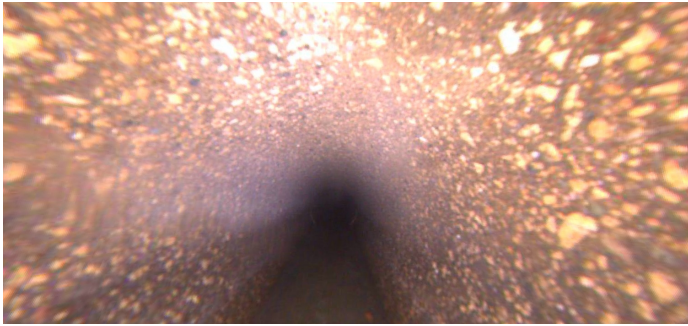
Code:	MSA
Description:	Abandoned Survey
Distance (ft):	144.6
Structural Grade:	0
O&M Grade:	0
Clock Start/From:	
Clock To:	
1st Value:	
2nd Value:	
Value Percent:	
Continuous Index:	
Within 8" of Joint:	NO
Remarks:	DAE
