## Profile/Photo Observation Report

Date:	<b>04/07/2018</b>	Weather:		Coding:	<b>PACP 6.0</b>
Pipe Length (ft):	<b>296.1</b>	Owner:	<b>NA</b>	Pre Clean:	<b>Not Known</b>
P.O.#:		Surveyor:	<b>Mark Ruby</b>	PSR:	<b>P-503-030-031</b>
Customer:		Clean Date:	<b>01/01/1900</b>	Shape:	<b>C</b>

Street:	<b>N DELAWARE ST</b>	Flow Control:	<b>Not Controlled</b>
City:	<b>Hobart, IN</b>	Year Renewed:	
Location:	<b>Other</b>	Tape/Media #:	
Purpose:	<b>Not Known</b>	Dia/Height:	<b>10"</b>
Use:	<b>Sanitary</b>	Material:	<b>VCP</b>
Drain Area:	<b>NA</b>	Lining:	
Category:	<b>NA</b>		
Comment:

Location Details:		Direction of Survey:	<b>Upstream</b>
US MH:	<b>M-503-031</b>	DS MH:	<b>M-503-030</b>
		Total Length Surveyed (ft):	<b>286.0</b>

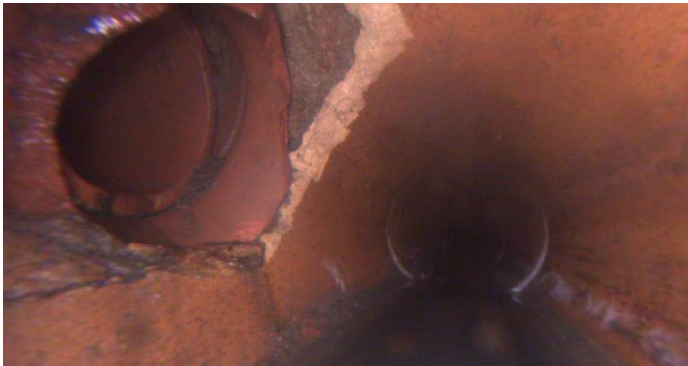
Code:	<b>TB</b>
Description:	<b>Tap Break-in</b>
Distance (ft):	<b>18.0</b>
Structural Grade:	<b>0</b>
O&M Grade:	<b>0</b>
Clock Start/From:	<b>9</b>
Clock To:	
1st Value:	<b>4.000</b>
2nd Value:	
Value Percent:	
Continuous Index:	
Within 8" of Joint:	
Remarks:

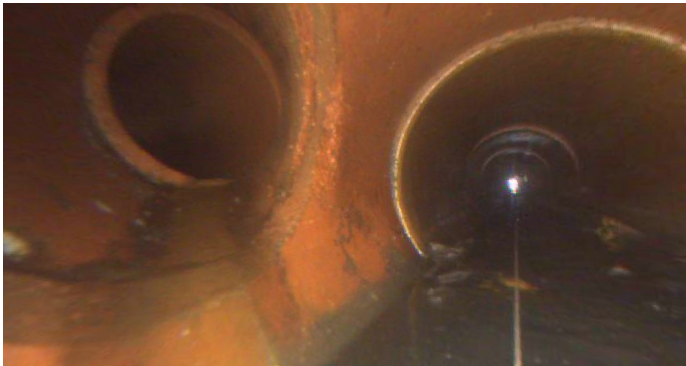
Code: **TF**  
Description: **Tap Factory**

Distance (ft): **47.6**  
Structural Grade: **0**  
O&M Grade: **0**  
Clock Start/From: **3**  
Clock To:  
1st Value: **4.000**  
2nd Value:  
Value Percent:  
Continuous Index:  
Within 8" of Joint:  
Remarks: **Photo taken from rear camera.**

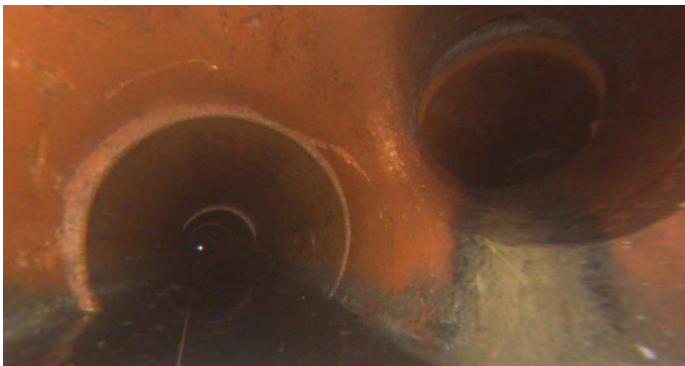
Code: **TF**  
Description: **Tap Factory**

Distance (ft): **79.5**  
Structural Grade: **0**  
O&M Grade: **0**  
Clock Start/From: **9**  
Clock To:  
1st Value: **4.000**  
2nd Value:  
Value Percent:  
Continuous Index:  
Within 8" of Joint:  
Remarks: **Photo taken from rear camera.**

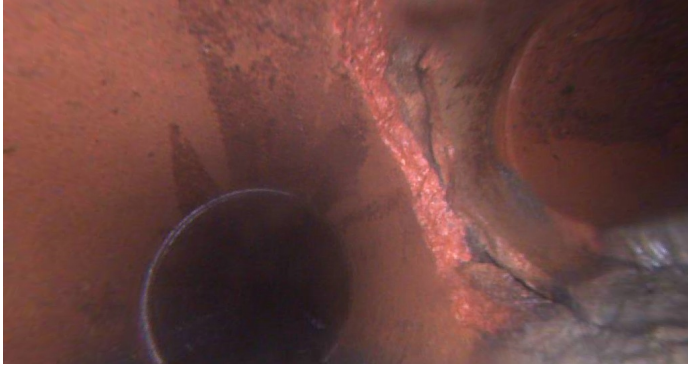
Code: **TF**  
Description: **Tap Factory**

Distance (ft): **83.2**  
Structural Grade: **0**  
O&M Grade: **0**  
Clock Start/From: **9**  
Clock To:  
1st Value: **4.000**  
2nd Value:  
Value Percent:  
Continuous Index:  
Within 8" of Joint:  
Remarks:

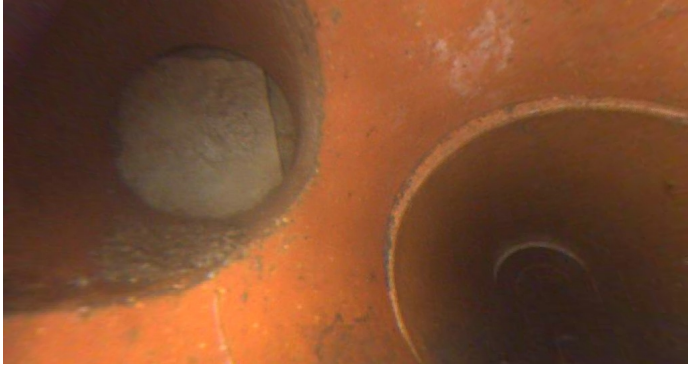
Code: **TFC**  
Description: **Tap Factory Capped**

Distance (ft): **101.2**  
Structural Grade: **0**  
O&M Grade: **0**  
Clock Start/From: **3**  
Clock To:  
1st Value: **4.000**  
2nd Value:  
Value Percent:  
Continuous Index:  
Within 8" of Joint:  
Remarks: **Photo taken from rear camera.**

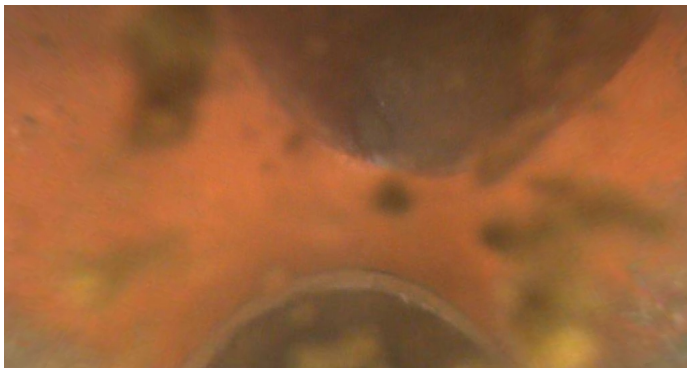
Code: **TFC**  
Description: **Tap Factory Capped**

Distance (ft): **203.5**  
Structural Grade: **0**  
O&M Grade: **0**  
Clock Start/From: **11**  
Clock To:  
1st Value: **4.000**  
2nd Value:  
Value Percent:  
Continuous Index:  
Within 8" of Joint:  
Remarks:
