Profile/Photo Observation Report

Date:	09/09/2021	Weather:		Coding:	PACP 7.0
Pipe Length (ft):	160.0	Owner:	City of Hobart	Pre Clean:	Light Cleaning
P.O.#:	YES502259	Surveyor:	S. Bucklin	PSR:	P-503-031-032
Customer:	City of Hobart	Clean Date:	08/27/2021	Shape:	C

Street:	West 41st Avenue	Flow Control:	Not Controlled
City:	Hobart, IN	Year Renewed:	
Location:	Local rural streets with light traffic, t	Tape/Media #:	
Purpose:	Routine Assessment	Dia/Height:	10"
Use:	Sanitary Sewage Pipe	Material:	VCP
Drain Area:		Lining:	None
Category:	NA		
Comment:			
Location Details:		Direction of Survey:	Upstream
US MH:	M-503-032	DS MH:	M-503-031
		Total Length Surveyed (ft):	160.0

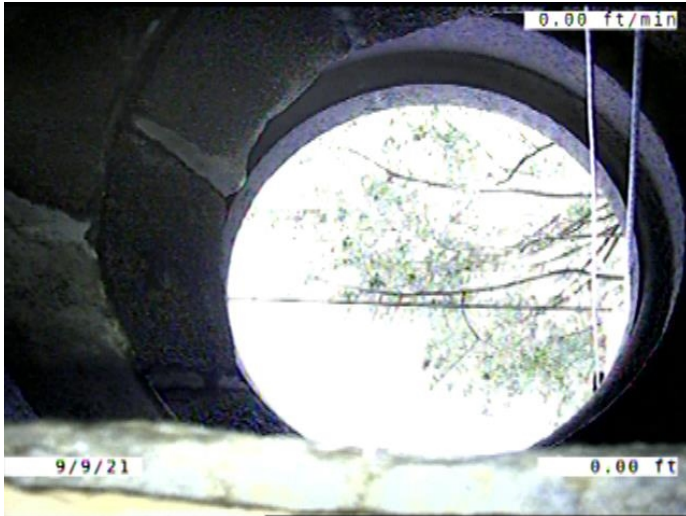
Code: **AMH**
Description: **Manhole**

Distance (ft): **.0**
Structural Grade: **0**
O&M Grade: **0**
Clock Start/From:
Clock To:
1st Value:
2nd Value:
Value Percent:
Continuous Index:
Within 8" of Joint: **NO**
Remarks: **M-503-031**

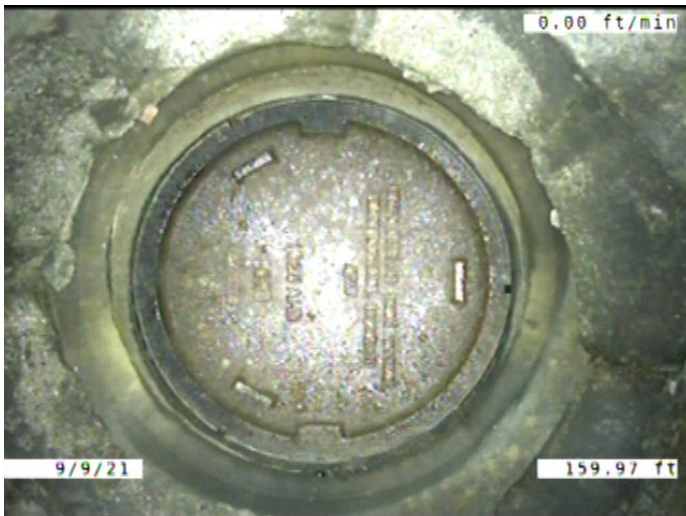
Code: **AMH**
 Description: **Manhole**

Distance (ft): **160.0**
 Structural Grade: **0**
 O&M Grade: **0**
 Clock Start/From:
 Clock To:
 1st Value:
 2nd Value:
 Value Percent:
 Continuous Index:
 Within 8" of Joint: **NO**
 Remarks: **M-503-032**
