# Profile/Photo Observation Report

Date:	09/08/2021	Weather:		Coding:	PACP 7.0
Pipe Length (ft):	308.1	Owner:	City of Hobart	Pre Clean:	Light Cleaning
P.O.#:	YES502259	Surveyor:	S. Bucklin	PSR:	P-503-034-033
Customer:	City of Hobart	Clean Date:	08/26/2021	Shape:	C

Street:	40th Avenue	Flow Control:	Not Controlled
City:	Hobart, IN	Year Renewed:	
Location:		Tape/Media #:	
Purpose:	Routine Assessment	Dia/Height:	8"
Use:	Sanitary Sewage Pipe	Material:	VCP
Drain Area:		Lining:	None
Category:	NA		
Comment:			
Location Details:		Direction of Survey:	Upstream
US MH:	M-503-033	DS MH:	M-503-034
		Total Length Surveyed (ft):	308.1

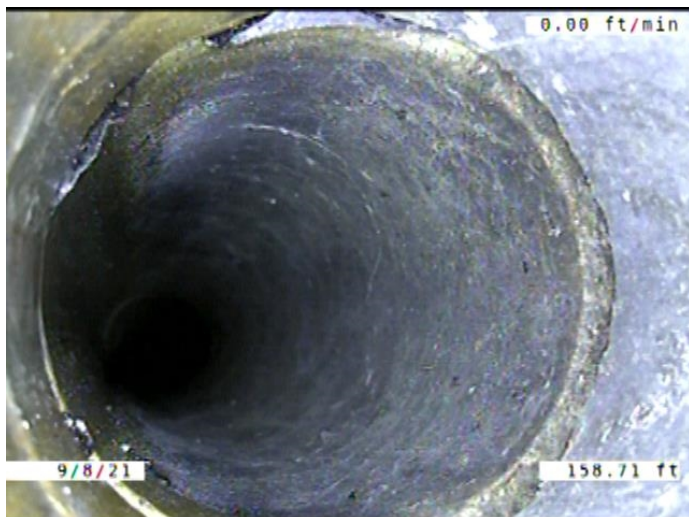
Code: **TBI**  
 Description: **Tap Break-in Intruding**

Distance (ft): **158.7**  
 Structural Grade: **0**  
 O&M Grade: **2**  
 Clock Start/From: **9**  
 Clock To:  
 1st Value: **4.000**  
 2nd Value: **3.000**  
 Value Percent:  
 Continuous Index:  
 Within 8" of Joint: **YES**  
 Remarks:

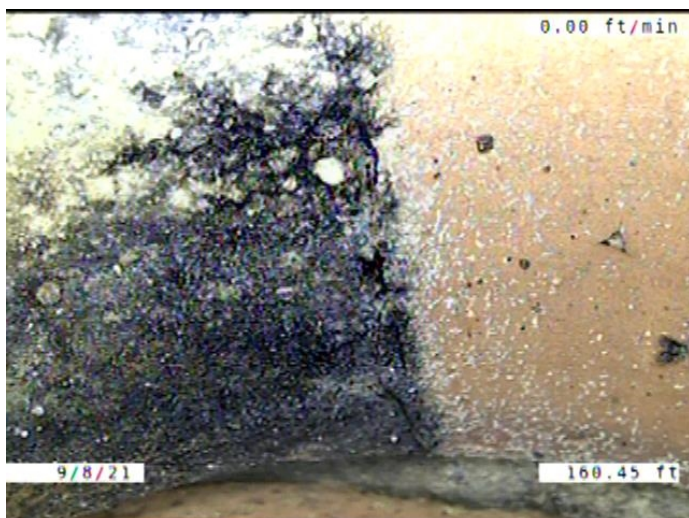
Code: **DAE**  
 Description: **Deposits Attached Encrustation**

Distance (ft): **160.4**  
 Structural Grade: **0**  
 O&M Grade: **2**  
 Clock Start/From: **7**  
 Clock To: **9**  
 1st Value:  
 2nd Value:  
 Value Percent: **5.000**  
 Continuous Index:  
 Within 8" of Joint: **YES**  
 Remarks:

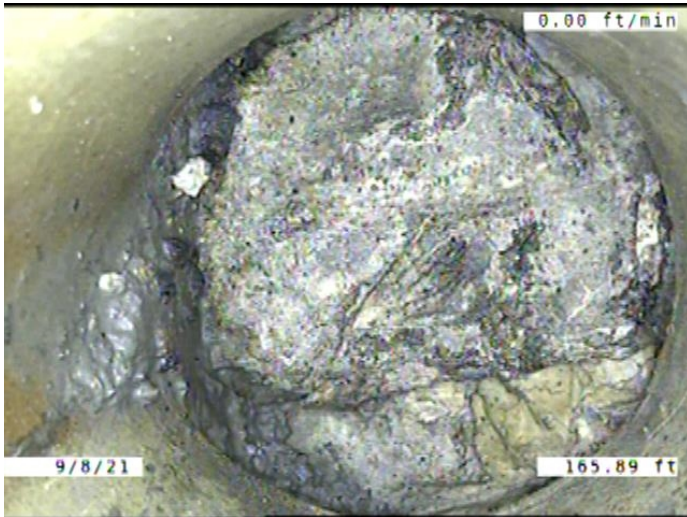
Code: **TFC**  
Description: **Tap Factory Capped**

Distance (ft): **165.9**  
Structural Grade: **0**  
O&M Grade: **0**  
Clock Start/From: **9**  
Clock To:  
1st Value: **4.000**  
2nd Value:  
Value Percent:  
Continuous Index:  
Within 8" of Joint: **YES**  
Remarks:

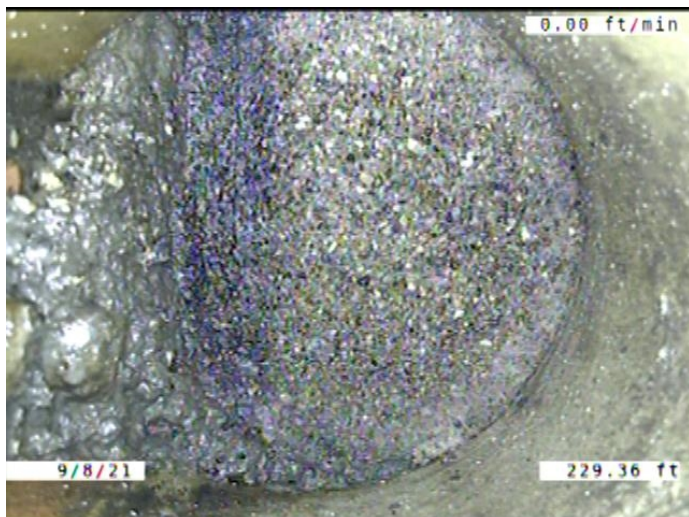
Code: **TFC**  
 Description: **Tap Factory Capped**

Distance (ft): **229.4**  
 Structural Grade: **0**  
 O&M Grade: **0**  
 Clock Start/From: **9**  
 Clock To:  
 1st Value: **4.000**  
 2nd Value:  
 Value Percent:  
 Continuous Index:  
 Within 8" of Joint: **YES**  
 Remarks:

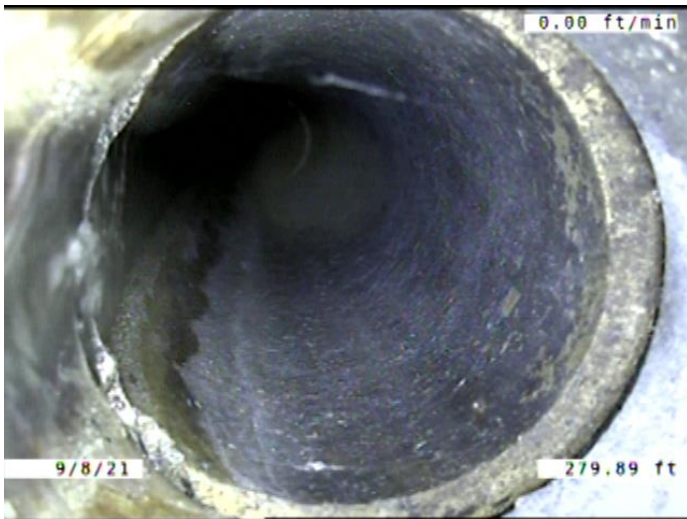
Code: **TBI**  
Description: **Tap Break-in Intruding**

Distance (ft): **279.9**  
Structural Grade: **0**  
O&M Grade: **2**  
Clock Start/From: **10**  
Clock To:  
1st Value: **4.000**  
2nd Value: **3.000**  
Value Percent:  
Continuous Index:  
Within 8" of Joint: **YES**  
Remarks:

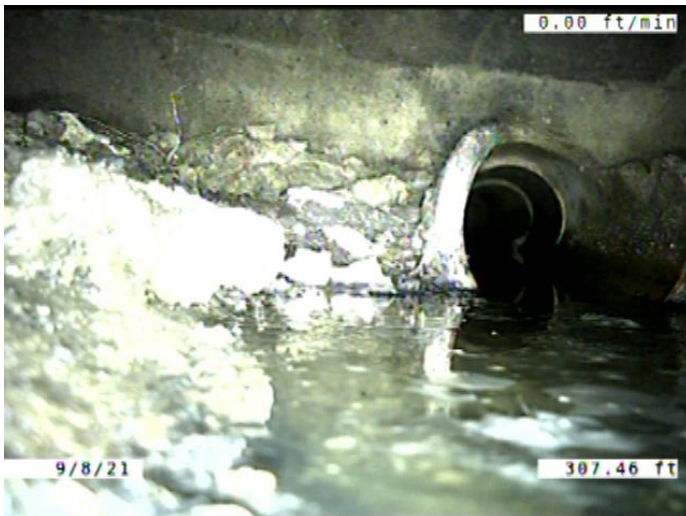
Code: **JOM**  
Description: **Joint Offset Medium**

Distance (ft): **307.5**  
Structural Grade: **3**  
O&M Grade: **0**  
Clock Start/From:  
Clock To:  
1st Value:  
2nd Value:  
Value Percent:  
Continuous Index: **F02**  
Within 8" of Joint: **NO**  
Remarks:

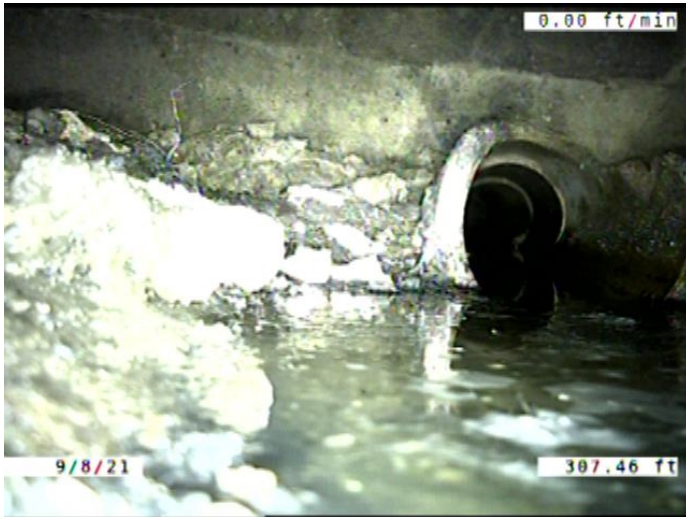
Code: **DSF**  
 Description: **Deposits Settled Fine**

Distance (ft): **307.5**  
 Structural Grade: **0**  
 O&M Grade: **2**  
 Clock Start/From: **5**  
 Clock To: **7**  
 1st Value:  
 2nd Value:  
 Value Percent: **5.000**  
 Continuous Index: **F01**  
 Within 8" of Joint: **YES**  
 Remarks:

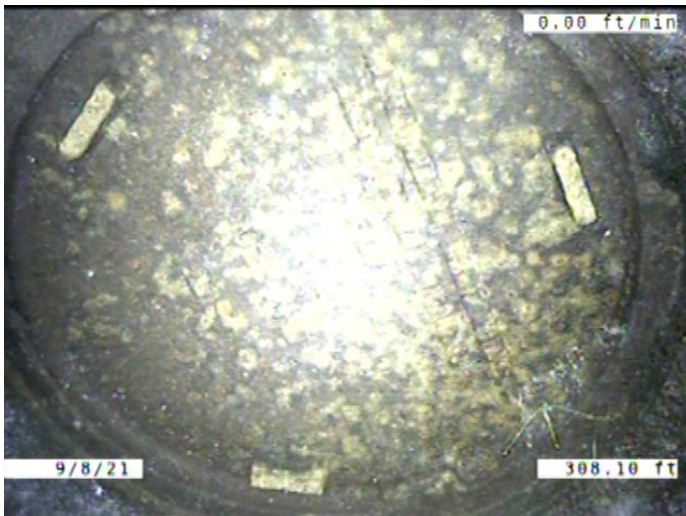
Code: **AMH**  
 Description: **Manhole**

Distance (ft): **308.1**  
 Structural Grade: **0**  
 O&M Grade: **0**  
 Clock Start/From:  
 Clock To:  
 1st Value:  
 2nd Value:  
 Value Percent:  
 Continuous Index:  
 Within 8" of Joint: **NO**  
 Remarks: **M-503-033**
