Profile/Photo Observation Report

Date:	09/08/2021	Weather:		Coding:	PACP 7.0
Pipe Length (ft):	308.1	Owner:	City of Hobart	Pre Clean:	Light Cleaning
P.O.#:	YES502259	Surveyor:	S. Bucklin	PSR:	P-503-034-033
Customer:	City of Hobart	Clean Date:	08/26/2021	Shape:	C

Street:	40th Avenue	Flow Control:	Not Controlled
City:	Hobart, IN	Year Renewed:	
Location:		Tape/Media #:	
Purpose:	Routine Assessment	Dia/Height:	8"
Use:	Sanitary Sewage Pipe	Material:	VCP
Drain Area:		Lining:	None
Category:	NA		
Comment:			
Location Details:		Direction of Survey:	Upstream
US MH:	M-503-033	DS MH:	M-503-034
		Total Length Surveyed (ft):	308.1

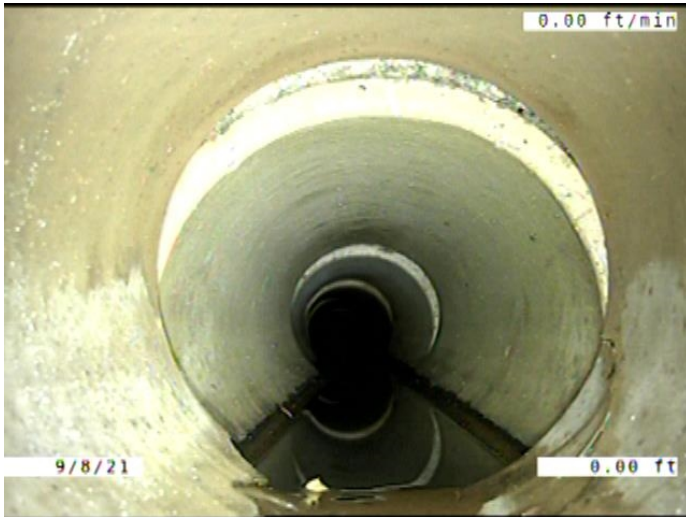
Code: **AMH**
Description: **Manhole**

Distance (ft): **.0**
Structural Grade: **0**
O&M Grade: **0**
Clock Start/From:
Clock To:
1st Value:
2nd Value:
Value Percent:
Continuous Index:
Within 8" of Joint: **NO**
Remarks: **M-503-034**

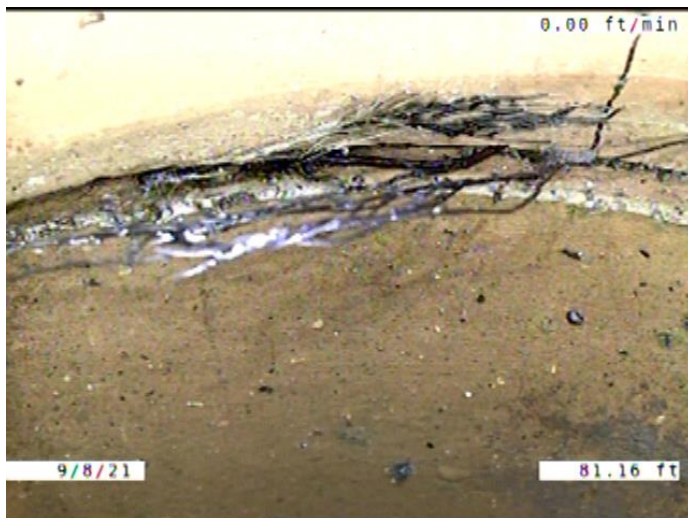
Code: **RFJ**
 Description: **Roots Fine Joint**

Distance (ft): **81.2**
 Structural Grade: **0**
 O&M Grade: **1**
 Clock Start/From: **3**
 Clock To:
 1st Value:
 2nd Value:
 Value Percent:
 Continuous Index:
 Within 8" of Joint: **YES**
 Remarks:

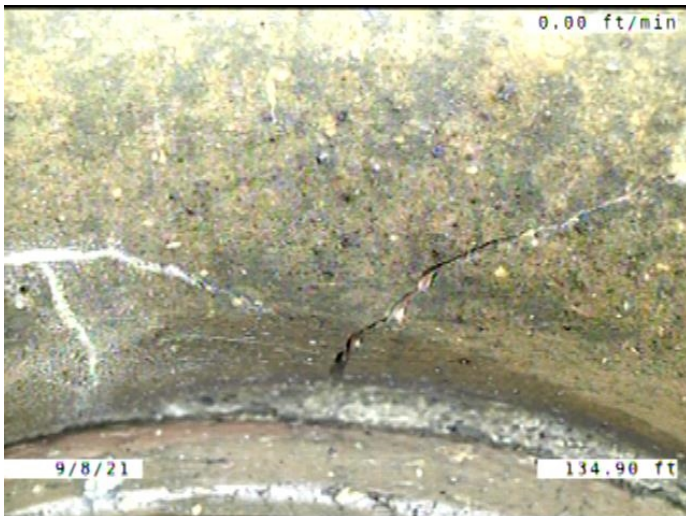
Code: **SMW**
 Description: **Surface Damage Missing Wall**

Distance (ft): **129.4**
 Structural Grade: **5**
 O&M Grade: **0**
 Clock Start/From: **3**
 Clock To:
 1st Value:
 2nd Value:
 Value Percent:
 Continuous Index:
 Within 8" of Joint: **YES**
 Remarks:

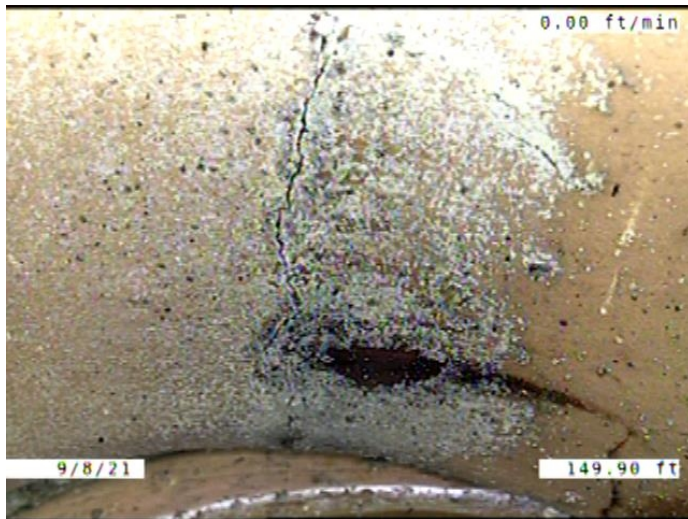
Code: **B**
Description: **Broken**

Distance (ft): **149.9**
Structural Grade: **4**
O&M Grade: **0**
Clock Start/From: **3**
Clock To: **12**
1st Value:
2nd Value:
Value Percent:
Continuous Index:
Within 8" of Joint: **YES**
Remarks:

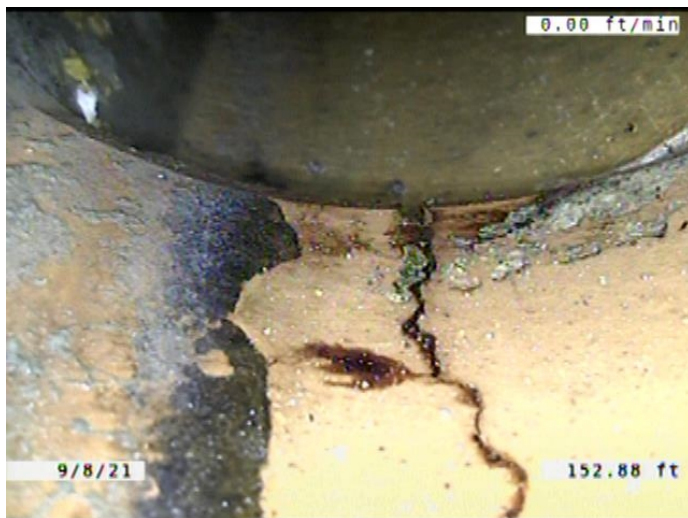
Code: **ISB**
Description: **Infiltration Stain Barrel**

Distance (ft): **149.9**
Structural Grade: **0**
O&M Grade: **1**
Clock Start/From: **3**
Clock To: **4**
1st Value:
2nd Value:
Value Percent:
Continuous Index:
Within 8" of Joint: **YES**
Remarks:

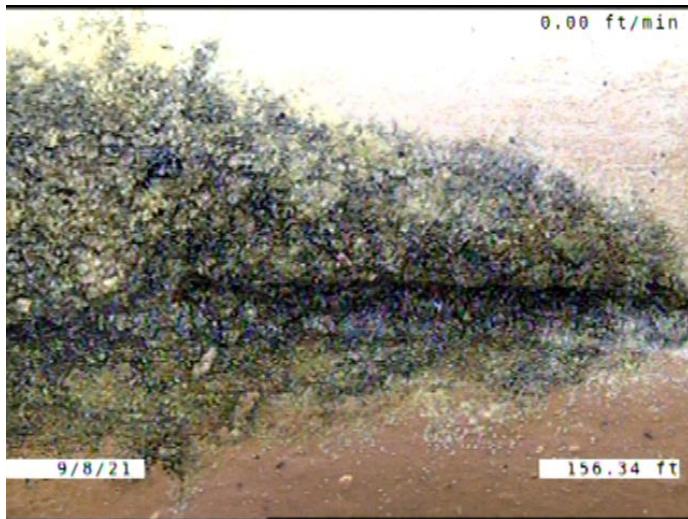
Code: **CM**
Description: **Crack Multiple**

Distance (ft): **152.9**
Structural Grade: **3**
O&M Grade: **0**
Clock Start/From: **3**
Clock To: **4**
1st Value:
2nd Value:
Value Percent:
Continuous Index:
Within 8" of Joint: **YES**
Remarks:

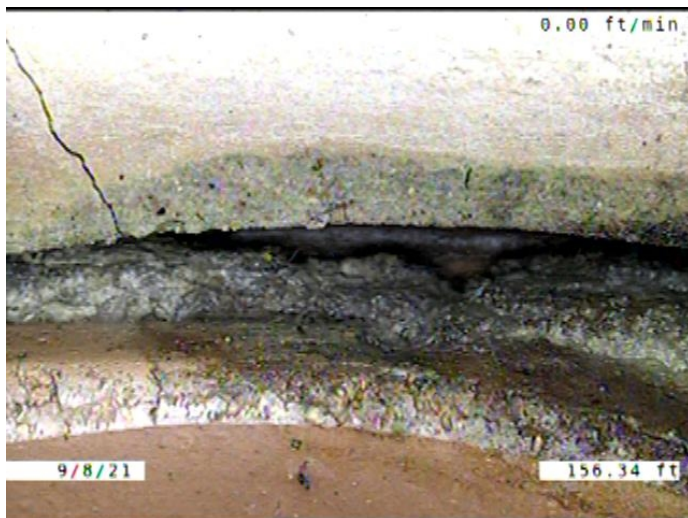
Code: **ISJ**
Description: **Infiltration Stain Joint**

Distance (ft): **156.3**
Structural Grade: **0**
O&M Grade: **1**
Clock Start/From: **7**
Clock To: **10**
1st Value:
2nd Value:
Value Percent:
Continuous Index:
Within 8" of Joint: **YES**
Remarks:

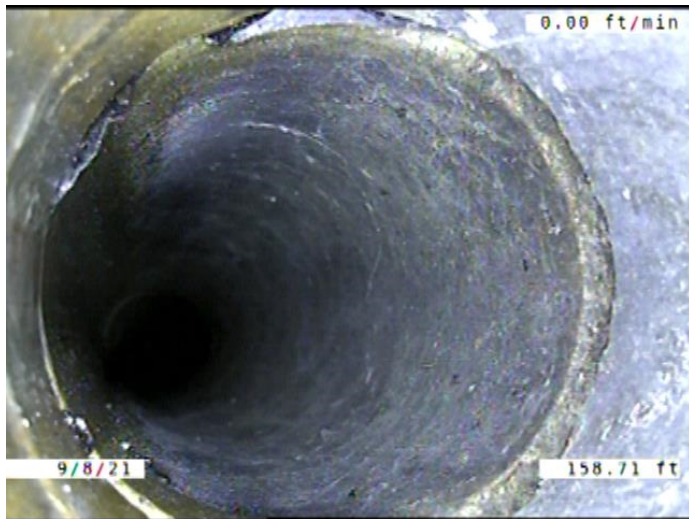
Code: **BSV**
 Description: **Broken Soil Visible**

Distance (ft): **158.5**
 Structural Grade: **5**
 O&M Grade: **0**
 Clock Start/From: **8**
 Clock To: **11**
 1st Value:
 2nd Value:
 Value Percent:
 Continuous Index:
 Within 8" of Joint: **YES**
 Remarks:

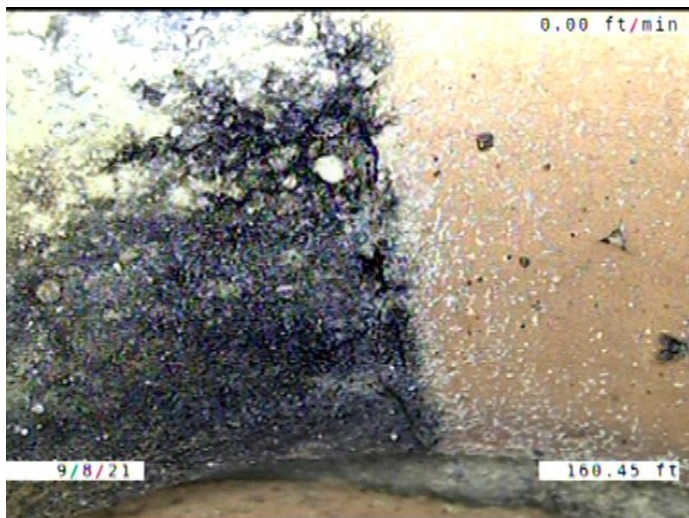
Code: **TBI**
 Description: **Tap Break-in Intruding**

Distance (ft): **158.7**
 Structural Grade: **0**
 O&M Grade: **2**
 Clock Start/From: **9**
 Clock To:
 1st Value: **4.000**
 2nd Value: **3.000**
 Value Percent:
 Continuous Index:
 Within 8" of Joint: **YES**
 Remarks:

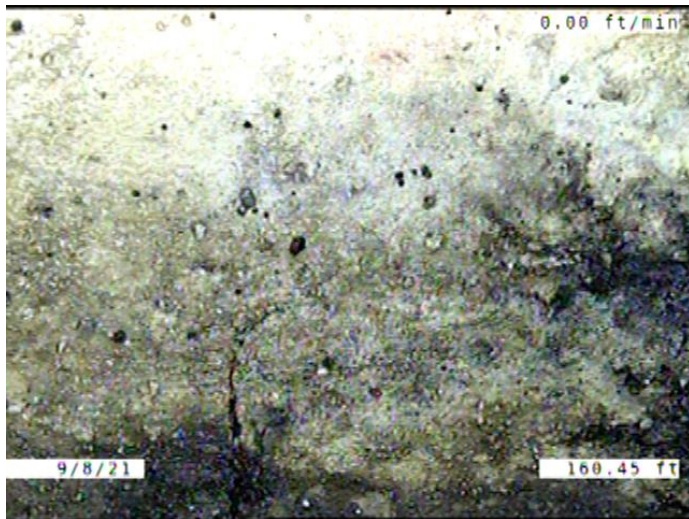
Code: **DAE**
 Description: **Deposits Attached Encrustation**

Distance (ft): **160.4**
 Structural Grade: **0**
 O&M Grade: **2**
 Clock Start/From: **7**
 Clock To: **9**
 1st Value:
 2nd Value:
 Value Percent: **5.000**
 Continuous Index:
 Within 8" of Joint: **YES**
 Remarks:

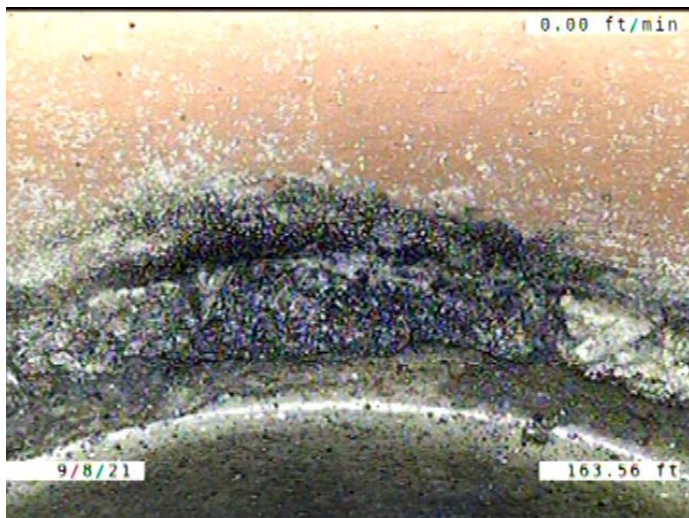
Code: **CM**
 Description: **Crack Multiple**

Distance (ft): **160.5**
 Structural Grade: **3**
 O&M Grade: **0**
 Clock Start/From: **7**
 Clock To: **9**
 1st Value:
 2nd Value:
 Value Percent:
 Continuous Index:
 Within 8" of Joint: **YES**
 Remarks:

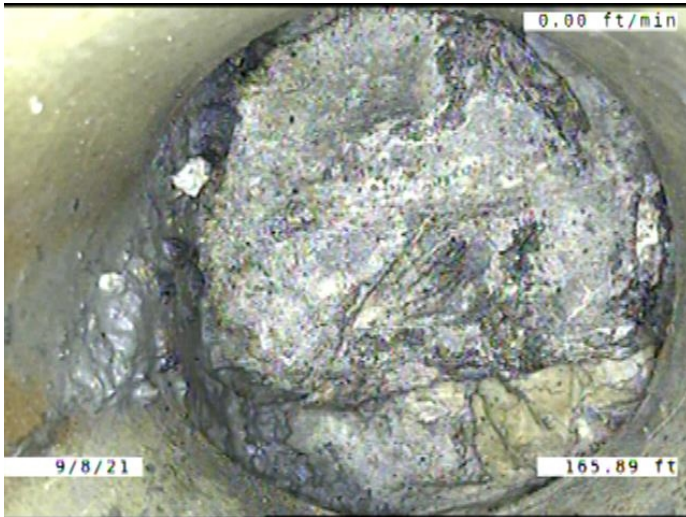
Code: **DAE**
 Description: **Deposits Attached Encrustation**

Distance (ft): **163.6**
 Structural Grade: **0**
 O&M Grade: **2**
 Clock Start/From: **8**
 Clock To: **12**
 1st Value:
 2nd Value:
 Value Percent: **5.000**
 Continuous Index:
 Within 8" of Joint: **YES**
 Remarks:

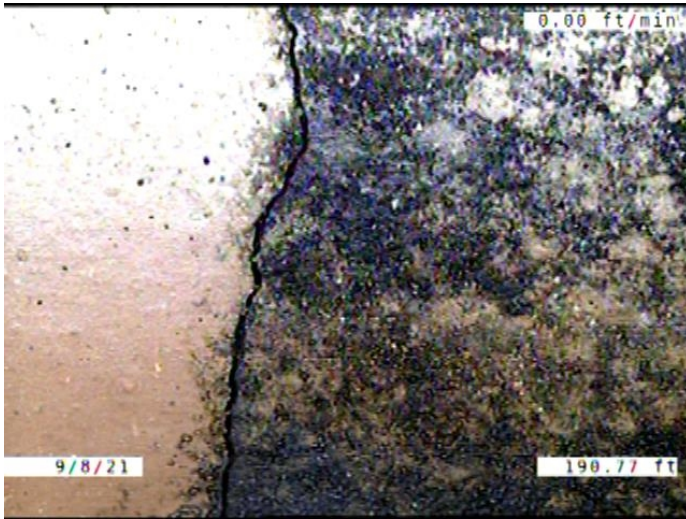
Code: **FM**
 Description: **Fracture Multiple**

Distance (ft): **187.9**
 Structural Grade: **4**
 O&M Grade: **0**
 Clock Start/From: **12**
 Clock To: **3**
 1st Value:
 2nd Value:
 Value Percent:
 Continuous Index:
 Within 8" of Joint: **YES**
 Remarks:

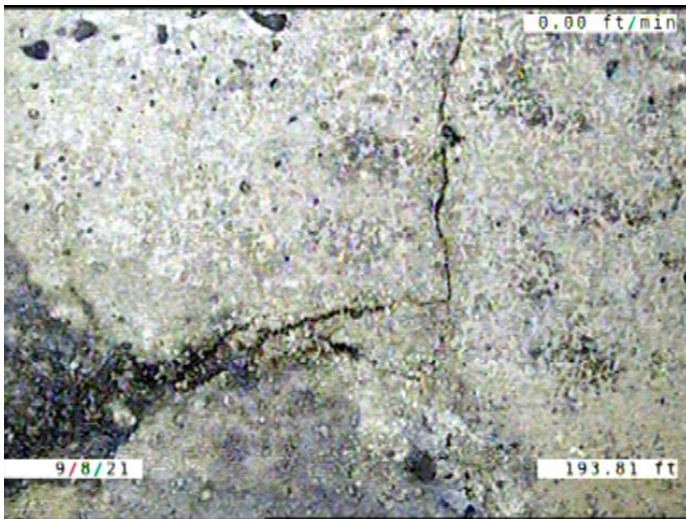
Code: **FS**
 Description: **Fracture Spiral**

Distance (ft): **190.8**
 Structural Grade: **3**
 O&M Grade: **0**
 Clock Start/From: **12**
 Clock To: **1**
 1st Value:
 2nd Value:
 Value Percent:
 Continuous Index:
 Within 8" of Joint: **YES**
 Remarks:

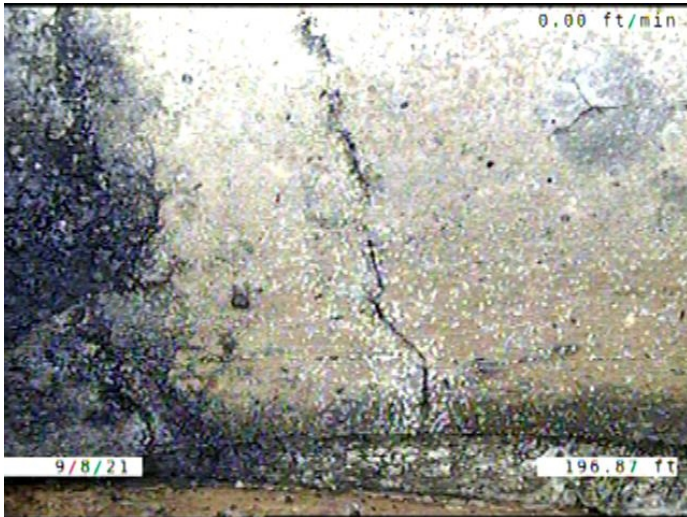
Code: **FM**
 Description: **Fracture Multiple**

Distance (ft): **193.8**
 Structural Grade: **4**
 O&M Grade: **0**
 Clock Start/From: **7**
 Clock To: **12**
 1st Value:
 2nd Value:
 Value Percent:
 Continuous Index:
 Within 8" of Joint: **YES**
 Remarks:

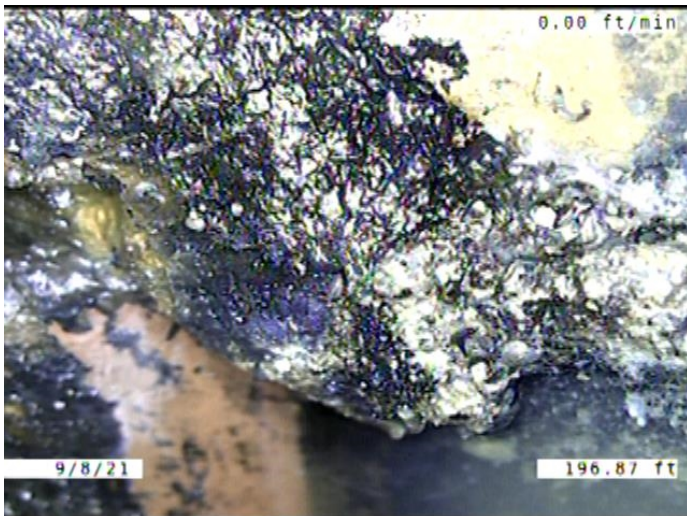
Code: **FM**
 Description: **Fracture Multiple**

Distance (ft): **196.9**
 Structural Grade: **4**
 O&M Grade: **0**
 Clock Start/From: **7**
 Clock To: **5**
 1st Value:
 2nd Value:
 Value Percent:
 Continuous Index:
 Within 8" of Joint: **YES**
 Remarks:

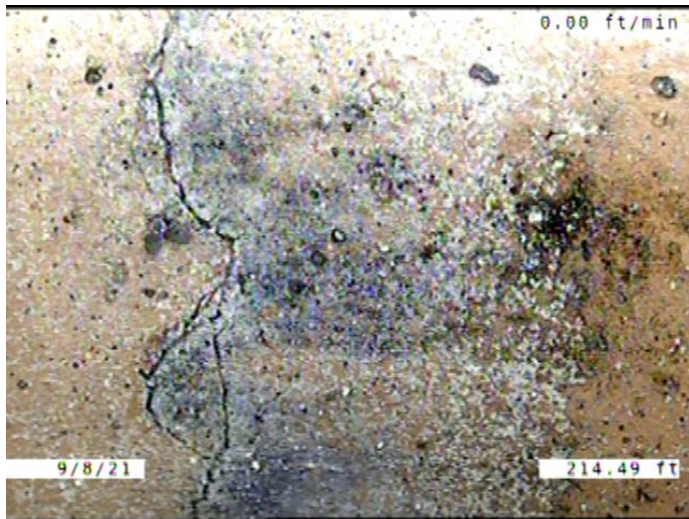
Code: **FS**
 Description: **Fracture Spiral**

Distance (ft): **211.8**
 Structural Grade: **3**
 O&M Grade: **0**
 Clock Start/From: **1**
 Clock To: **5**
 1st Value:
 2nd Value:
 Value Percent:
 Continuous Index:
 Within 8" of Joint: **YES**
 Remarks:

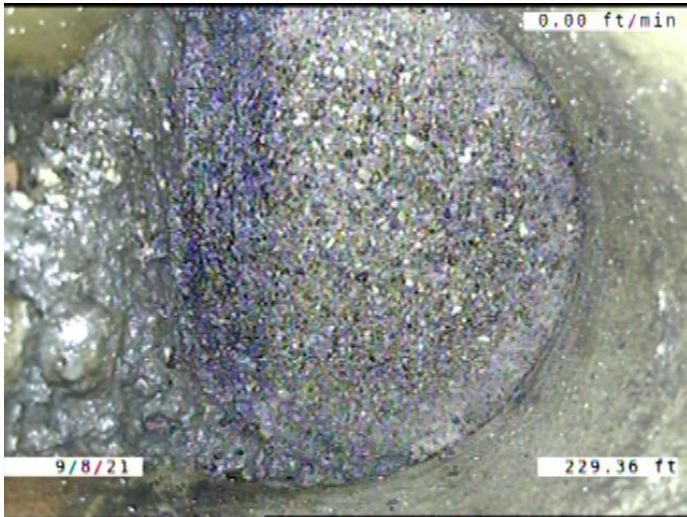
Code: **B**
 Description: **Broken**

Distance (ft): **224.1**
 Structural Grade: **4**
 O&M Grade: **0**
 Clock Start/From: **4**
 Clock To: **6**
 1st Value:
 2nd Value:
 Value Percent:
 Continuous Index:
 Within 8" of Joint: **YES**
 Remarks:

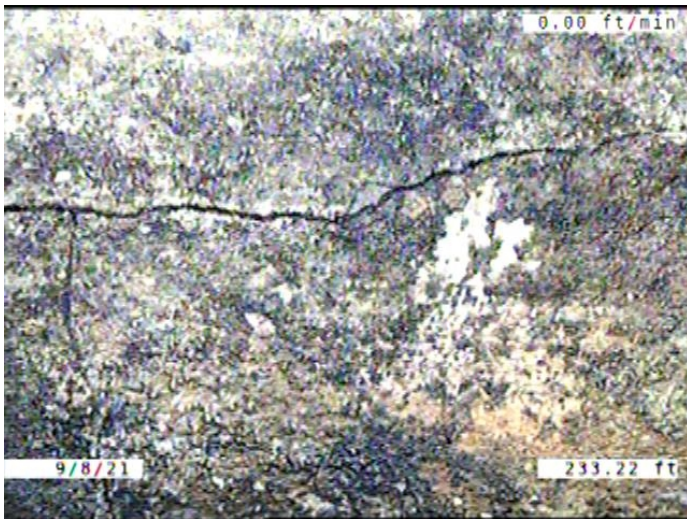
Code: **TFC**
 Description: **Tap Factory Capped**

Distance (ft): **229.4**
 Structural Grade: **0**
 O&M Grade: **0**
 Clock Start/From: **9**
 Clock To:
 1st Value: **4.000**
 2nd Value:
 Value Percent:
 Continuous Index:
 Within 8" of Joint: **YES**
 Remarks:

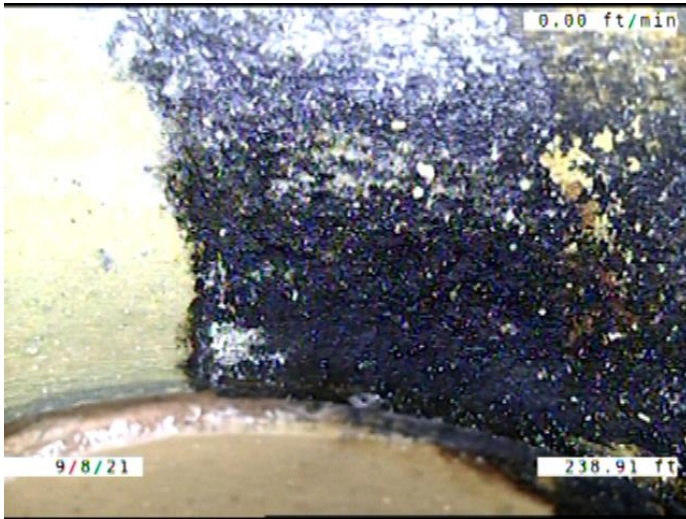
Code: **ISB**
 Description: **Infiltration Stain Barrel**

Distance (ft): **235.9**
 Structural Grade: **0**
 O&M Grade: **1**
 Clock Start/From: **1**
 Clock To: **4**
 1st Value:
 2nd Value:
 Value Percent:
 Continuous Index:
 Within 8" of Joint: **YES**
 Remarks:

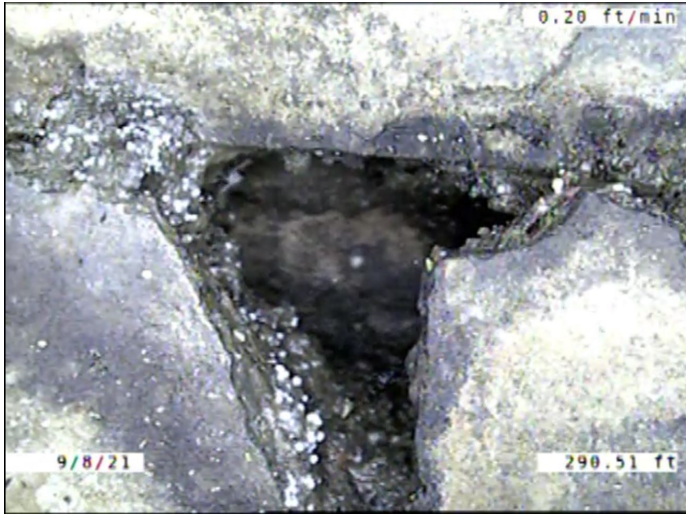
Code: **FM**
Description: **Fracture Multiple**

Distance (ft): **287.3**
Structural Grade: **4**
O&M Grade: **0**
Clock Start/From: **12**
Clock To: **12**
1st Value:
2nd Value:
Value Percent:
Continuous Index:
Within 8" of Joint: **YES**
Remarks:

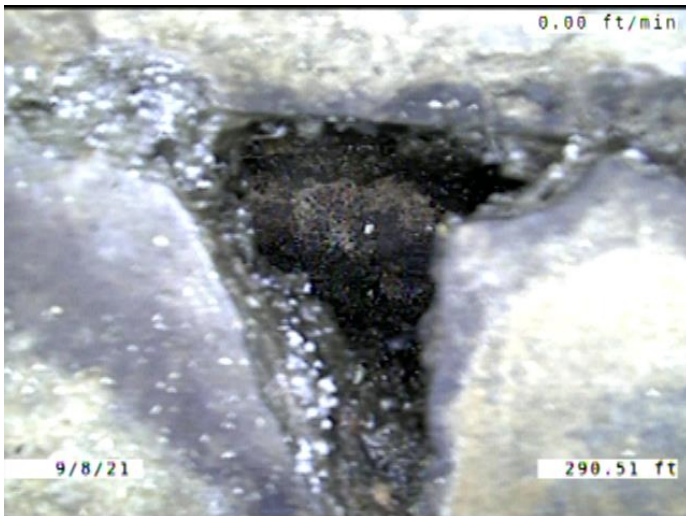
Code: **HVV**
 Description: **Hole Void Visible**

Distance (ft): **290.5**
 Structural Grade: **5**
 O&M Grade: **0**
 Clock Start/From: **12**
 Clock To:
 1st Value:
 2nd Value:
 Value Percent:
 Continuous Index:
 Within 8" of Joint: **YES**
 Remarks:

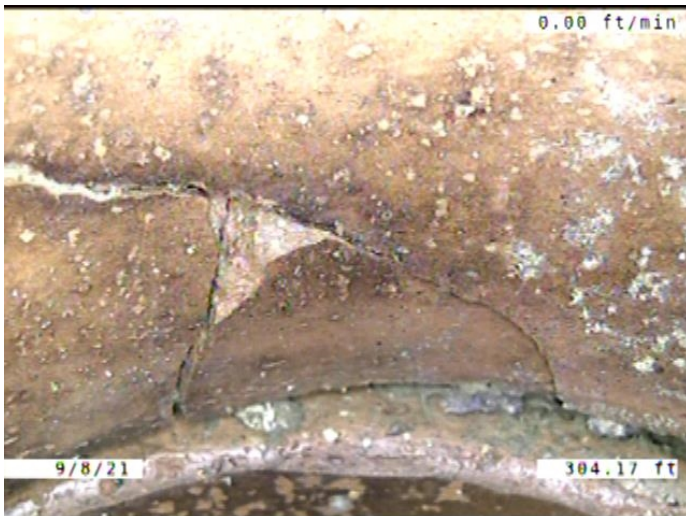
Code: **B**
 Description: **Broken**

Distance (ft): **300.1**
 Structural Grade: **4**
 O&M Grade: **0**
 Clock Start/From: **7**
 Clock To: **11**
 1st Value:
 2nd Value:
 Value Percent:
 Continuous Index:
 Within 8" of Joint: **YES**
 Remarks:

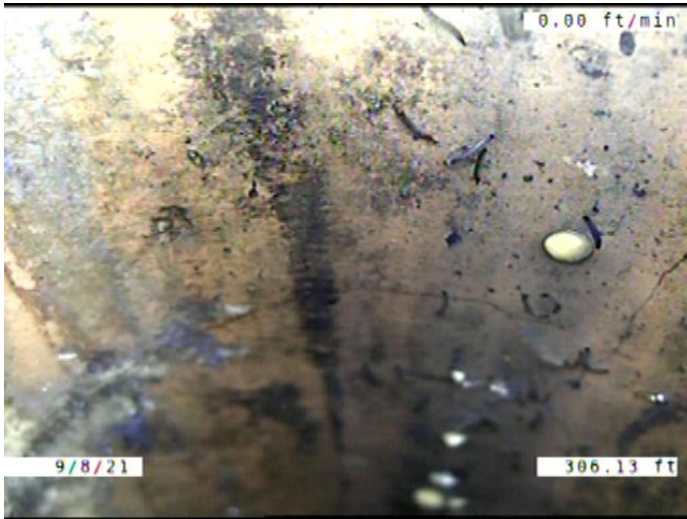
Code: **B**
 Description: **Broken**

Distance (ft): **304.2**
 Structural Grade: **4**
 O&M Grade: **0**
 Clock Start/From: **7**
 Clock To: **11**
 1st Value:
 2nd Value:
 Value Percent:
 Continuous Index:
 Within 8" of Joint: **YES**
 Remarks:

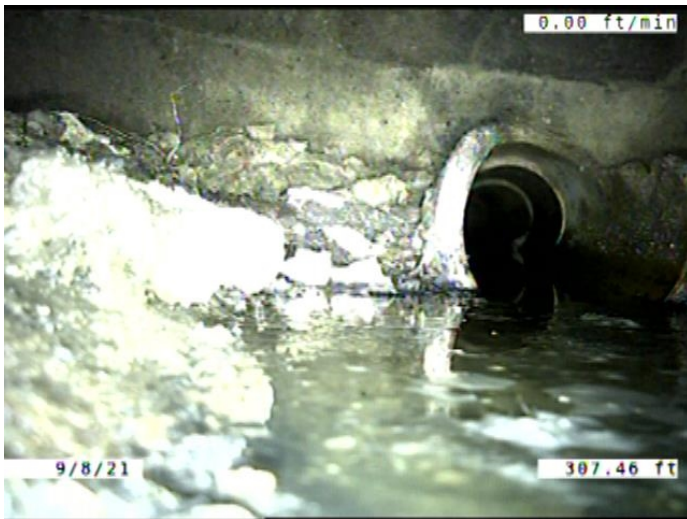
Code: **B**
Description: **Broken**

Distance (ft): **306.1**
Structural Grade: **4**
O&M Grade: **0**
Clock Start/From: **12**
Clock To: **12**
1st Value:
2nd Value:
Value Percent:
Continuous Index:
Within 8" of Joint: **YES**
Remarks:

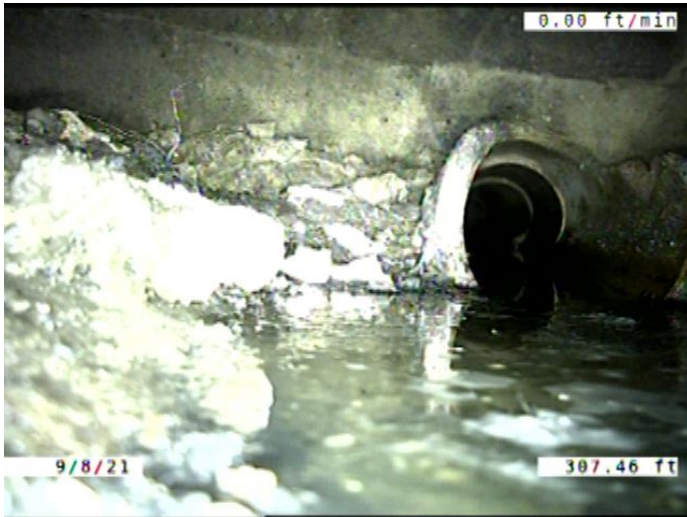
Code: **JOM**
Description: **Joint Offset Medium**

Distance (ft): **307.5**
Structural Grade: **3**
O&M Grade: **0**
Clock Start/From:
Clock To:
1st Value:
2nd Value:
Value Percent:
Continuous Index: **F02**
Within 8" of Joint: **NO**
Remarks:

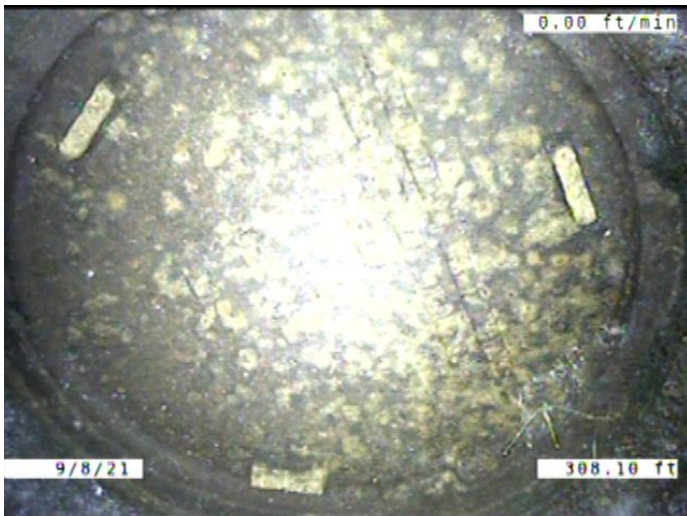
Code: **DSF**
 Description: **Deposits Settled Fine**

Distance (ft): **307.5**
 Structural Grade: **0**
 O&M Grade: **2**
 Clock Start/From: **5**
 Clock To: **7**
 1st Value:
 2nd Value:
 Value Percent: **5.000**
 Continuous Index: **F01**
 Within 8" of Joint: **YES**
 Remarks:
