Profile/Photo Observation Report

Date:	09/30/2018	Weather:		Coding:	PACP 6.0
Pipe Length (ft):	207.9	Owner:	NA	Pre Clean:	Not Known
P.O.#:		Surveyor:	Selasie Honu	PSR:	P-503-036-037
Customer:		Clean Date:	01/01/1900	Shape:	C

Street:	40th. Ave.	Flow Control:	Not Controlled
City:	Hobart, IN	Year Renewed:	
Location:	Light Highway	Tape/Media #:	
Purpose:	Routine Assessment	Dia/Height:	10"
Use:	Sanitary	Material:	VCP
Drain Area:	NA	Lining:	
Category:	NA		
Comment:

Location Details:		Direction of Survey:	Downstream
US MH:	M-503-037	DS MH:	M-503-036
		Total Length Surveyed (ft):	191.9

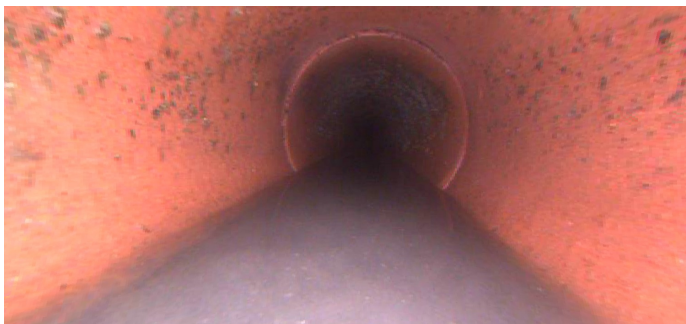
Code: **AMH**
 Description: **Manhole**
 Distance (ft): **.0**
 Structural Grade: **0**
 O&M Grade: **0**
 Clock Start/From:
 Clock To:
 1st Value:
 2nd Value:
 Value Percent:
 Continuous Index:
 Within 8" of Joint: **NO**
 Remarks: **M-503-037**

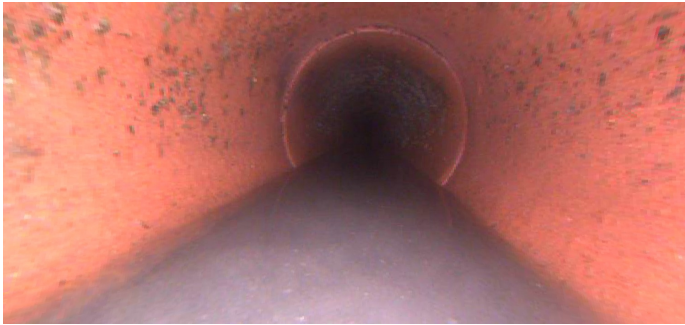
Code:	MWL
Description:	Water Level

Distance (ft):	.0
Structural Grade:	0
O&M Grade:	0
Clock Start/From:	
Clock To:	
1st Value:	
2nd Value:	
Value Percent:	5.000
Continuous Index:	
Within 8" of Joint:	NO
Remarks:

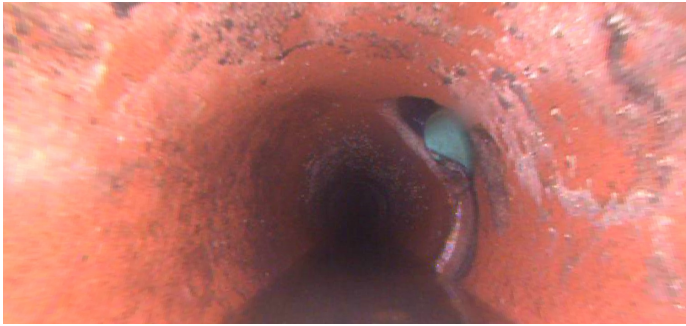
Code: **TF**
Description: **Tap Factory**

Distance (ft): **42.1**
Structural Grade: **0**
O&M Grade: **0**
Clock Start/From: **2**
Clock To:
1st Value: **4.000**
2nd Value:
Value Percent:
Continuous Index:
Within 8" of Joint:
Remarks:

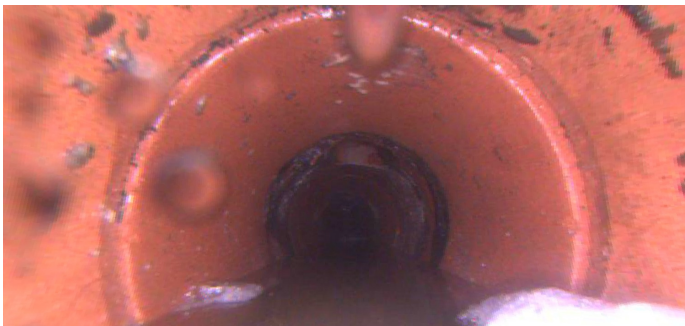
Code: **TF**
Description: **Tap Factory**

Distance (ft): **67.5**
Structural Grade: **0**
O&M Grade: **0**
Clock Start/From: **12**
Clock To:
1st Value: **4.000**
2nd Value:
Value Percent:
Continuous Index:
Within 8" of Joint:
Remarks:

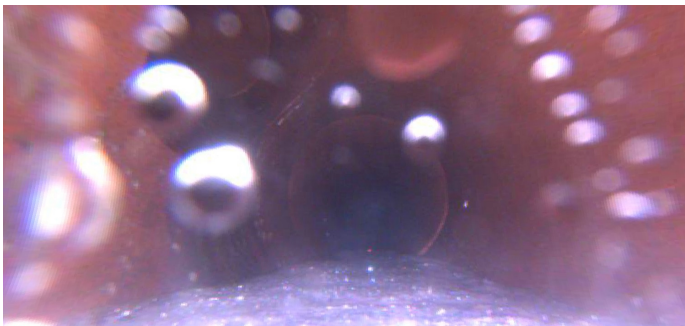
Code: **TF**
Description: **Tap Factory**

Distance (ft): **122.2**
Structural Grade: **0**
O&M Grade: **0**
Clock Start/From: **11**
Clock To:
1st Value: **4.000**
2nd Value:
Value Percent:
Continuous Index:
Within 8" of Joint:
Remarks:

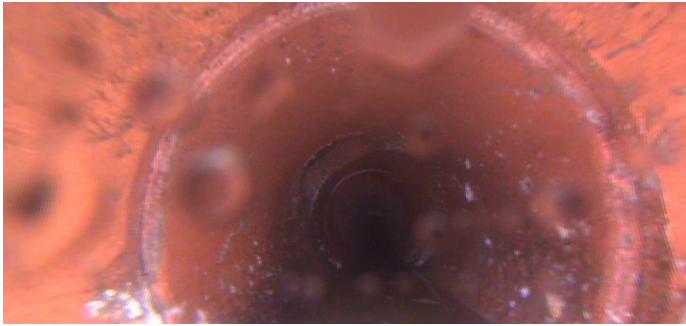
Code: **TF**
Description: **Tap Factory**

Distance (ft): **162.9**
Structural Grade: **0**
O&M Grade: **0**
Clock Start/From: **11**
Clock To:
1st Value: **4.000**
2nd Value:
Value Percent:
Continuous Index:
Within 8" of Joint:
Remarks:

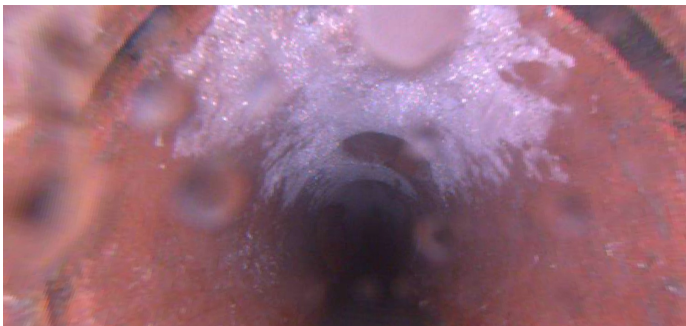
Code: **TF**
Description: **Tap Factory**

Distance (ft): **175.0**
Structural Grade: **0**
O&M Grade: **0**
Clock Start/From: **12**
Clock To:
1st Value: **4.000**
2nd Value:
Value Percent:
Continuous Index:
Within 8" of Joint:
Remarks:
