Profile/Photo Observation Report

Date:	04/07/2018	Weather:		Coding:	PACP 6.0
Pipe Length (ft):	195.9	Owner:	NA	Pre Clean:	Not Known
P.O.#:		Surveyor:	Mark Ruby	PSR:	P-503-038-039
Customer:		Clean Date:	01/01/1900	Shape:	C

Street:	canender st	Flow Control:	Not Controlled
City:	Hobart, IN	Year Renewed:	
Location:	Other	Tape/Media #:	
Purpose:	Not Known	Dia/Height:	10"
Use:	Sanitary	Material:	VCP
Drain Area:	NA	Lining:	
Category:	NA		
Comment:

Location Details:		Direction of Survey:	Downstream
US MH:	M-503-039	DS MH:	M-503-038
		Total Length Surveyed (ft):	194.5

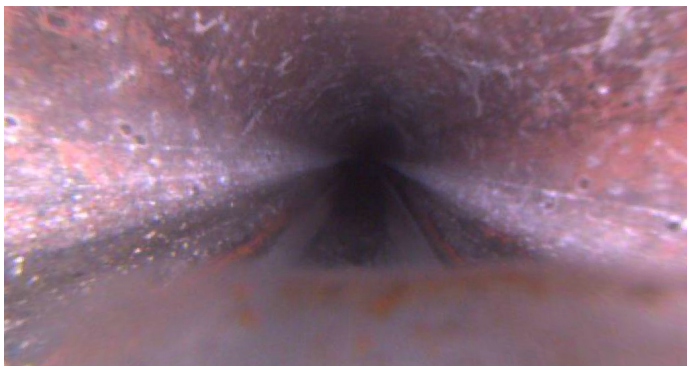
Position	Code	Observation	Video (sec)	Grade
M-503-039				
.0	AMH	Manhole	10	NA
.0	MWL	Water Level	21	NA
42.0	FC	Fracture Circumferential	116	S 2
52.3	FC	Fracture Circumferential	148	S 2
52.3	DAZ	Deposits Attached Other	160	M 2
59.9	TF	Tap Factory	187	NA
75.4	FC	Fracture Circumferential	230	S 2
90.1	IW	Infil Weeper	271	M 2
95.3	IW	Infil Weeper	293	M 2
96.6	TF	Tap Factory	307	NA
102.1	MMC	Material Change	330	NA
107.6	MMC	Material Change	353	NA
133.1	TF	Tap Factory	416	NA
148.4	IS	Infil Stain	458	NA
153.7	IS	Infil Stain	480	NA
158.4	IS	Infil Stain	501	NA
194.5	AMH	Manhole	585	NA
M-503-038
