# Profile/Photo Observation Report

Date:	<b>04/07/2018</b>	Weather:		Coding:	<b>PACP 6.0</b>
Pipe Length (ft):	<b>478.8</b>	Owner:	<b>NA</b>	Pre Clean:	<b>Not Known</b>
P.O.#:		Surveyor:	<b>Mark Ruby</b>	PSR:	<b>P-503-042-041</b>
Customer:		Clean Date:	<b>01/01/1900</b>	Shape:	<b>C</b>

Street:	<b>guyer st</b>	Flow Control:	<b>Not Controlled</b>
City:	<b>Hobart, IN</b>	Year Renewed:	
Location:	<b>Other</b>	Tape/Media #:	
Purpose:	<b>Not Known</b>	Dia/Height:	<b>10"</b>
Use:	<b>Sanitary</b>	Material:	<b>VCP</b>
Drain Area:	<b>NA</b>	Lining:	
Category:	<b>NA</b>		
Comment:			
Location Details:		Direction of Survey:	<b>Downstream</b>
US MH:	<b>M-503-041</b>	DS MH:	<b>M-503-042</b>
		Total Length Surveyed (ft):	<b>301.4</b>

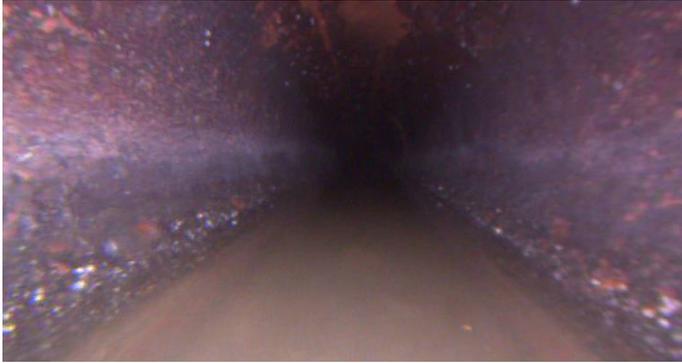
Code: **AMH**  
Description: **Manhole**

Distance (ft): **.0**  
Structural Grade: **0**  
O&M Grade: **0**  
Clock Start/From:  
Clock To:  
1st Value:  
2nd Value:  
Value Percent:  
Continuous Index:  
Within 8" of Joint: **NO**  
Remarks: **M-503-041**

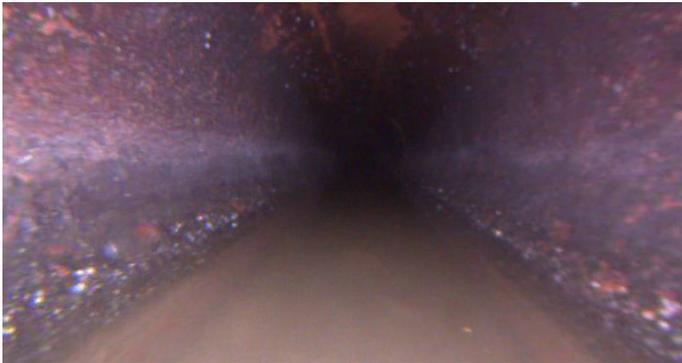
Code: **MWL**  
Description: **Water Level**

Distance (ft): **.0**  
Structural Grade: **0**  
O&M Grade: **0**  
Clock Start/From:  
Clock To:  
1st Value:  
2nd Value:  
Value Percent: **10.000**  
Continuous Index:  
Within 8" of Joint: **NO**  
Remarks:

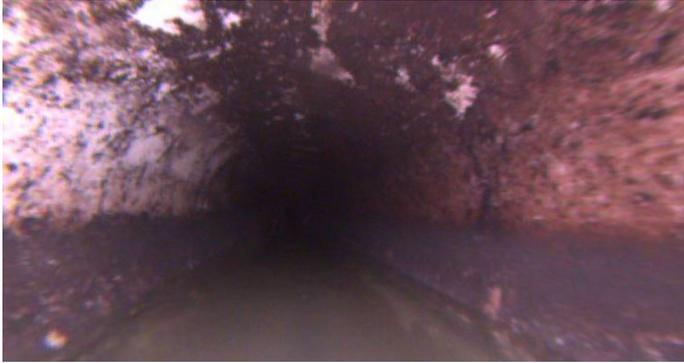
Code: **MMC**  
Description: **Material Change**

Distance (ft): **58.9**  
Structural Grade: **0**  
O&M Grade: **0**  
Clock Start/From:  
Clock To:  
1st Value:  
2nd Value:  
Value Percent:  
Continuous Index:  
Within 8" of Joint: **NO**  
Remarks: **PVC**

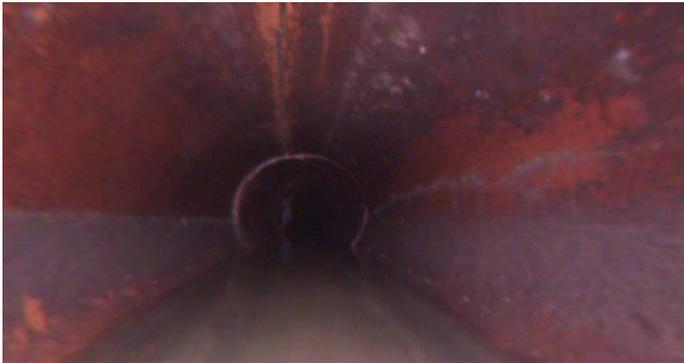
Code: **MMC**  
Description: **Material Change**

Distance (ft): **67.0**  
Structural Grade: **0**  
O&M Grade: **0**  
Clock Start/From:  
Clock To:  
1st Value:  
2nd Value:  
Value Percent:  
Continuous Index:  
Within 8" of Joint: **NO**  
Remarks: **VCP**

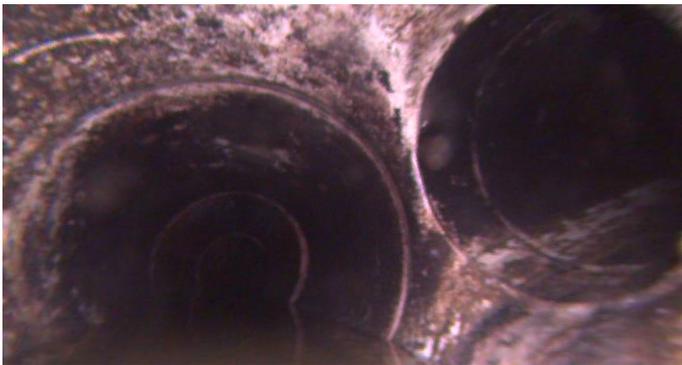
Code: **TF**  
Description: **Tap Factory**

Distance (ft): **75.0**  
Structural Grade: **0**  
O&M Grade: **0**  
Clock Start/From: **3**  
Clock To:  
1st Value: **4.000**  
2nd Value:  
Value Percent:  
Continuous Index:  
Within 8" of Joint:  
Remarks:

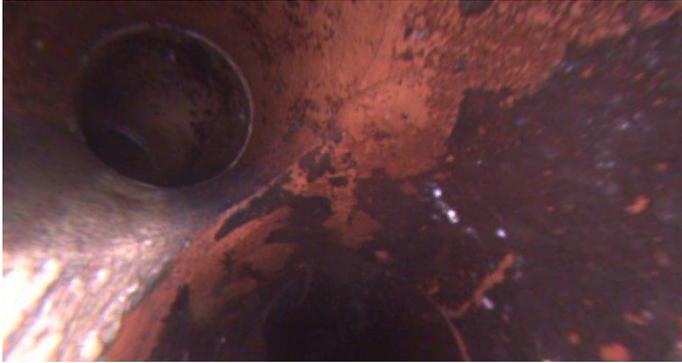
Code: **TF**  
Description: **Tap Factory**

Distance (ft): **195.3**  
Structural Grade: **0**  
O&M Grade: **0**  
Clock Start/From: **10**  
Clock To:  
1st Value: **4.000**  
2nd Value:  
Value Percent:  
Continuous Index:  
Within 8" of Joint:  
Remarks:

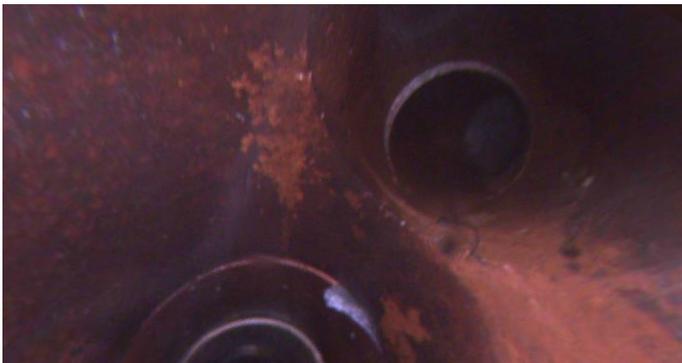
Code: **TF**  
Description: **Tap Factory**

Distance (ft): **212.3**  
Structural Grade: **0**  
O&M Grade: **0**  
Clock Start/From: **2**  
Clock To:  
1st Value: **4.000**  
2nd Value:  
Value Percent:  
Continuous Index:  
Within 8" of Joint:  
Remarks:

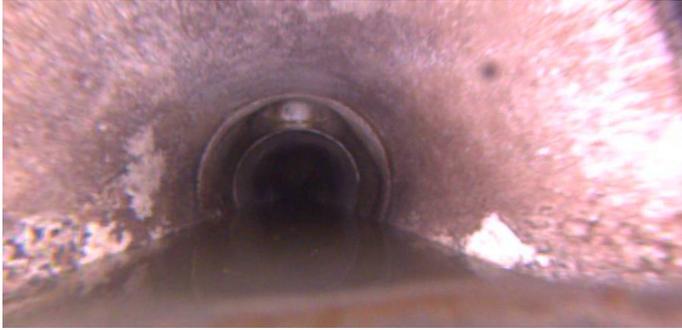
Code: **MMC**  
Description: **Material Change**

Distance (ft): **214.3**  
Structural Grade: **0**  
O&M Grade: **0**  
Clock Start/From:  
Clock To:  
1st Value:  
2nd Value:  
Value Percent:  
Continuous Index:  
Within 8" of Joint: **NO**  
Remarks: **pvc**

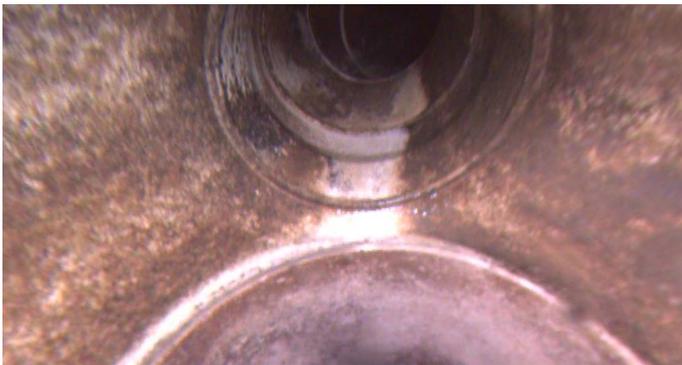
Code: **TF**  
Description: **Tap Factory**

Distance (ft): **215.8**  
Structural Grade: **0**  
O&M Grade: **0**  
Clock Start/From: **12**  
Clock To:  
1st Value: **4.000**  
2nd Value:  
Value Percent:  
Continuous Index:  
Within 8" of Joint:  
Remarks:

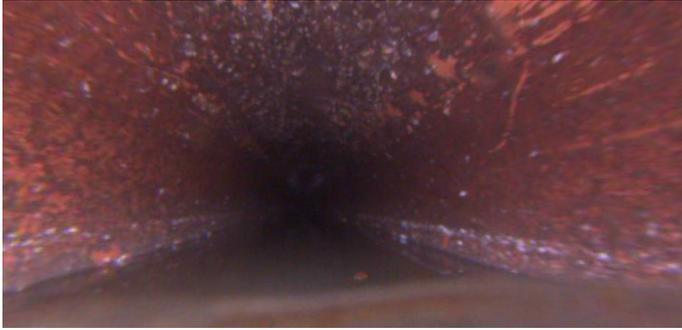
Code: **MMC**  
Description: **Material Change**

Distance (ft): **218.7**  
Structural Grade: **0**  
O&M Grade: **0**  
Clock Start/From:  
Clock To:  
1st Value:  
2nd Value:  
Value Percent:  
Continuous Index:  
Within 8" of Joint: **NO**  
Remarks: **VCP**

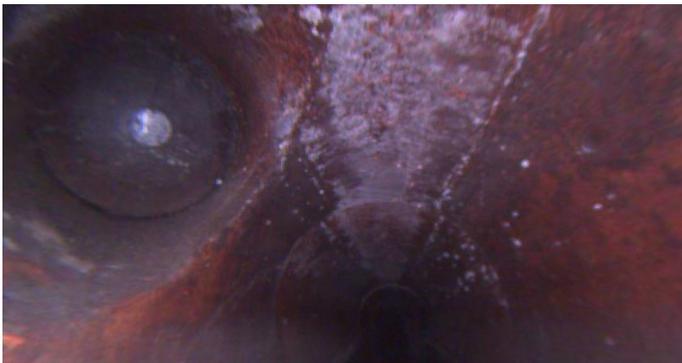
Code: **TFC**  
Description: **Tap Factory Capped**

Distance (ft): **274.4**  
Structural Grade: **0**  
O&M Grade: **0**  
Clock Start/From: **10**  
Clock To:  
1st Value: **4.000**  
2nd Value:  
Value Percent:  
Continuous Index:  
Within 8" of Joint:  
Remarks:

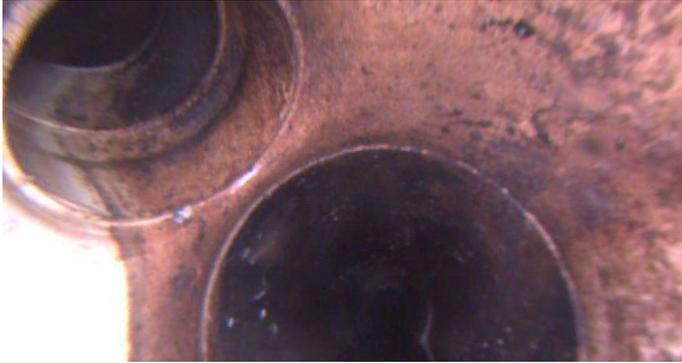
Code: **TF**  
Description: **Tap Factory**

Distance (ft): **280.7**  
Structural Grade: **0**  
O&M Grade: **0**  
Clock Start/From: **10**  
Clock To:  
1st Value: **4.000**  
2nd Value:  
Value Percent:  
Continuous Index:  
Within 8" of Joint:  
Remarks:

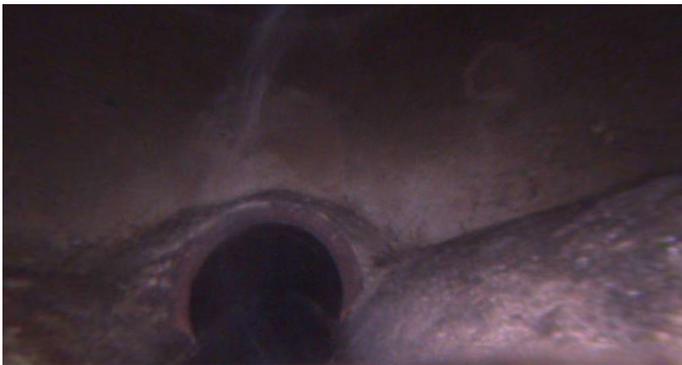
Code: **AMH**  
Description: **Manhole**

Distance (ft): **301.4**  
Structural Grade: **0**  
O&M Grade: **0**  
Clock Start/From:  
Clock To:  
1st Value:  
2nd Value:  
Value Percent:  
Continuous Index:  
Within 8" of Joint: **NO**  
Remarks: **M-503-042**
