Profile/Photo Observation Report

Date:	04/07/2018	Weather:		Coding:	PACP 6.0
Pipe Length (ft):	478.8	Owner:	NA	Pre Clean:	Not Known
P.O.#:		Surveyor:	Mark Ruby	PSR:	P-503-042-041
Customer:		Clean Date:	01/01/1900	Shape:	C

Street:	PENNSYLVANIA ST	Flow Control:	Not Controlled
City:	Hobart, IN	Year Renewed:	
Location:	Other	Tape/Media #:	
Purpose:	Not Known	Dia/Height:	12"
Use:	Sanitary	Material:	VCP
Drain Area:	NA	Lining:	
Category:	NA		
Comment:			
Location Details:		Direction of Survey:	Upstream
US MH:	M-503-041	DS MH:	M-503-042
		Total Length Surveyed (ft):	65.4

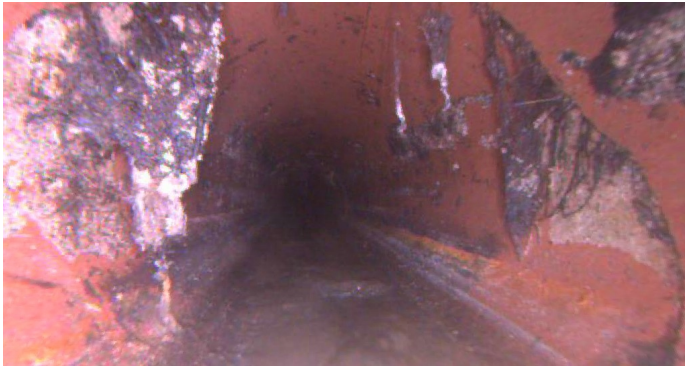
Code:	AMH
Description:	Manhole

Distance (ft):	.0
Structural Grade:	0
O&M Grade:	0
Clock Start/From:	
Clock To:	
1st Value:	
2nd Value:	
Value Percent:	
Continuous Index:	
Within 8" of Joint:	NO
Remarks:	M-503-042

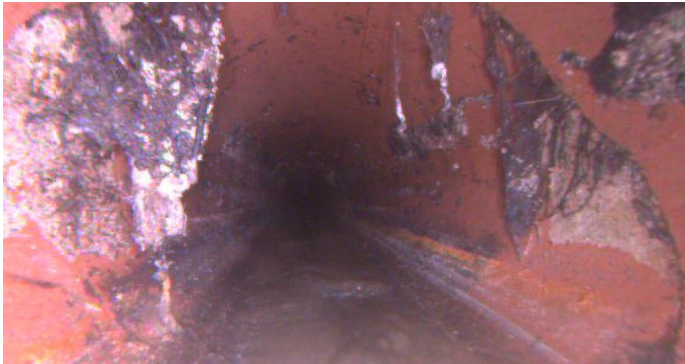
Code:	MWL
Description:	Water Level

Distance (ft):	.0
Structural Grade:	0
O&M Grade:	0
Clock Start/From:	
Clock To:	
1st Value:	
2nd Value:	
Value Percent:	10.000
Continuous Index:	
Within 8" of Joint:	NO
Remarks:

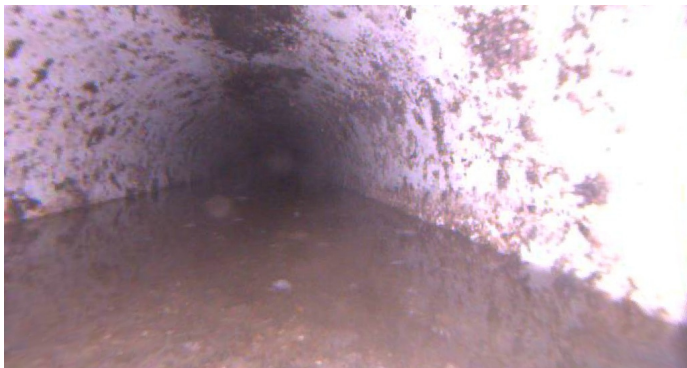
Code: **MMC**
Description: **Material Change**

Distance (ft): **23.8**
Structural Grade: **0**
O&M Grade: **0**
Clock Start/From:
Clock To:
1st Value:
2nd Value:
Value Percent:
Continuous Index:
Within 8" of Joint: **NO**
Remarks: **PVC**

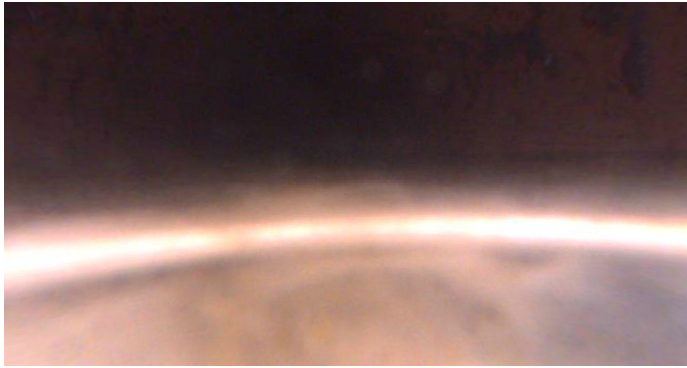
Code:	MMC
Description:	Material Change
Distance (ft):	44.4
Structural Grade:	0
O&M Grade:	0
Clock Start/From:	
Clock To:	
1st Value:	
2nd Value:	
Value Percent:	
Continuous Index:	
Within 8" of Joint:	NO
Remarks:	VCP

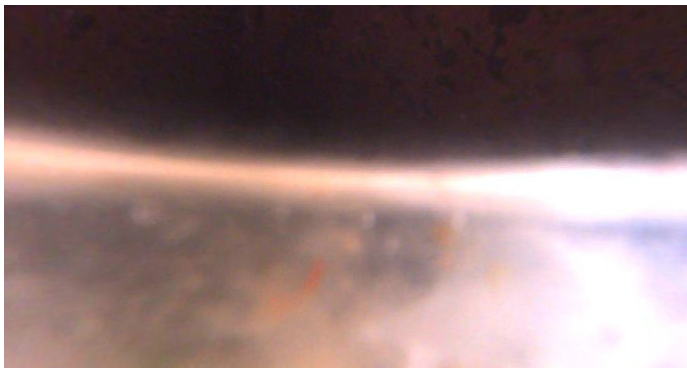
Code:	MWL
Description:	Water Level
Distance (ft):	45.7
Structural Grade:	0
O&M Grade:	0
Clock Start/From:	
Clock To:	
1st Value:	
2nd Value:	
Value Percent:	40.000
Continuous Index:	
Within 8" of Joint:	NO
Remarks:

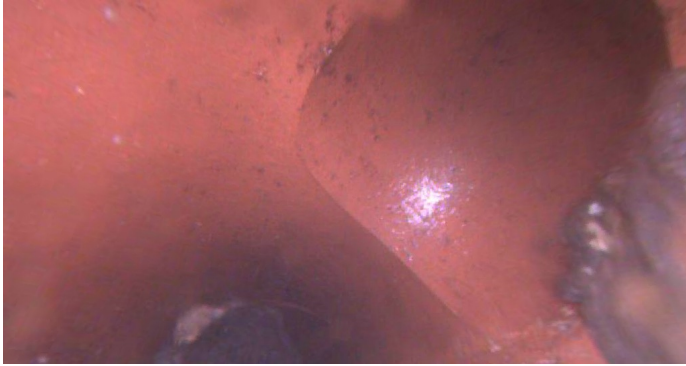
Code: **TF**
Description: **Tap Factory**

Distance (ft): **64.1**
Structural Grade: **0**
O&M Grade: **0**
Clock Start/From: **2**
Clock To:
1st Value: **4.000**
2nd Value:
Value Percent:
Continuous Index:
Within 8" of Joint:
Remarks:

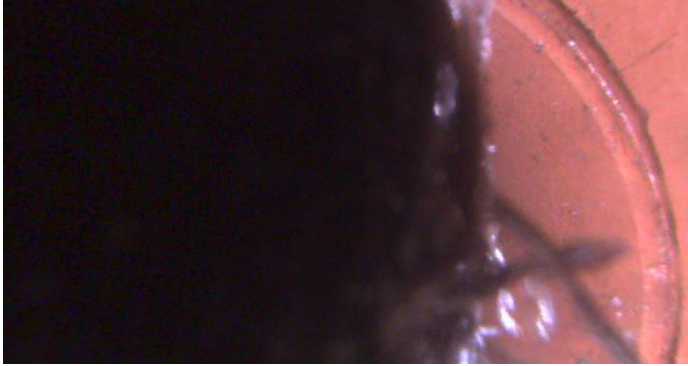
Code:	MSA
Description:	Abandoned Survey
Distance (ft):	65.4
Structural Grade:	0
O&M Grade:	0
Clock Start/From:	
Clock To:	
1st Value:	
2nd Value:	
Value Percent:	
Continuous Index:	
Within 8" of Joint:	NO
Remarks:	RMJ
