Profile/Photo Observation Report

Date:	04/07/2018	Weather:		Coding:	PACP 6.0
Pipe Length (ft):	311.7	Owner:	NA	Pre Clean:	Not Known
P.O.#:		Surveyor:	Mark Ruby	PSR:	P-503-041-043
Customer:		Clean Date:	01/01/1900	Shape:	C

Street:	N GUYER ST & PENNSYLVANIA ST	Flow Control:	Not Controlled
City:	Hobart, IN	Year Renewed:	
Location:	Other	Tape/Media #:	
Purpose:	Not Known	Dia/Height:	10"
Use:	Sanitary	Material:	VCP
Drain Area:	NA	Lining:	
Category:	NA		
Comment:

Location Details:		Direction of Survey:	Upstream
US MH:	M-503-043	DS MH:	M-503-041
		Total Length Surveyed (ft):	173.5

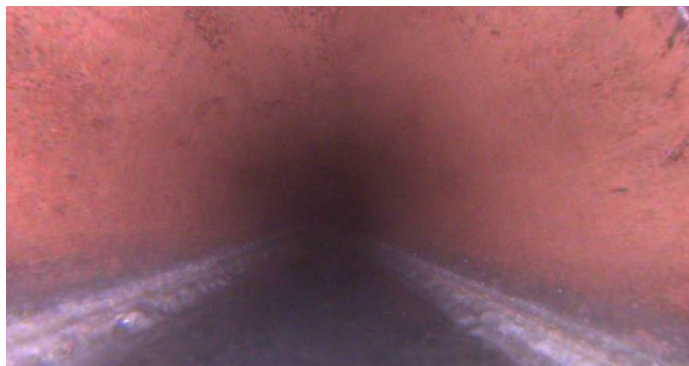
Code: **AMH**
Description: **Manhole**

Distance (ft): **.0**
Structural Grade: **0**
O&M Grade: **0**
Clock Start/From:
Clock To:
1st Value:
2nd Value:
Value Percent:
Continuous Index:
Within 8" of Joint: **NO**
Remarks: **M-503-041**
