## Profile/Photo Observation Report

Date:	<b>04/07/2018</b>	Weather:		Coding:	<b>PACP 6.0</b>
Pipe Length (ft):	<b>311.7</b>	Owner:	<b>NA</b>	Pre Clean:	<b>Not Known</b>
P.O.#:		Surveyor:	<b>Mark Ruby</b>	PSR:	<b>P-503-041-043</b>
Customer:		Clean Date:	<b>01/01/1900</b>	Shape:	<b>C</b>

Street:	<b>guyer st</b>	Flow Control:	<b>Not Controlled</b>
City:	<b>Hobart, IN</b>	Year Renewed:	
Location:	<b>Other</b>	Tape/Media #:	
Purpose:	<b>Not Known</b>	Dia/Height:	<b>10"</b>
Use:	<b>Sanitary</b>	Material:	<b>VCP</b>
Drain Area:	<b>NA</b>	Lining:	
Category:	<b>NA</b>		
Comment:

Location Details:		Direction of Survey:	<b>Upstream</b>
US MH:	<b>M-503-043</b>	DS MH:	<b>M-503-041</b>
		Total Length Surveyed (ft):	<b>173.5</b>

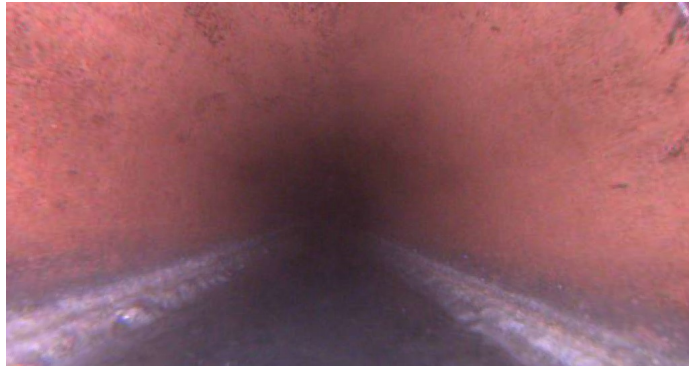
Code: **MWL**  
Description: **Water Level**

Distance (ft): **.0**  
Structural Grade: **0**  
O&M Grade: **0**  
Clock Start/From:  
Clock To:  
1st Value:  
2nd Value:  
Value Percent: **10.000**  
Continuous Index:  
Within 8" of Joint: **NO**  
Remarks:

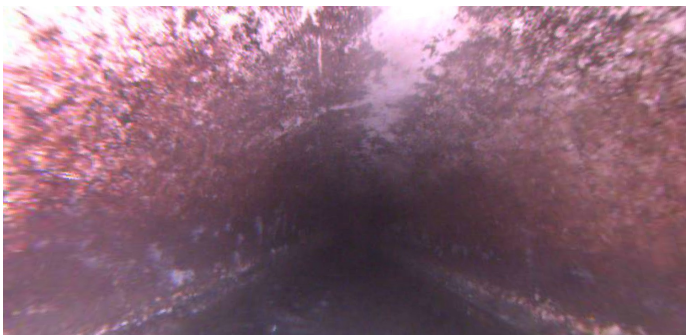
Code: **MMC**  
Description: **Material Change**

Distance (ft): **59.2**  
Structural Grade: **0**  
O&M Grade: **0**  
Clock Start/From:  
Clock To:  
1st Value:  
2nd Value:  
Value Percent:  
Continuous Index:  
Within 8" of Joint: **NO**  
Remarks: **PVC**

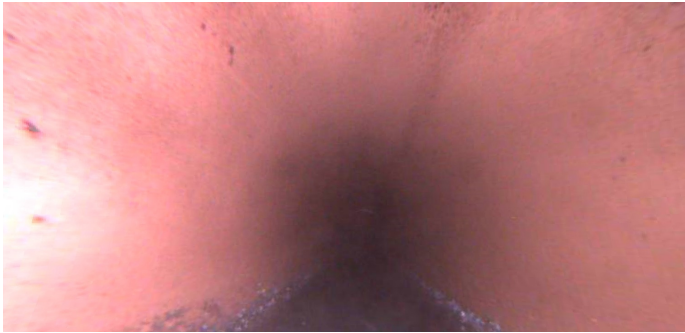
Code: **MMC**  
Description: **Material Change**

Distance (ft): **69.8**  
Structural Grade: **0**  
O&M Grade: **0**  
Clock Start/From:  
Clock To:  
1st Value:  
2nd Value:  
Value Percent:  
Continuous Index:  
Within 8" of Joint: **NO**  
Remarks: **vcp**

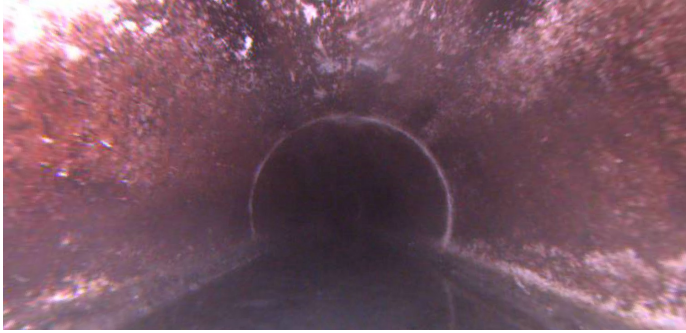
Code: **MMC**  
Description: **Material Change**

Distance (ft): **83.9**  
Structural Grade: **0**  
O&M Grade: **0**  
Clock Start/From:  
Clock To:  
1st Value:  
2nd Value:  
Value Percent:  
Continuous Index:  
Within 8" of Joint: **NO**  
Remarks: **PVC**

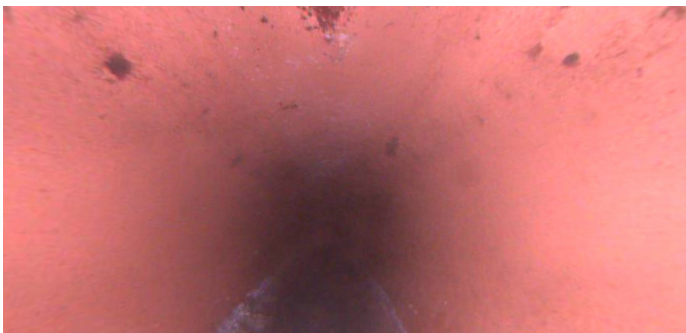
Code: **MMC**  
Description: **Material Change**

Distance (ft): **89.7**  
Structural Grade: **0**  
O&M Grade: **0**  
Clock Start/From:  
Clock To:  
1st Value:  
2nd Value:  
Value Percent:  
Continuous Index:  
Within 8" of Joint: **NO**  
Remarks: **vcp**
