Profile/Photo Observation Report

Date:	04/12/2018	Weather:		Coding:	PACP 6.0
Pipe Length (ft):	276.6	Owner:	NA	Pre Clean:	Not Known
P.O.#:		Surveyor:	Jen Costello	PSR:	P-503-046-045
Customer:		Clean Date:	01/01/1900	Shape:	C

Street:	W 40th ave	Flow Control:	Not Controlled
City:	Hobart, IN	Year Renewed:	
Location:	Other	Tape/Media #:	
Purpose:	Not Known	Dia/Height:	10"
Use:	Sanitary	Material:	VCP
Drain Area:	NA	Lining:	
Category:	NA		
Comment:

Location Details:		Direction of Survey:	Upstream
US MH:	M-503-045	DS MH:	M-503-046
		Total Length Surveyed (ft):	89.9

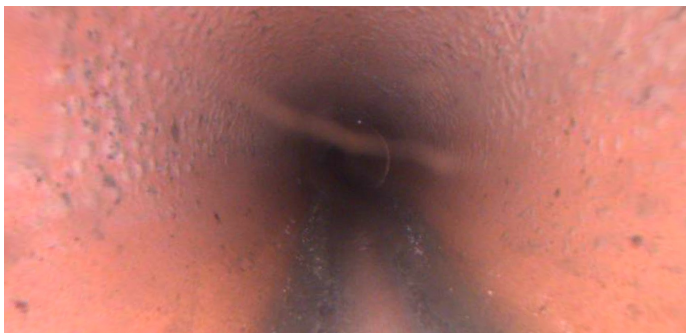
Code: **AMH**
Description: **Manhole**

Distance (ft): **.0**
Structural Grade: **0**
O&M Grade: **0**
Clock Start/From:
Clock To:
1st Value:
2nd Value:
Value Percent:
Continuous Index:
Within 8" of Joint: **NO**
Remarks: **M-503-045**

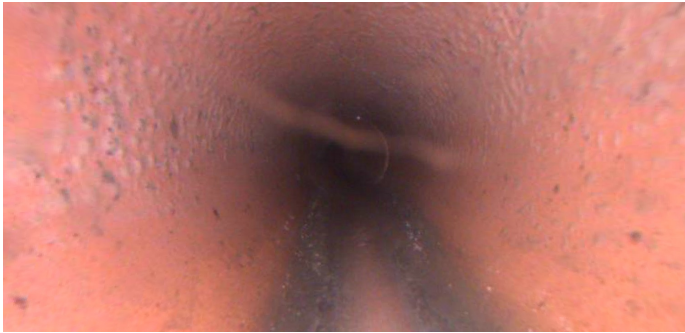
Code:	MWL
Description:	Water Level

Distance (ft):	.0
Structural Grade:	0
O&M Grade:	0
Clock Start/From:	
Clock To:	
1st Value:	
2nd Value:	
Value Percent:	5.000
Continuous Index:	
Within 8" of Joint:	NO
Remarks:

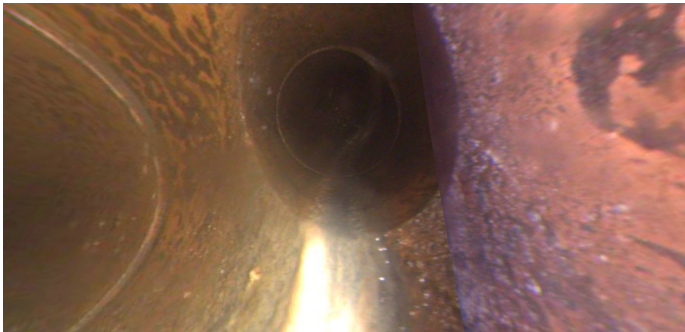
Code: **TFA**
Description: **Tap Factory Active**

Distance (ft): **33.9**
Structural Grade: **0**
O&M Grade: **0**
Clock Start/From: **2**
Clock To:
1st Value: **4.000**
2nd Value:
Value Percent:
Continuous Index:
Within 8" of Joint:
Remarks:

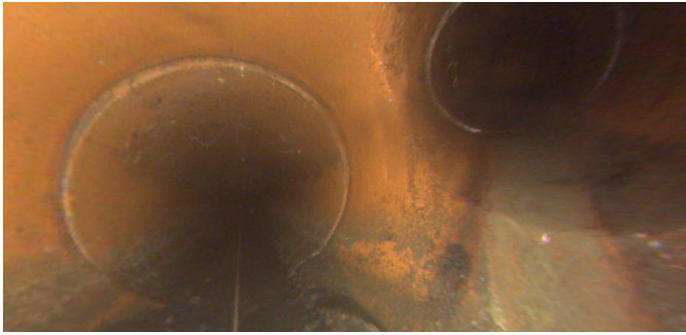
Code: **TFA**
Description: **Tap Factory Active**

Distance (ft): **82.6**
Structural Grade: **0**
O&M Grade: **0**
Clock Start/From: **9**
Clock To:
1st Value: **4.000**
2nd Value:
Value Percent:
Continuous Index:
Within 8" of Joint:
Remarks:
