Profile/Photo Observation Report

Street:	W 39TH AVE & W 38TH PL	Flow Control:	Not Controlled
City:	Hobart, IN	Year Renewed:	
Location:	Other	Tape/Media #:	
Purpose:	Not Known	Dia/Height:	10"
Use:	Sanitary	Material:	VCP
Drain Area:	NA	Lining:	
Category:	NA		
Comment:

Location Details:		Direction of Survey:	Downstream
US MH:	M-503-046	DS MH:	M-503-047
		Total Length Surveyed (ft):	196.7

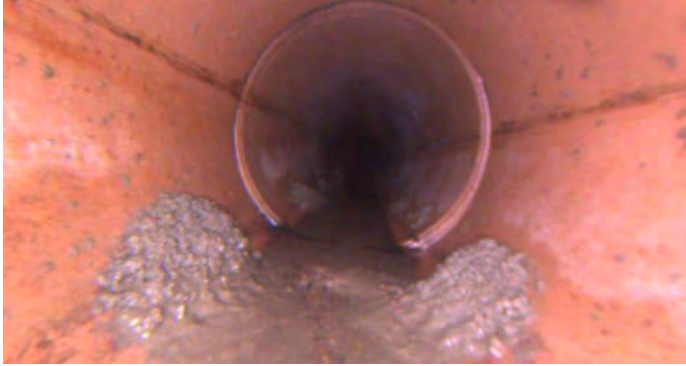
Code: **MWL**
Description: **Water Level**

Distance (ft): **.0**
Structural Grade: **0**
O&M Grade: **0**
Clock Start/From:
Clock To:
1st Value:
2nd Value:
Value Percent: **10.000**
Continuous Index:
Within 8" of Joint: **NO**
Remarks:

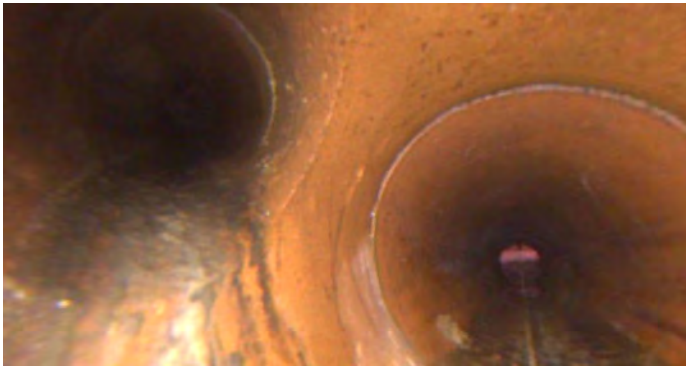
Code: **TF**
Description: **Tap Factory**

Distance (ft): **8.0**
Structural Grade: **0**
O&M Grade: **0**
Clock Start/From: **2**
Clock To:
1st Value: **4.000**
2nd Value:
Value Percent:
Continuous Index:
Within 8" of Joint:
Remarks: **Photo taken from rear camera.**

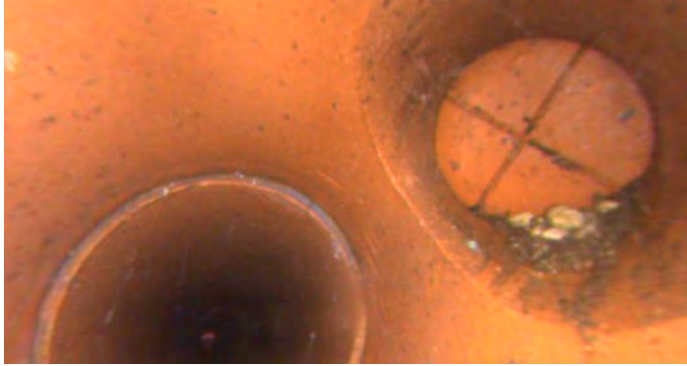
Code: **TFC**
Description: **Tap Factory Capped**

Distance (ft): **25.0**
Structural Grade: **0**
O&M Grade: **0**
Clock Start/From: **10**
Clock To:
1st Value: **4.000**
2nd Value:
Value Percent:
Continuous Index:
Within 8" of Joint:
Remarks: **Photo taken from rear camera.**

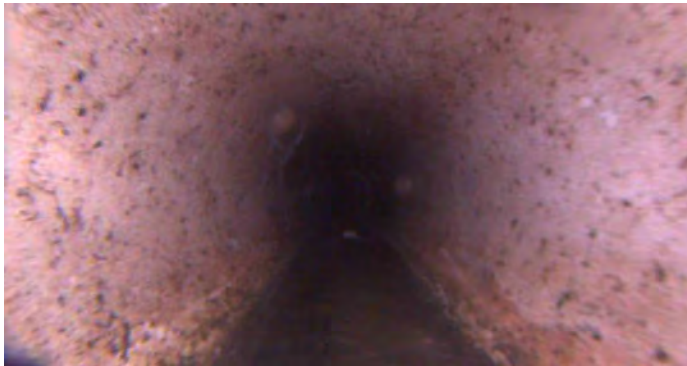
Code: **MMC**
Description: **Material Change**

Distance (ft): **36.0**
Structural Grade: **0**
O&M Grade: **0**
Clock Start/From:
Clock To:
1st Value:
2nd Value:
Value Percent:
Continuous Index:
Within 8" of Joint: **NO**
Remarks: **PVC**

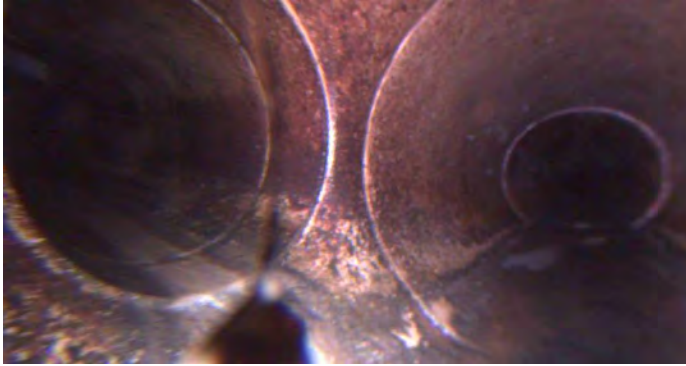
Code: **TF**
Description: **Tap Factory**

Distance (ft): **39.1**
Structural Grade: **0**
O&M Grade: **0**
Clock Start/From: **8**
Clock To:
1st Value: **4.000**
2nd Value:
Value Percent:
Continuous Index:
Within 8" of Joint:
Remarks:

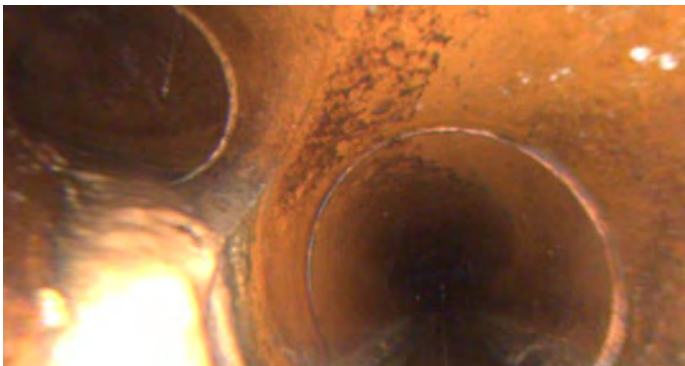
Code: **TF**
Description: **Tap Factory**

Distance (ft): **66.7**
Structural Grade: **0**
O&M Grade: **0**
Clock Start/From: **2**
Clock To:
1st Value: **4.000**
2nd Value:
Value Percent:
Continuous Index:
Within 8" of Joint:
Remarks: **Photo taken from rear camera.**

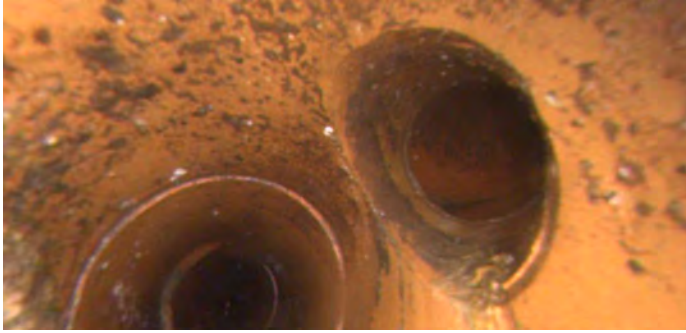
Code: **TF**
Description: **Tap Factory**

Distance (ft): **69.0**
Structural Grade: **0**
O&M Grade: **0**
Clock Start/From: **2**
Clock To:
1st Value: **4.000**
2nd Value:
Value Percent:
Continuous Index:
Within 8" of Joint:
Remarks:

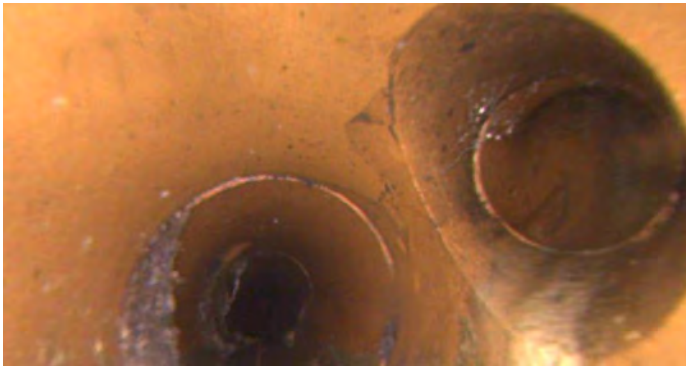
Code: **TF**
Description: **Tap Factory**

Distance (ft): **148.0**
Structural Grade: **0**
O&M Grade: **0**
Clock Start/From: **10**
Clock To:
1st Value: **4.000**
2nd Value:
Value Percent:
Continuous Index:
Within 8" of Joint:
Remarks: **Photo taken from rear camera.**
