Profile/Photo Observation Report

Date:	04/10/2018	Weather:		Coding:	PACP 6.0
Pipe Length (ft):	224.0	Owner:	NA	Pre Clean:	Not Known
P.O.#:		Surveyor:	Mark Ruby	PSR:	P-503-047-046
Customer:		Clean Date:	01/01/1900	Shape:	C

Street:	W 40th ave	Flow Control:	Not Controlled
City:	Hobart, IN	Year Renewed:	
Location:	Other	Tape/Media #:	
Purpose:	Not Known	Dia/Height:	10"
Use:	Sanitary	Material:	VCP
Drain Area:	NA	Lining:	
Category:	NA		
Comment:

Location Details:		Direction of Survey:	Downstream
US MH:	M-503-046	DS MH:	M-503-047
		Total Length Surveyed (ft):	196.7

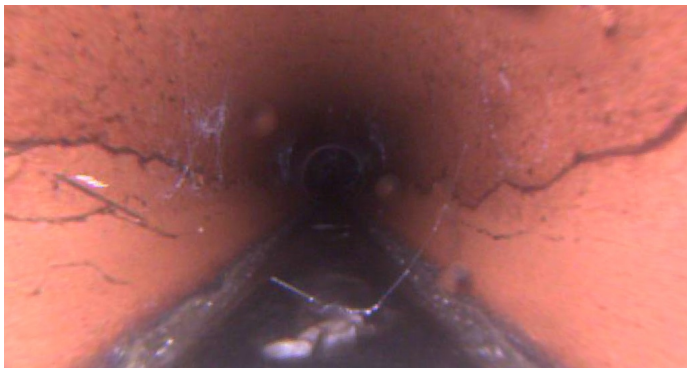
Code: **TF**
Description: **Tap Factory**

Distance (ft): **39.1**
Structural Grade: **0**
O&M Grade: **0**
Clock Start/From: **8**
Clock To:
1st Value: **4.000**
2nd Value:
Value Percent:
Continuous Index:
Within 8" of Joint:
Remarks:
