Profile/Photo Observation Report

Date:	10/18/2021	Weather:		Coding:	PACP 6.0
Pipe Length (ft):		Owner:	Hobart, IN	Pre Clean:	Not Known
P.O.#:	879_1	Surveyor:	M. Pielacha	PSR:	P-503-052-053
Customer:	Hobart, IN	Clean Date:		Shape:	C

Street:	Off 38th Place	Flow Control:	
City:	Hobart, IN	Year Renewed:	
Location:	Yard	Tape/Media #:	879
Purpose:	Routine Assessment	Dia/Height:	10"
Use:	Sanitary	Material:	VCP
Drain Area:		Lining:	
Category:	NA		
Comment:

Location Details:		Direction of Survey:	Downstream
US MH:	M-503-53	DS MH:	M-503-52
		Total Length Surveyed (ft):	212.5

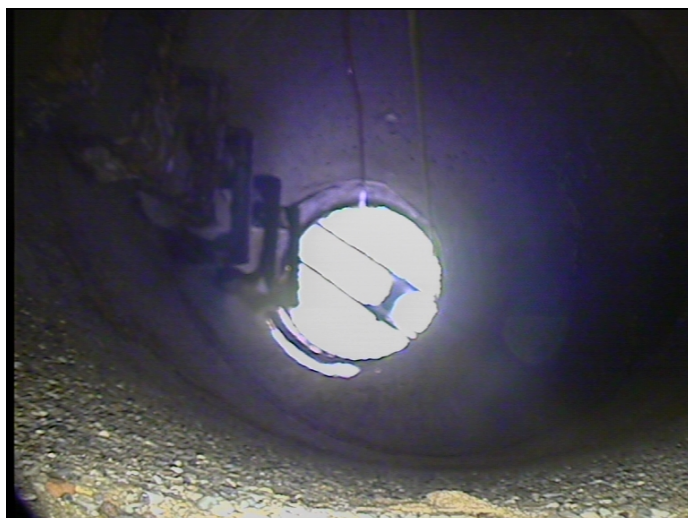
Code: **AMH**
Description: **Manhole**

Distance (ft): **.0**
Structural Grade: **0**
O&M Grade: **0**
Clock Start/From:
Clock To:
1st Value:
2nd Value:
Value Percent:
Continuous Index:
Within 8" of Joint: **NO**
Remarks: **M-503-53**

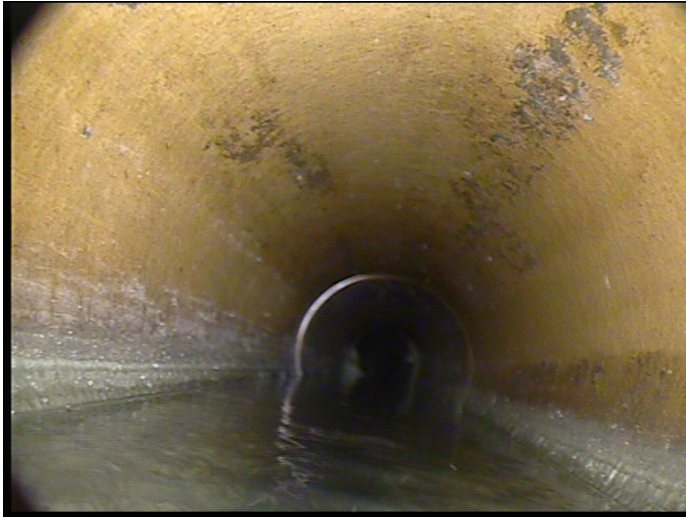
Code: **MWL**
Description: **Water Level**

Distance (ft): **.0**
Structural Grade: **0**
O&M Grade: **0**
Clock Start/From:
Clock To:
1st Value:
2nd Value:
Value Percent: **10.000**
Continuous Index:
Within 8" of Joint: **NO**
Remarks:

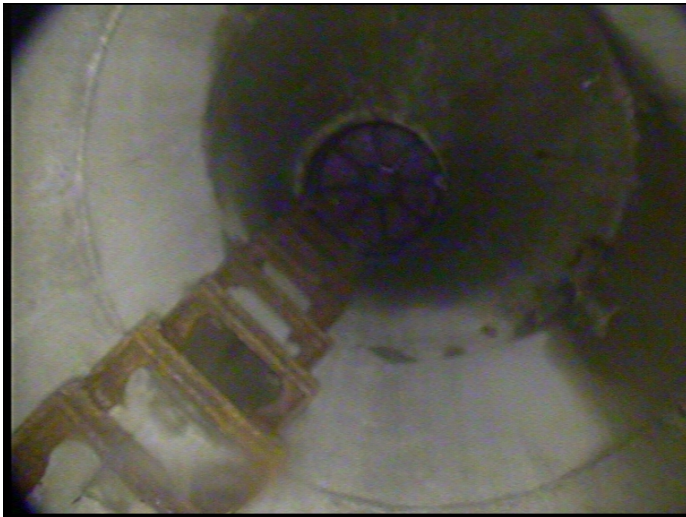
Code:	AMH
Description:	Manhole
Distance (ft):	212.5
Structural Grade:	0
O&M Grade:	0
Clock Start/From:	
Clock To:	
1st Value:	
2nd Value:	
Value Percent:	
Continuous Index:	
Within 8" of Joint:	NO
Remarks:	M-503-52
