Profile/Photo Observation Report

Date:	09/17/2021	Weather:		Coding:	PACP 7.0
Pipe Length (ft):	256.6	Owner:	City of Hobart	Pre Clean:	Heavy Cleaning
P.O.#:	YES502259	Surveyor:	S. Bucklin	PSR:	P-503-054-055
Customer:	City of Hobart	Clean Date:	08/24/2021	Shape:	C

Street:	North Guyer Street	Flow Control:	Not Controlled
City:	Hobart, IN	Year Renewed:	
Location:	Local rural streets with light traffic, t	Tape/Media #:	
Purpose:	Routine Assessment	Dia/Height:	10"
Use:	Sanitary Sewage Pipe	Material:	VCP
Drain Area:		Lining:	None
Category:	NA		
Comment:			
Location Details:		Direction of Survey:	Downstream
US MH:	M-503-054	DS MH:	M-503-055
		Total Length Surveyed (ft):	256.6

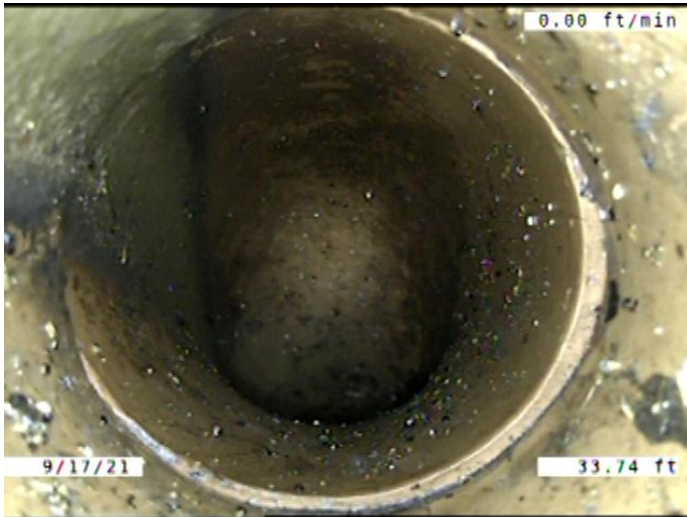
Code: **DAE**
Description: **Deposits Attached Encrustation**

Distance (ft): **22.7**
Structural Grade: **0**
O&M Grade: **2**
Clock Start/From: **8**
Clock To: **4**
1st Value:
2nd Value:
Value Percent: **5.000**
Continuous Index: **S01**
Within 8" of Joint: **YES**
Remarks:

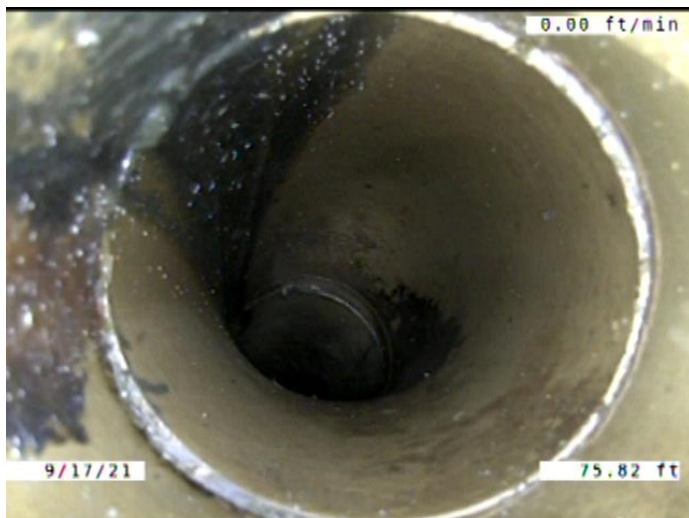
Code: **ISB**
Description: **Infiltration Stain Barrel**

Distance (ft): **63.9**
Structural Grade: **0**
O&M Grade: **1**
Clock Start/From: **8**
Clock To: **12**
1st Value:
2nd Value:
Value Percent:
Continuous Index:
Within 8" of Joint: **YES**
Remarks:

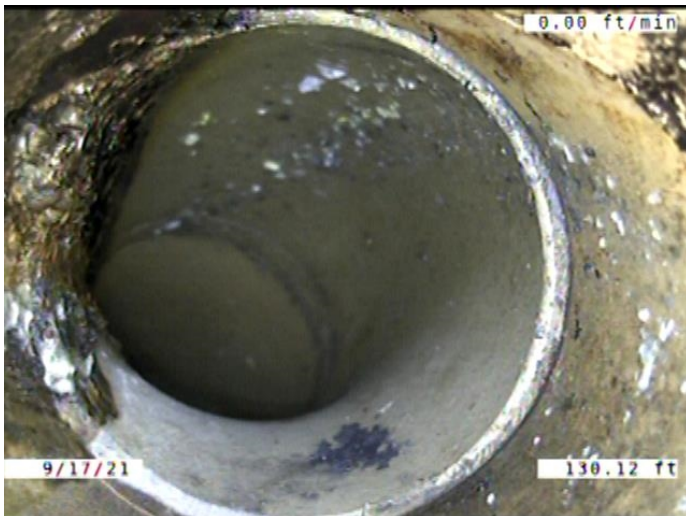
Code: **TFD**
Description: **Tap Factory Defective**

Distance (ft): **92.8**
Structural Grade: **0**
O&M Grade: **3**
Clock Start/From: **1**
Clock To:
1st Value: **4.000**
2nd Value:
Value Percent:
Continuous Index:
Within 8" of Joint: **YES**
Remarks: **Defective**

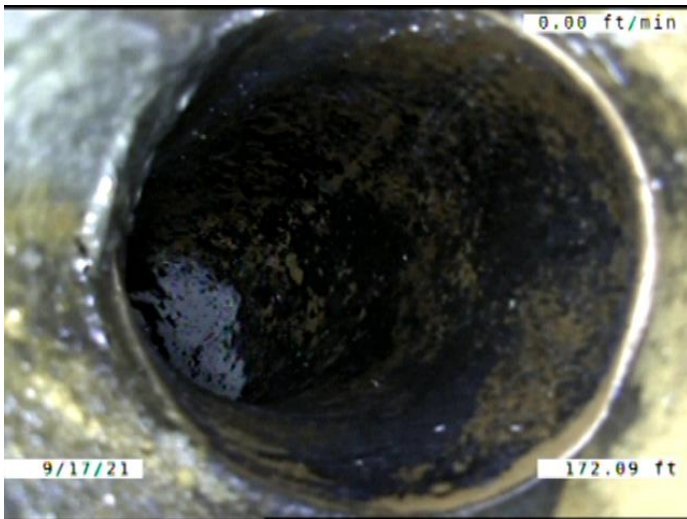
Code: **CS**
 Description: **Crack Spiral**

Distance (ft): **166.4**
 Structural Grade: **2**
 O&M Grade: **0**
 Clock Start/From: **3**
 Clock To: **5**
 1st Value:
 2nd Value:
 Value Percent:
 Continuous Index:
 Within 8" of Joint: **YES**
 Remarks:
