Profile/Photo Observation Report

Date:	09/17/2021	Weather:		Coding:	PACP 7.0
Pipe Length (ft):	238.3	Owner:	City of Hobart	Pre Clean:	Light Cleaning
P.O.#:	YES502259	Surveyor:	S. Bucklin	PSR:	P-503-059-058
Customer:	City of Hobart	Clean Date:	08/24/2021	Shape:	C

Street:	North Virginia Street	Flow Control:	Not Controlled
City:	Hobart, IN	Year Renewed:	
Location:	Alley	Tape/Media #:	
Purpose:	Routine Assessment	Dia/Height:	10"
Use:	Sanitary Sewage Pipe	Material:	VCP
Drain Area:		Lining:	None
Category:	NA		
Comment:			
Location Details:		Direction of Survey:	Downstream
US MH:	M-503-058	DS MH:	M-503-059
		Total Length Surveyed (ft):	238.3

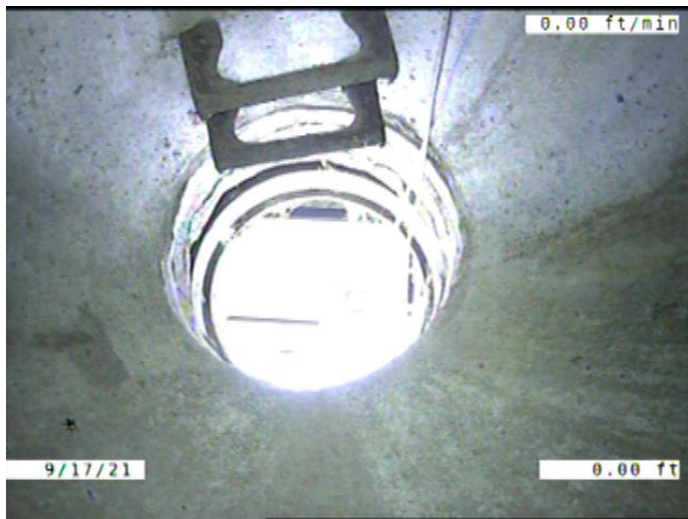
Code: **AMH**
Description: **Manhole**

Distance (ft): **.0**
Structural Grade: **0**
O&M Grade: **0**
Clock Start/From:
Clock To:
1st Value:
2nd Value:
Value Percent:
Continuous Index:
Within 8" of Joint: **NO**
Remarks: **M-503-058**

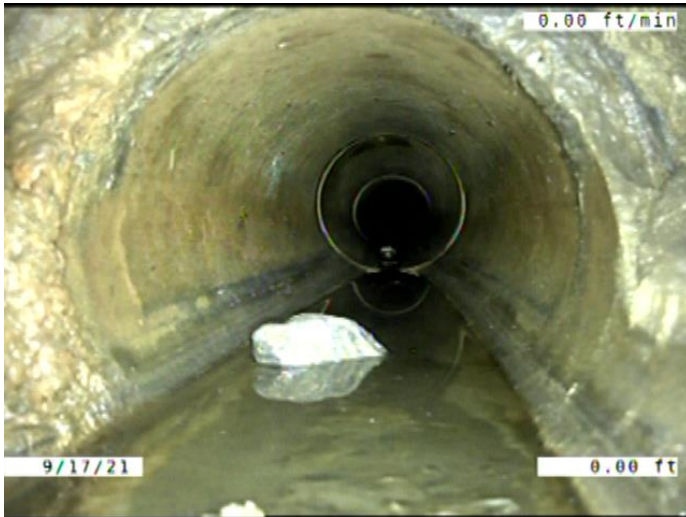
Code: **MWL**
 Description: **Miscellaneous Water Level**

Distance (ft): **.0**
 Structural Grade: **0**
 O&M Grade: **0**
 Clock Start/From:
 Clock To:
 1st Value:
 2nd Value:
 Value Percent: **5.000**
 Continuous Index:
 Within 8" of Joint: **NO**
 Remarks:

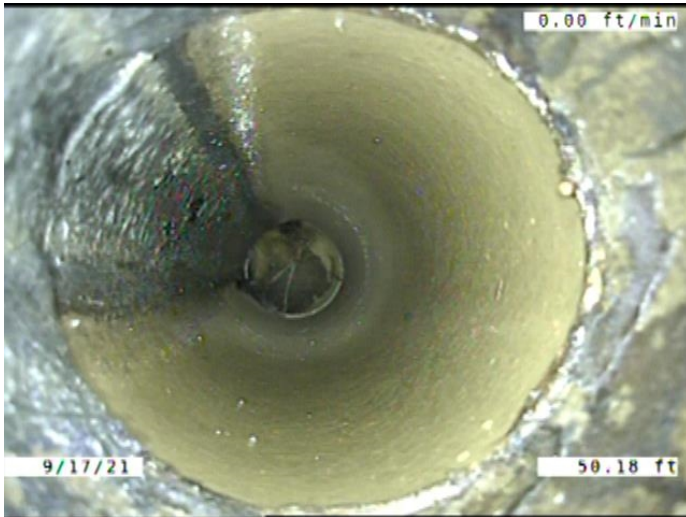
Code: **TF**
 Description: **Tap Factory**

Distance (ft): **50.2**
 Structural Grade: **0**
 O&M Grade: **0**
 Clock Start/From: **11**
 Clock To:
 1st Value: **4.000**
 2nd Value:
 Value Percent:
 Continuous Index:
 Within 8" of Joint: **YES**
 Remarks:

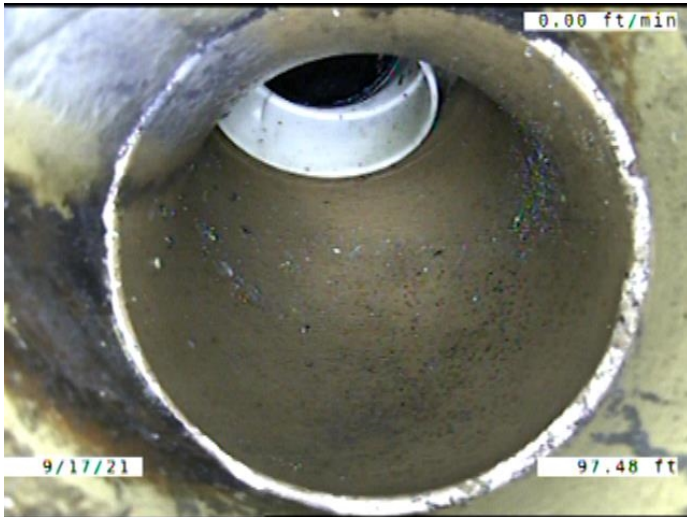
Code: **TF**
 Description: **Tap Factory**

Distance (ft): **97.5**
 Structural Grade: **0**
 O&M Grade: **0**
 Clock Start/From: **11**
 Clock To:
 1st Value: **4.000**
 2nd Value:
 Value Percent:
 Continuous Index:
 Within 8" of Joint: **YES**
 Remarks:

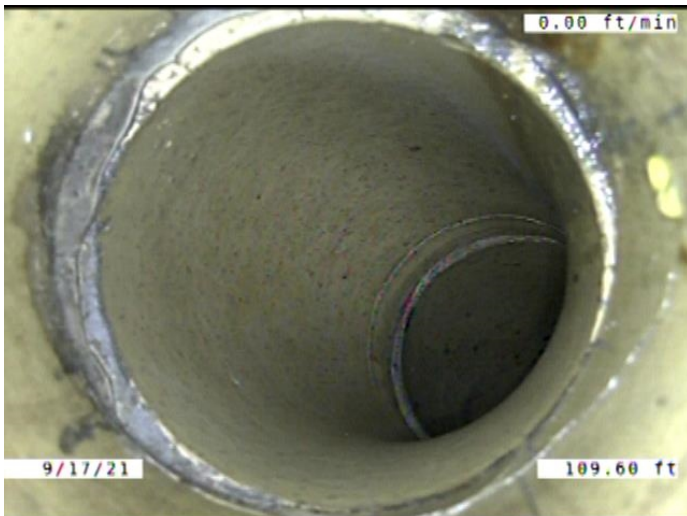
Code: **TF**
 Description: **Tap Factory**

Distance (ft): **109.6**
 Structural Grade: **0**
 O&M Grade: **0**
 Clock Start/From: **1**
 Clock To:
 1st Value: **4.000**
 2nd Value:
 Value Percent:
 Continuous Index:
 Within 8" of Joint: **YES**
 Remarks:

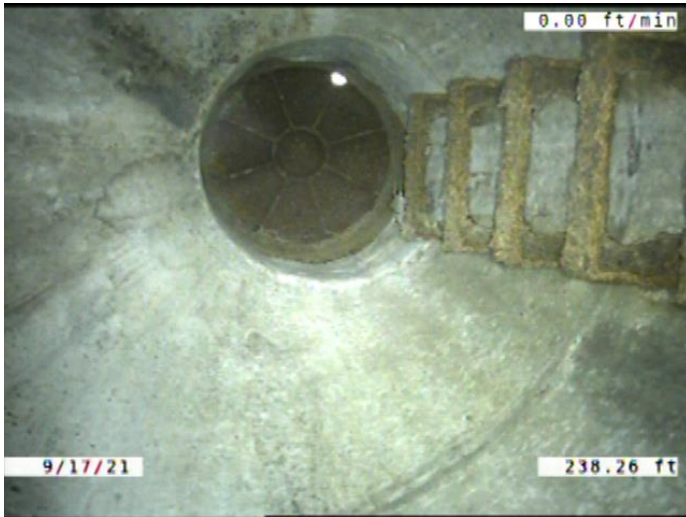
Code:	AMH
Description:	Manhole
Distance (ft):	238.3
Structural Grade:	0
O&M Grade:	0
Clock Start/From:	
Clock To:	
1st Value:	
2nd Value:	
Value Percent:	
Continuous Index:	
Within 8" of Joint:	NO
Remarks:	M-503-059
