Profile/Photo Observation Report

Date:	09/17/2021	Weather:		Coding:	PACP 7.0
Pipe Length (ft):	238.3	Owner:	City of Hobart	Pre Clean:	Light Cleaning
P.O.#:	YES502259	Surveyor:	S. Bucklin	PSR:	P-503-059-058
Customer:	City of Hobart	Clean Date:	08/24/2021	Shape:	C

Street:	North Virginia Street	Flow Control:	Not Controlled
City:	Hobart, IN	Year Renewed:	
Location:	Alley	Tape/Media #:	
Purpose:	Routine Assessment	Dia/Height:	10"
Use:	Sanitary Sewage Pipe	Material:	VCP
Drain Area:		Lining:	None
Category:	NA		
Comment:			
Location Details:		Direction of Survey:	Downstream
US MH:	M-503-058	DS MH:	M-503-059
		Total Length Surveyed (ft):	238.3

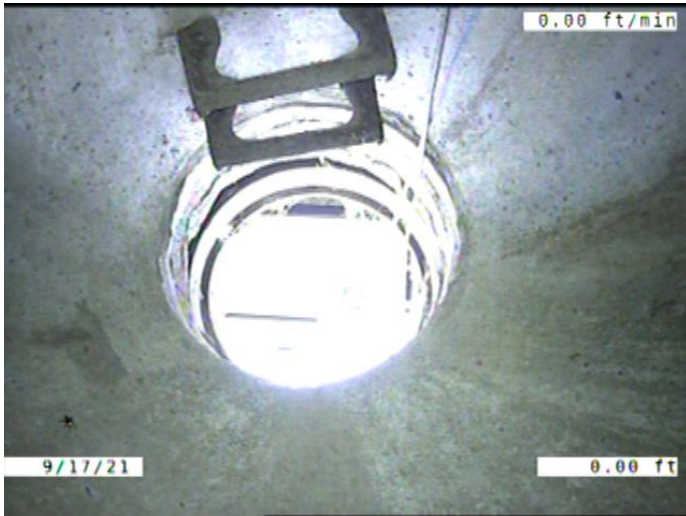
Code: **AMH**
Description: **Manhole**

Distance (ft): **.0**
Structural Grade: **0**
O&M Grade: **0**
Clock Start/From:
Clock To:
1st Value:
2nd Value:
Value Percent:
Continuous Index:
Within 8" of Joint: **NO**
Remarks: **M-503-058**

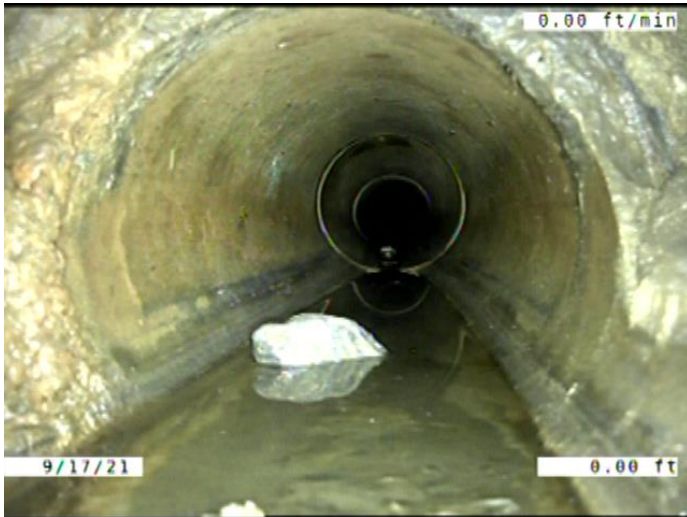
Code: **MWL**
 Description: **Miscellaneous Water Level**

Distance (ft): **.0**
 Structural Grade: **0**
 O&M Grade: **0**
 Clock Start/From:
 Clock To:
 1st Value:
 2nd Value:
 Value Percent: **5.000**
 Continuous Index:
 Within 8" of Joint: **NO**
 Remarks:
