Profile/Photo Observation Report

Date:	04/13/2018	Weather:		Coding:	PACP 6.0
Pipe Length (ft):	267.4	Owner:	NA	Pre Clean:	Not Known
P.O.#:		Surveyor:	Jen Costello	PSR:	P-503-061-062
Customer:		Clean Date:	01/01/1900	Shape:	C

Street:	ALLEY BETWEEN W 38TH PL & W 38	Flow Control:	Not Controlled
City:	Hobart, IN	Year Renewed:	
Location:	Other	Tape/Media #:	
Purpose:	Not Known	Dia/Height:	10"
Use:	Sanitary	Material:	VCP
Drain Area:	NA	Lining:	
Category:	NA		
Comment:

Location Details:		Direction of Survey:	Downstream
US MH:	M-503-062	DS MH:	M-503-061
		Total Length Surveyed (ft):	164.9

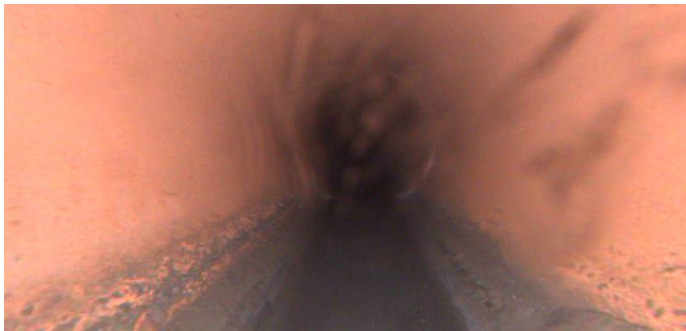
Code: **AMH**
Description: **Manhole**

Distance (ft): **.0**
Structural Grade: **0**
O&M Grade: **0**
Clock Start/From:
Clock To:
1st Value:
2nd Value:
Value Percent:
Continuous Index:
Within 8" of Joint: **NO**
Remarks: **M-503-062**

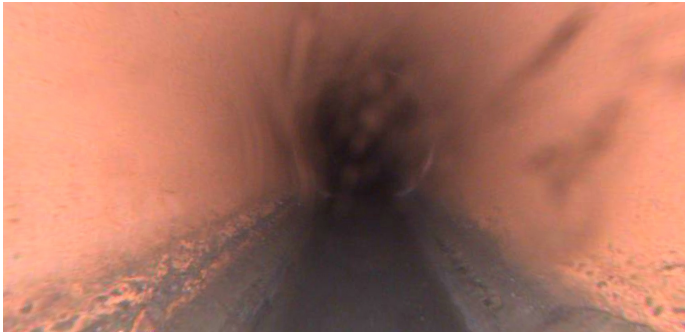
Code:	MWL
Description:	Water Level

Distance (ft):	.0
Structural Grade:	0
O&M Grade:	0
Clock Start/From:	
Clock To:	
1st Value:	
2nd Value:	
Value Percent:	5.000
Continuous Index:	
Within 8" of Joint:	NO
Remarks:

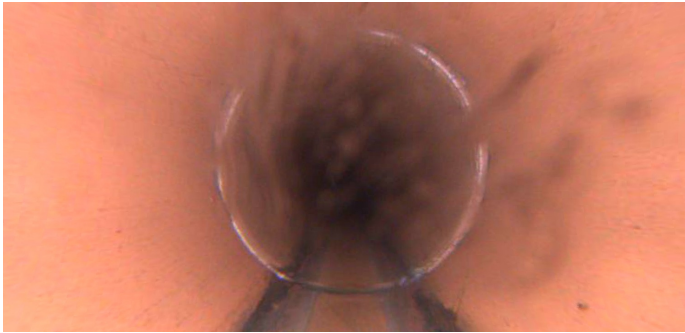
Code: **MGO**
Description: **General Observation**

Distance (ft): **24.2**
Structural Grade: **0**
O&M Grade: **0**
Clock Start/From:
Clock To:
1st Value:
2nd Value:
Value Percent:
Continuous Index:
Within 8" of Joint: **NO**
Remarks: **REAR CAMERA**

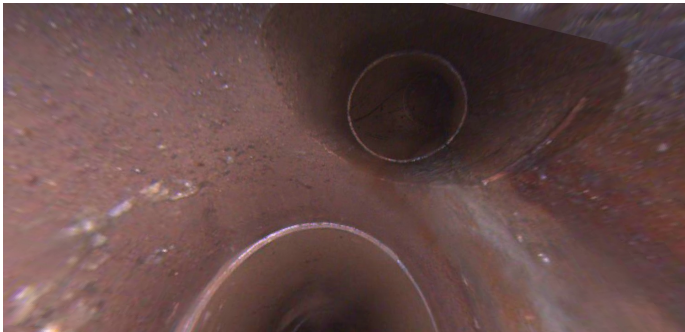
Code: **TF**
Description: **Tap Factory**

Distance (ft): **88.4**
Structural Grade: **0**
O&M Grade: **0**
Clock Start/From: **11**
Clock To:
1st Value: **4.000**
2nd Value:
Value Percent:
Continuous Index:
Within 8" of Joint:
Remarks:

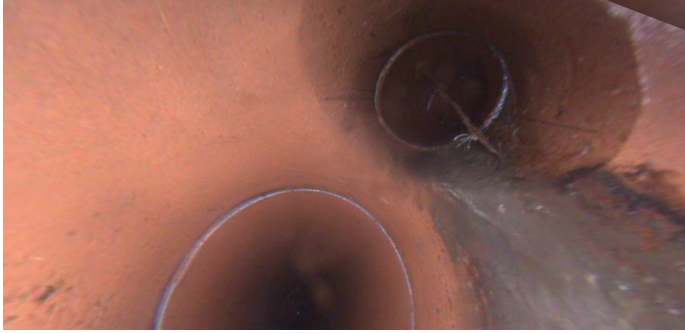
Code: **TF**
Description: **Tap Factory**

Distance (ft): **145.8**
Structural Grade: **0**
O&M Grade: **0**
Clock Start/From: **11**
Clock To:
1st Value: **4.000**
2nd Value:
Value Percent:
Continuous Index:
Within 8" of Joint:
Remarks:

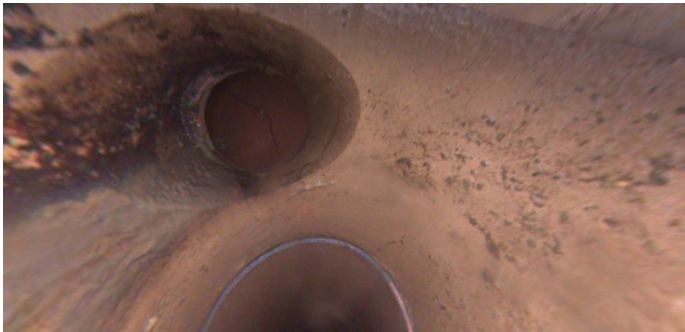
Code: **TF**
Description: **Tap Factory**

Distance (ft): **148.0**
Structural Grade: **0**
O&M Grade: **0**
Clock Start/From: **1**
Clock To:
1st Value: **4.000**
2nd Value:
Value Percent:
Continuous Index:
Within 8" of Joint:
Remarks:
