Profile/Photo Observation Report

Date:	09/18/2021	Weather:		Coding:	PACP 7.0
Pipe Length (ft):	266.7	Owner:	City of Hobart	Pre Clean:	Light Cleaning
P.O.#:	YES502259	Surveyor:	S. Bucklin	PSR:	P-503-061-062
Customer:	City of Hobart	Clean Date:	08/25/2021	Shape:	C

Street:	North Wisconsin Street	Flow Control:	Not Controlled
City:	Hobart, IN	Year Renewed:	
Location:	Easement/Right of Way	Tape/Media #:	
Purpose:	Routine Assessment	Dia/Height:	10"
Use:	Sanitary Sewage Pipe	Material:	VCP
Drain Area:		Lining:	None
Category:	NA		
Comment:			
Location Details:	JUST OFF THE SW CORNER OF THE C	Direction of Survey:	Upstream
US MH:	M-503-062	DS MH:	M-503-061
		Total Length Surveyed (ft):	266.7

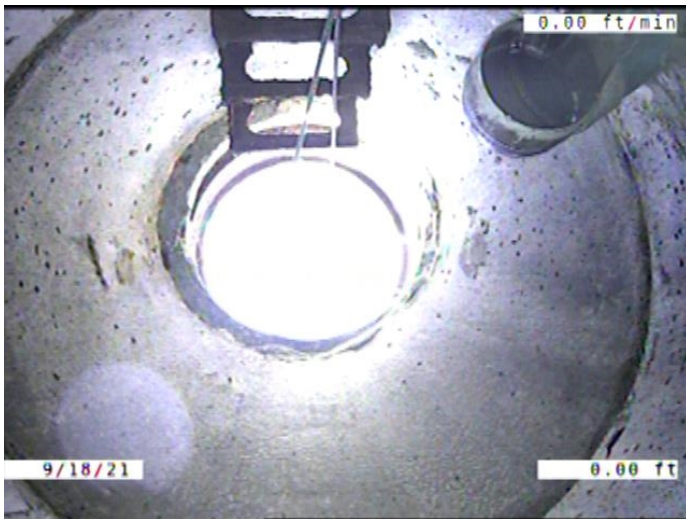
Code: **AMH**
Description: **Manhole**

Distance (ft): **.0**
Structural Grade: **0**
O&M Grade: **0**
Clock Start/From:
Clock To:
1st Value:
2nd Value:
Value Percent:
Continuous Index:
Within 8" of Joint: **NO**
Remarks: **M-503-061**

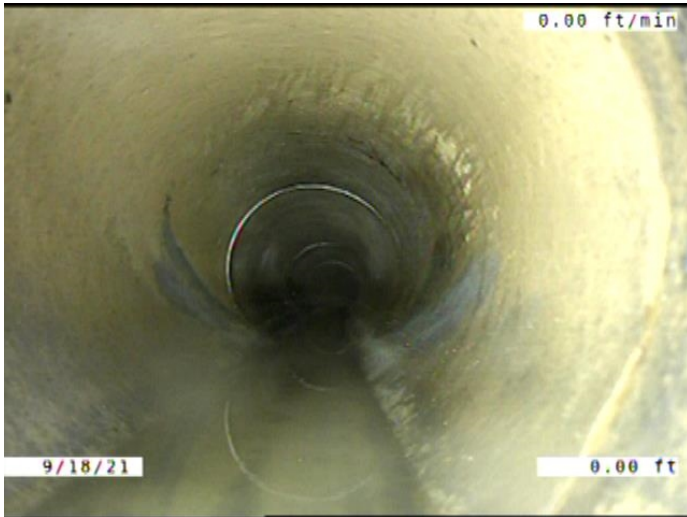
Code: **MWL**
 Description: **Miscellaneous Water Level**

Distance (ft): **.0**
 Structural Grade: **0**
 O&M Grade: **0**
 Clock Start/From:
 Clock To:
 1st Value:
 2nd Value:
 Value Percent: **5.000**
 Continuous Index:
 Within 8" of Joint: **NO**
 Remarks:

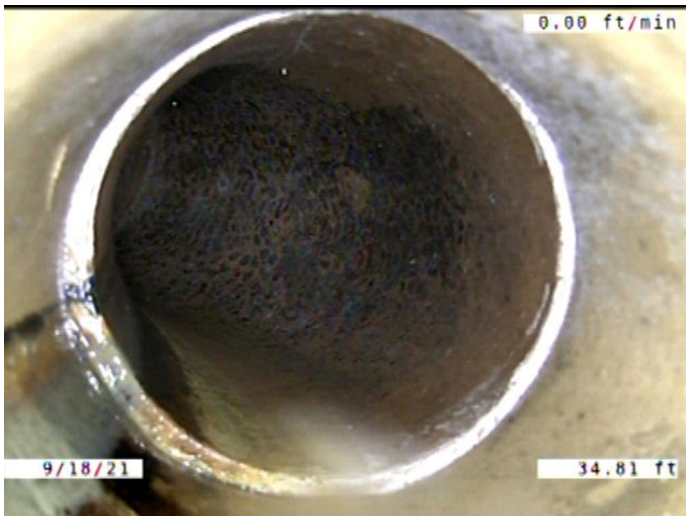
Code: **TF**
 Description: **Tap Factory**

Distance (ft): **34.8**
 Structural Grade: **0**
 O&M Grade: **0**
 Clock Start/From: **11**
 Clock To:
 1st Value: **4.000**
 2nd Value:
 Value Percent:
 Continuous Index:
 Within 8" of Joint: **YES**
 Remarks:

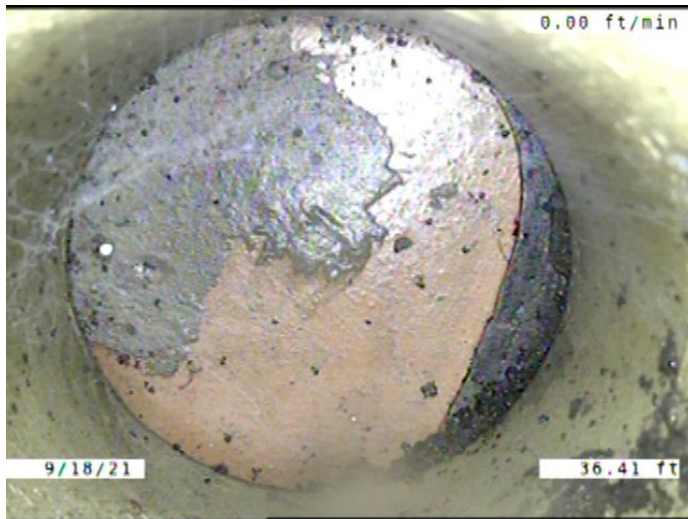
Code: **TFC**
 Description: **Tap Factory Capped**

Distance (ft): **36.4**
 Structural Grade: **0**
 O&M Grade: **0**
 Clock Start/From: **2**
 Clock To:
 1st Value: **4.000**
 2nd Value:
 Value Percent:
 Continuous Index:
 Within 8" of Joint: **YES**
 Remarks:

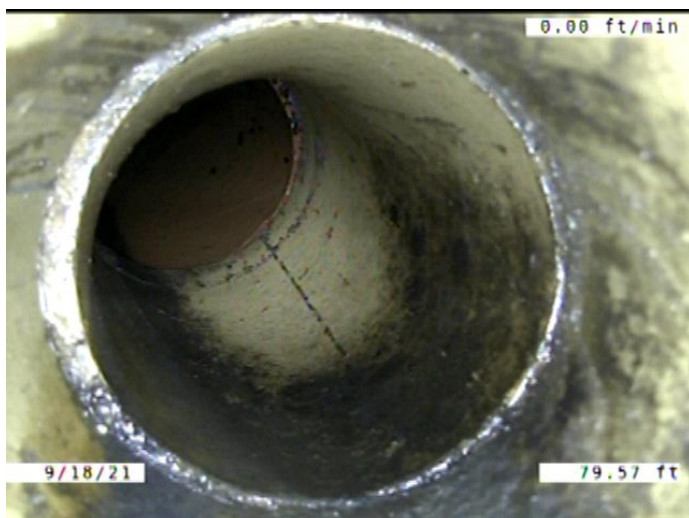
Code: **TF**
Description: **Tap Factory**

Distance (ft): **79.6**
Structural Grade: **0**
O&M Grade: **0**
Clock Start/From: **12**
Clock To:
1st Value: **4.000**
2nd Value:
Value Percent:
Continuous Index:
Within 8" of Joint: **YES**
Remarks:

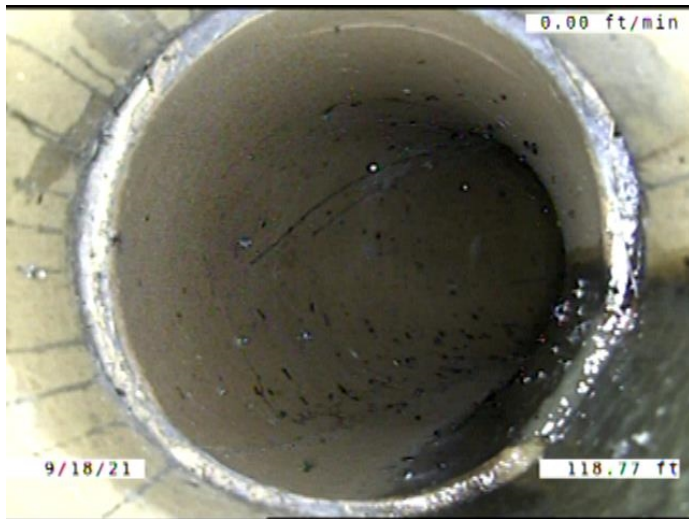
Code: **TF**
Description: **Tap Factory**

Distance (ft): **118.8**
Structural Grade: **0**
O&M Grade: **0**
Clock Start/From: **1**
Clock To:
1st Value: **4.000**
2nd Value:
Value Percent:
Continuous Index:
Within 8" of Joint: **YES**
Remarks:

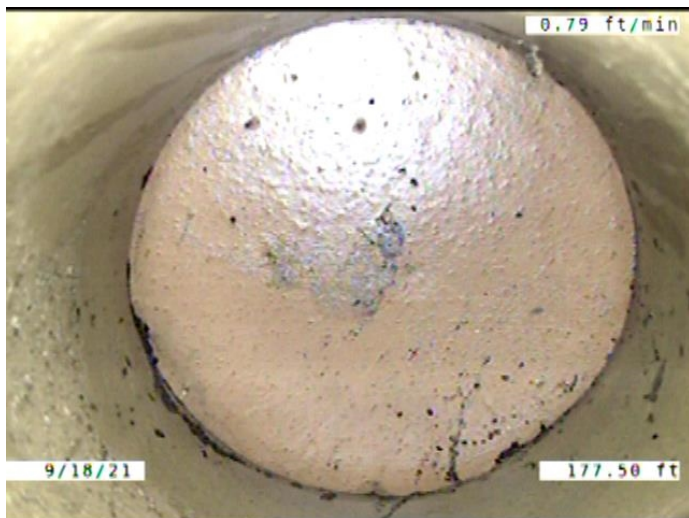
Code: **TFC**
Description: **Tap Factory Capped**

Distance (ft): **177.4**
Structural Grade: **0**
O&M Grade: **0**
Clock Start/From: **11**
Clock To:
1st Value: **4.000**
2nd Value:
Value Percent:
Continuous Index:
Within 8" of Joint: **YES**
Remarks:

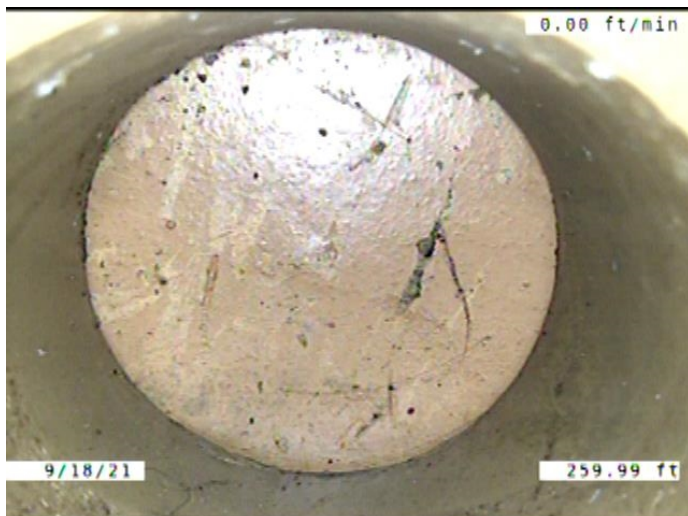
Code: **TFC**
 Description: **Tap Factory Capped**

Distance (ft): **260.0**
 Structural Grade: **0**
 O&M Grade: **0**
 Clock Start/From: **12**
 Clock To:
 1st Value: **4.000**
 2nd Value:
 Value Percent:
 Continuous Index:
 Within 8" of Joint: **YES**
 Remarks:

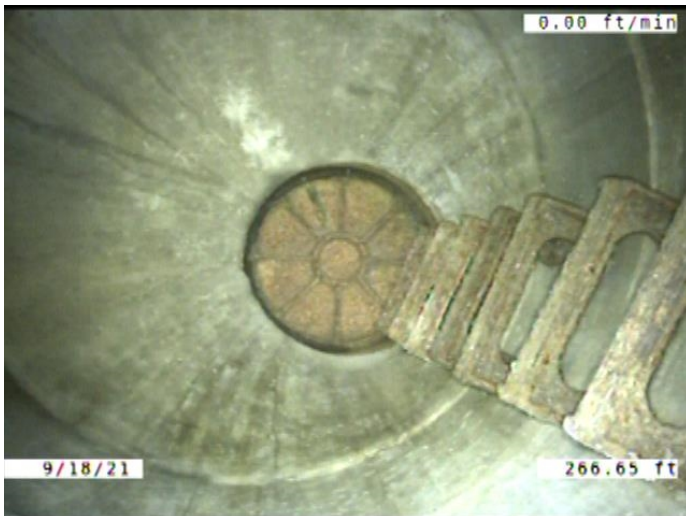
Code: **AMH**
 Description: **Manhole**

Distance (ft): **266.7**
 Structural Grade: **0**
 O&M Grade: **0**
 Clock Start/From:
 Clock To:
 1st Value:
 2nd Value:
 Value Percent:
 Continuous Index:
 Within 8" of Joint: **NO**
 Remarks: **M-503-062**
