Profile/Photo Observation Report

Date:	09/18/2021	Weather:		Coding:	PACP 7.0
Pipe Length (ft):	266.7	Owner:	City of Hobart	Pre Clean:	Light Cleaning
P.O.#:	YES502259	Surveyor:	S. Bucklin	PSR:	P-503-061-062
Customer:	City of Hobart	Clean Date:	08/25/2021	Shape:	C

Street:	North Wisconsin Street	Flow Control:	Not Controlled
City:	Hobart, IN	Year Renewed:	
Location:	Easement/Right of Way	Tape/Media #:	
Purpose:	Routine Assessment	Dia/Height:	10"
Use:	Sanitary Sewage Pipe	Material:	VCP
Drain Area:		Lining:	None
Category:	NA		
Comment:			
Location Details:	JUST OFF THE SW CORNER OF THE C	Direction of Survey:	Upstream
US MH:	M-503-062	DS MH:	M-503-061
		Total Length Surveyed (ft):	266.7

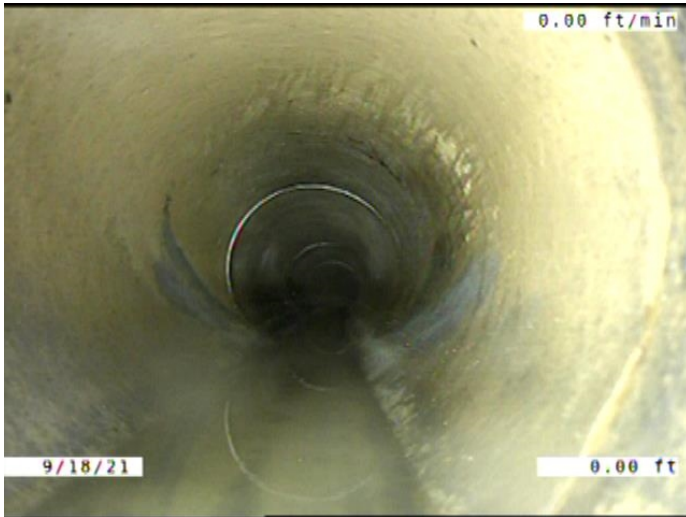
Code: **MWL**
 Description: **Miscellaneous Water Level**

Distance (ft): **.0**
 Structural Grade: **0**
 O&M Grade: **0**
 Clock Start/From:
 Clock To:
 1st Value:
 2nd Value:
 Value Percent: **5.000**
 Continuous Index:
 Within 8" of Joint: **NO**
 Remarks:

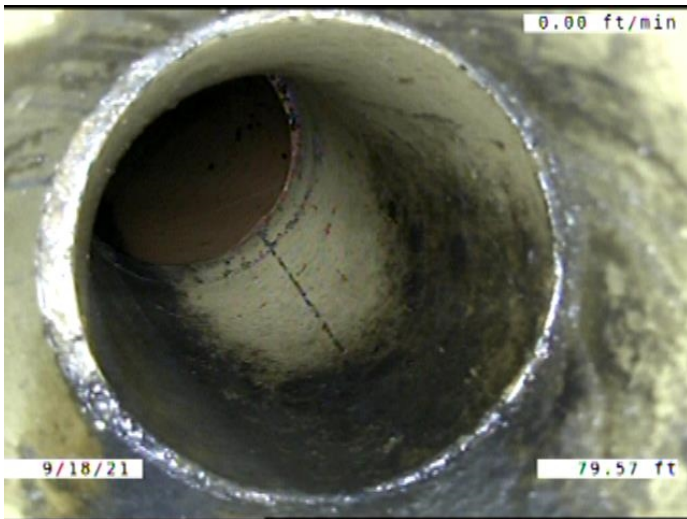
Code: **TF**
Description: **Tap Factory**

Distance (ft): **79.6**
Structural Grade: **0**
O&M Grade: **0**
Clock Start/From: **12**
Clock To:
1st Value: **4.000**
2nd Value:
Value Percent:
Continuous Index:
Within 8" of Joint: **YES**
Remarks:

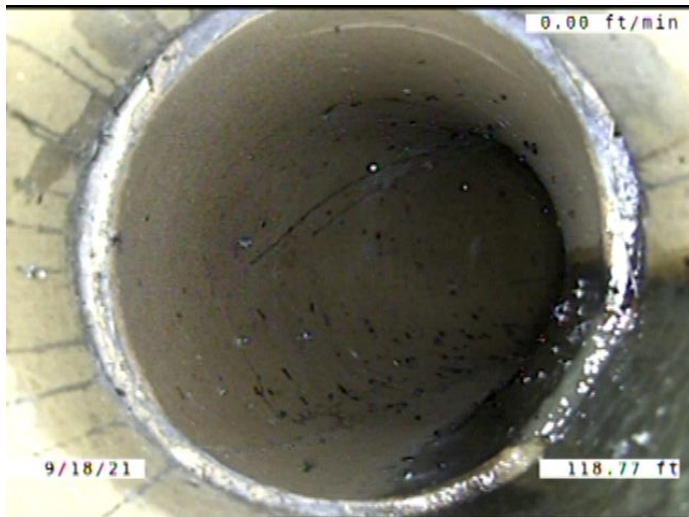
Code: **TF**
Description: **Tap Factory**

Distance (ft): **118.8**
Structural Grade: **0**
O&M Grade: **0**
Clock Start/From: **1**
Clock To:
1st Value: **4.000**
2nd Value:
Value Percent:
Continuous Index:
Within 8" of Joint: **YES**
Remarks:

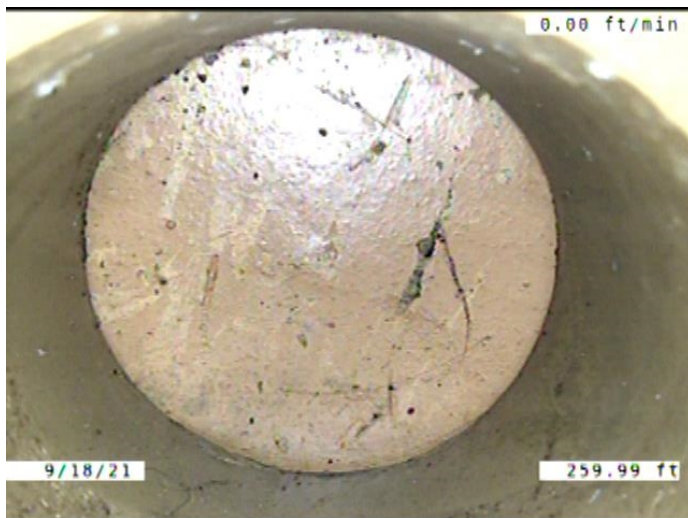
Code: **TFC**
 Description: **Tap Factory Capped**

Distance (ft): **260.0**
 Structural Grade: **0**
 O&M Grade: **0**
 Clock Start/From: **12**
 Clock To:
 1st Value: **4.000**
 2nd Value:
 Value Percent:
 Continuous Index:
 Within 8" of Joint: **YES**
 Remarks:
