Profile/Photo Observation Report

Date:	04/14/2018	Weather:		Coding:	PACP 6.0
Pipe Length (ft):	180.6	Owner:	NA	Pre Clean:	Not Known
P.O.#:		Surveyor:	Jen Costello	PSR:	P-503-062-063
Customer:		Clean Date:	01/01/1900	Shape:	C

Street:	W 40th ave	Flow Control:	Not Controlled
City:	Hobart, IN	Year Renewed:	
Location:	Other	Tape/Media #:	
Purpose:	Not Known	Dia/Height:	10"
Use:	Sanitary	Material:	VCP
Drain Area:	NA	Lining:	
Category:	NA		
Comment:

Location Details:		Direction of Survey:	Downstream
US MH:	M-503-063	DS MH:	M-503-062
		Total Length Surveyed (ft):	174.0

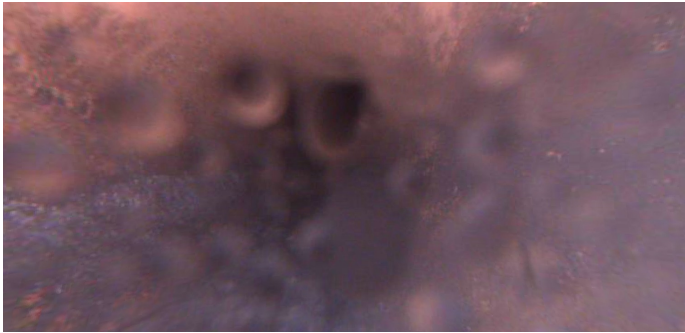
Code:	MWL
Description:	Water Level

Distance (ft):	.0
Structural Grade:	0
O&M Grade:	0
Clock Start/From:	
Clock To:	
1st Value:	
2nd Value:	
Value Percent:	5.000
Continuous Index:	
Within 8" of Joint:	NO
Remarks:
