Profile/Photo Observation Report

Street:	N WISCONSIN ST & W 38TH AVE	Flow Control:	Not Controlled
City:	Hobart, IN	Year Renewed:	
Location:	Other	Tape/Media #:	
Purpose:	Not Known	Dia/Height:	12"
Use:	Sanitary	Material:	VCP
Drain Area:	NA	Lining:	
Category:	NA		
Comment:

Location Details:		Direction of Survey:	Downstream
US MH:	M-503-063	DS MH:	M-503-064
		Total Length Surveyed (ft):	141.0

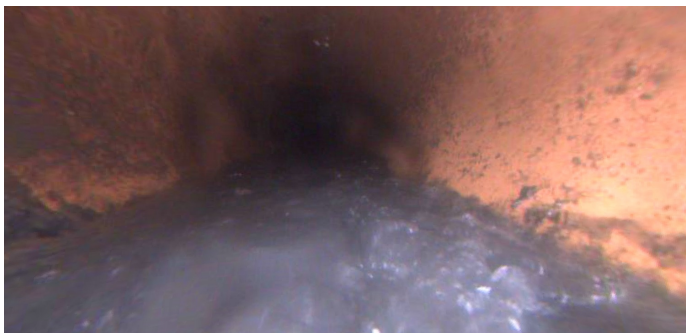
Code: **AMH**
Description: **Manhole**

Distance (ft): **.0**
Structural Grade: **0**
O&M Grade: **0**
Clock Start/From:
Clock To:
1st Value:
2nd Value:
Value Percent:
Continuous Index:
Within 8" of Joint: **NO**
Remarks: **M-503-063**

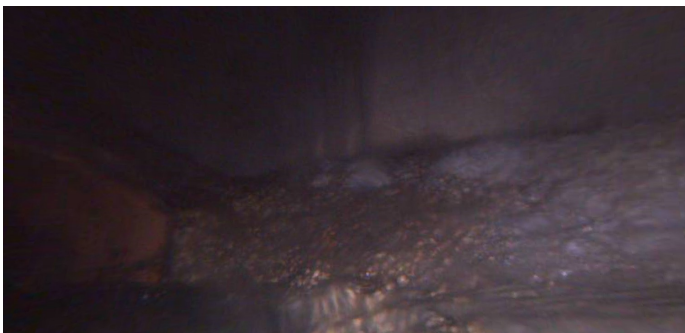
Code: **AMH**
Description: **Manhole**

Distance (ft): **141.0**
Structural Grade: **0**
O&M Grade: **0**
Clock Start/From:
Clock To:
1st Value:
2nd Value:
Value Percent:
Continuous Index:
Within 8" of Joint: **NO**
Remarks: **M-503-064**
