Profile/Photo Observation Report

Date:	04/15/2018	Weather:		Coding:	PACP 6.0
Pipe Length (ft):	135.9	Owner:	NA	Pre Clean:	Not Known
P.O.#:		Surveyor:	Selasie Honu	PSR:	P-503-068-067
Customer:		Clean Date:	01/01/1900	Shape:	C

Street:	N WISCONSIN ST	Flow Control:	Not Controlled
City:	Hobart, IN	Year Renewed:	
Location:	Other	Tape/Media #:	
Purpose:	Not Known	Dia/Height:	8"
Use:	Sanitary	Material:	VCP
Drain Area:	NA	Lining:	
Category:	NA		
Comment:

Location Details:		Direction of Survey:	Downstream
US MH:	M-503-067	DS MH:	M-503-068
		Total Length Surveyed (ft):	111.9

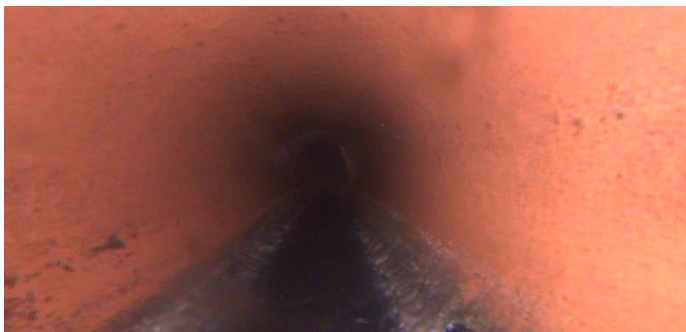
Code: **AMH**
Description: **Manhole**

Distance (ft): **.0**
Structural Grade: **0**
O&M Grade: **0**
Clock Start/From:
Clock To:
1st Value:
2nd Value:
Value Percent:
Continuous Index:
Within 8" of Joint: **NO**
Remarks: **M-503-067**

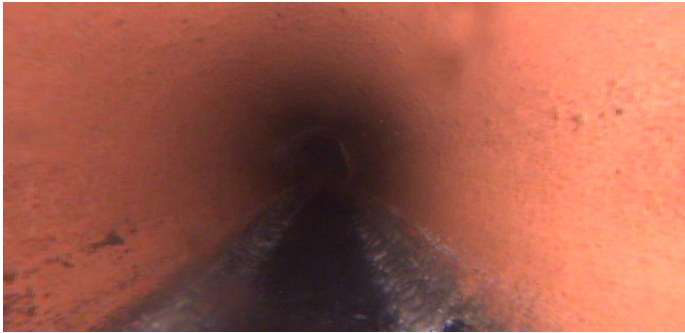
Code:	MWL
Description:	Water Level

Distance (ft):	.0
Structural Grade:	0
O&M Grade:	0
Clock Start/From:	
Clock To:	
1st Value:	
2nd Value:	
Value Percent:	5.000
Continuous Index:	
Within 8" of Joint:	NO
Remarks:
