Profile/Photo Observation Report

Date:	08/21/2021	Weather:		Coding:	PACP 7.0
Pipe Length (ft):	156.1	Owner:	City of Hobart	Pre Clean:	Light Cleaning
P.O.#:	YES502259	Surveyor:	S. Bucklin	PSR:	P-503-075-074
Customer:	City of Hobart	Clean Date:	08/16/2021	Shape:	C

Street:	North Colorado Street	Flow Control:	Not Controlled
City:	Hobart, IN	Year Renewed:	
Location:	Local rural streets with light traffic, t	Tape/Media #:	
Purpose:	Routine Assessment	Dia/Height:	10"
Use:	Sanitary Sewage Pipe	Material:	VCP
Drain Area:		Lining:	
Category:	NA		
Comment:			
Location Details:		Direction of Survey:	Downstream
US MH:	M-503-074	DS MH:	M-503-075
		Total Length Surveyed (ft):	156.1

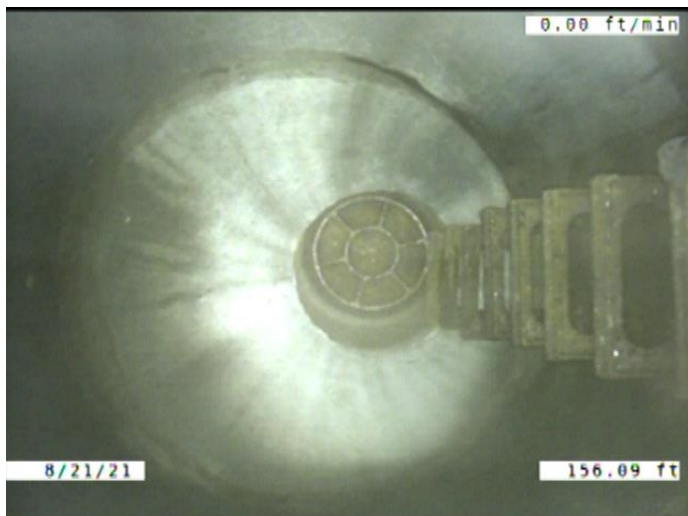
Code: **DSF**
 Description: **Deposits Settled Fine**

Distance (ft): **155.3**
 Structural Grade: **0**
 O&M Grade: **2**
 Clock Start/From: **5**
 Clock To: **7**
 1st Value:
 2nd Value:
 Value Percent: **5.000**
 Continuous Index: **F01**
 Within 8" of Joint: **YES**
 Remarks:
