Profile/Photo Observation Report

Street:	W 37TH PL & N COLORADO ST	Flow Control:	Not Controlled
City:	Hobart, IN	Year Renewed:	
Location:	Other	Tape/Media #:	
Purpose:	Not Known	Dia/Height:	10"
Use:	Sanitary	Material:	VCP
Drain Area:	NA	Lining:	
Category:	NA		
Comment:

Location Details:		Direction of Survey:	Downstream
US MH:	M-503-075	DS MH:	M-503-078
		Total Length Surveyed (ft):	192.1

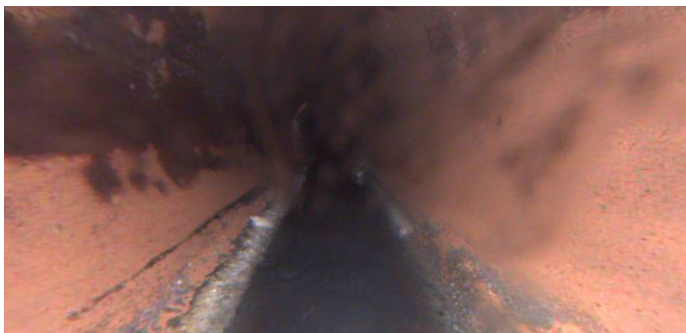
Code: **AMH**
Description: **Manhole**

Distance (ft): **.0**
Structural Grade: **0**
O&M Grade: **0**
Clock Start/From:
Clock To:
1st Value:
2nd Value:
Value Percent:
Continuous Index:
Within 8" of Joint: **NO**
Remarks: **M-503-075**

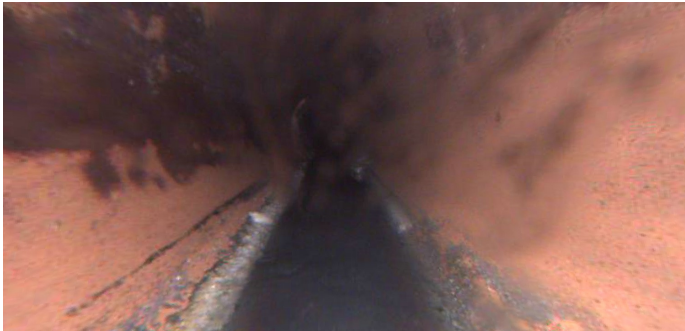
Code:	MWL
Description:	Water Level

Distance (ft):	.0
Structural Grade:	0
O&M Grade:	0
Clock Start/From:	
Clock To:	
1st Value:	
2nd Value:	
Value Percent:	5.000
Continuous Index:	
Within 8" of Joint:	NO
Remarks:
