Profile/Photo Observation Report

Date:	08/21/2021	Weather:		Coding:	PACP 7.0
Pipe Length (ft):	329.6	Owner:	City of Hobart	Pre Clean:	Light Cleaning
P.O.#:	YES502259	Surveyor:	S. Bucklin	PSR:	P-503-078-075
Customer:	City of Hobart	Clean Date:	08/16/2021	Shape:	C

Street:	North Colorado Street	Flow Control:	Not Controlled
City:	Hobart, IN	Year Renewed:	
Location:	Local rural streets with light traffic, t	Tape/Media #:	
Purpose:	Routine Assessment	Dia/Height:	10"
Use:	Sanitary Sewage Pipe	Material:	VCP
Drain Area:		Lining:	
Category:	NA		
Comment:			
Location Details:		Direction of Survey:	Downstream
US MH:	M-503-075	DS MH:	M-503-078
		Total Length Surveyed (ft):	329.6

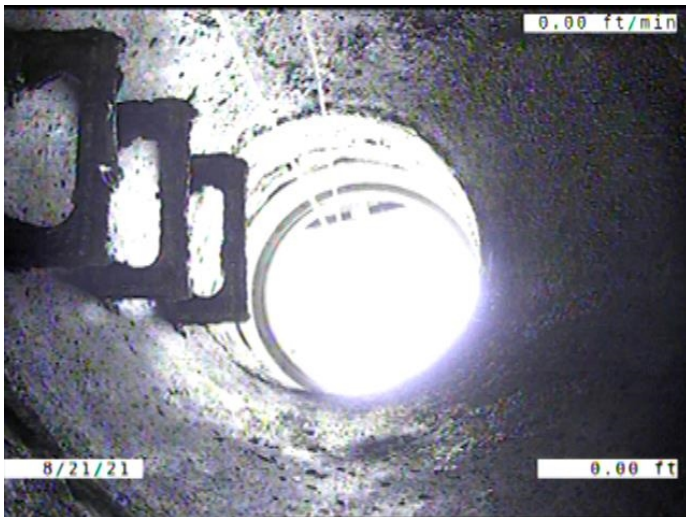
Code: **AMH**
Description: **Manhole**

Distance (ft): **.0**
Structural Grade: **0**
O&M Grade: **0**
Clock Start/From:
Clock To:
1st Value:
2nd Value:
Value Percent:
Continuous Index:
Within 8" of Joint: **NO**
Remarks: **M-503-075**

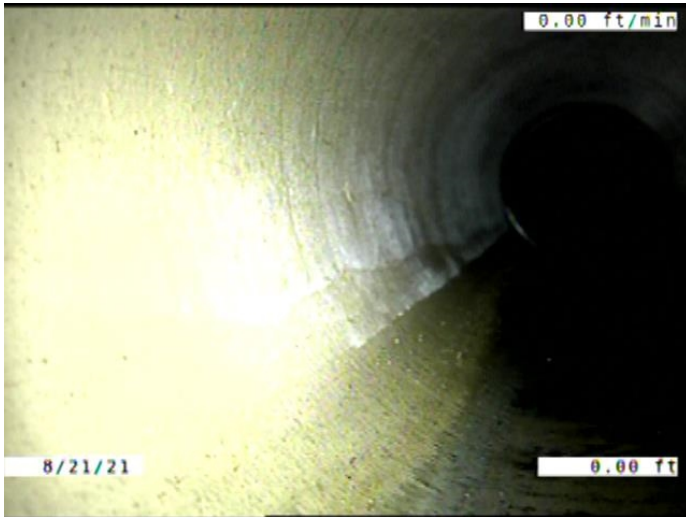
Code: **MWL**
 Description: **Miscellaneous Water Level**

Distance (ft): **.0**
 Structural Grade: **0**
 O&M Grade: **0**
 Clock Start/From:
 Clock To:
 1st Value:
 2nd Value:
 Value Percent: **5.000**
 Continuous Index:
 Within 8" of Joint: **NO**
 Remarks:

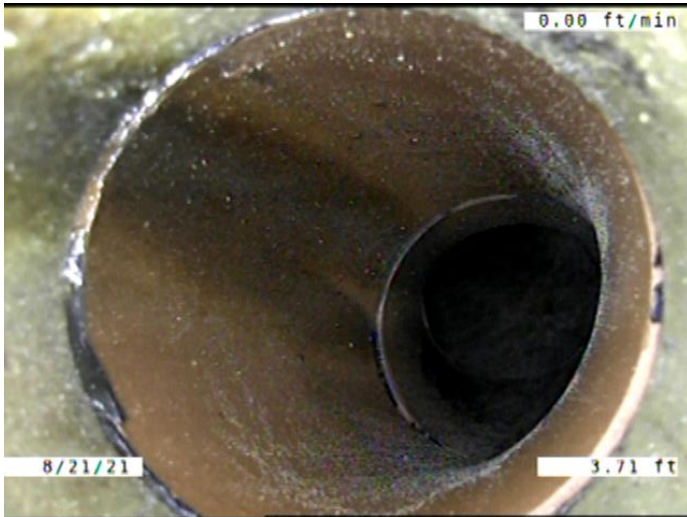
Code: **TF**
 Description: **Tap Factory**

Distance (ft): **3.7**
 Structural Grade: **0**
 O&M Grade: **0**
 Clock Start/From: **10**
 Clock To:
 1st Value: **4.000**
 2nd Value:
 Value Percent:
 Continuous Index:
 Within 8" of Joint: **YES**
 Remarks:

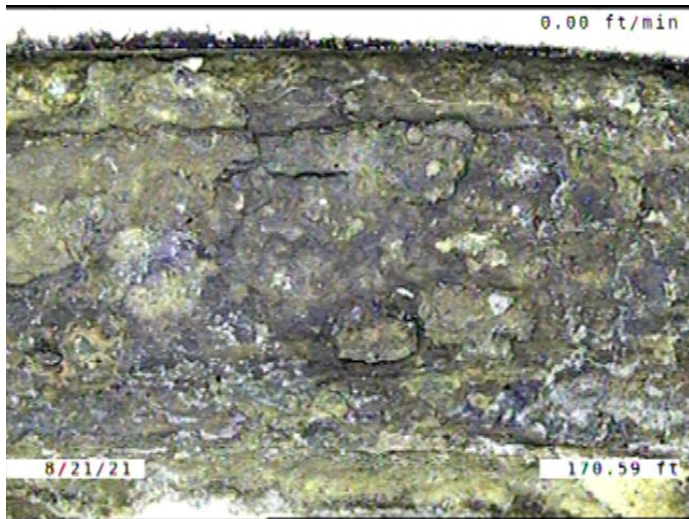
Code: **MMC**
 Description: **Miscellaneous Material Change**

Distance (ft): **170.6**
 Structural Grade: **0**
 O&M Grade: **0**
 Clock Start/From:
 Clock To:
 1st Value:
 2nd Value:
 Value Percent:
 Continuous Index:
 Within 8" of Joint: **NO**
 Remarks: **VCP TO CAST IRON**

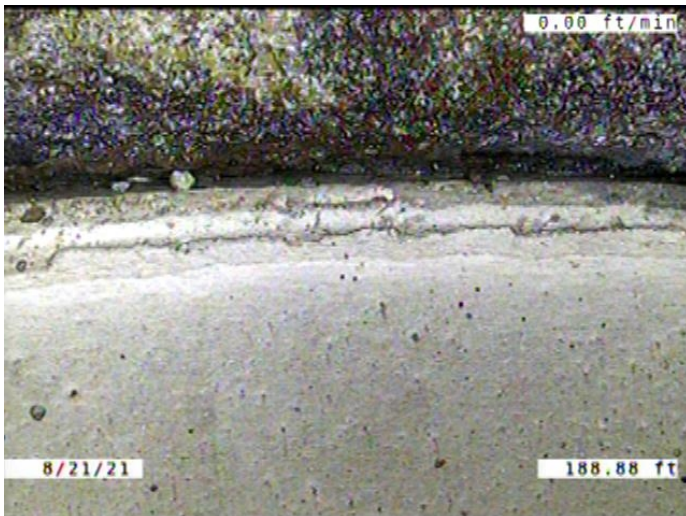
Code: **MMC**
Description: **Miscellaneous Material Change**

Distance (ft): **188.9**
Structural Grade: **0**
O&M Grade: **0**
Clock Start/From:
Clock To:
1st Value:
2nd Value:
Value Percent:
Continuous Index:
Within 8" of Joint: **NO**
Remarks: **CAST IRON TO VCP**

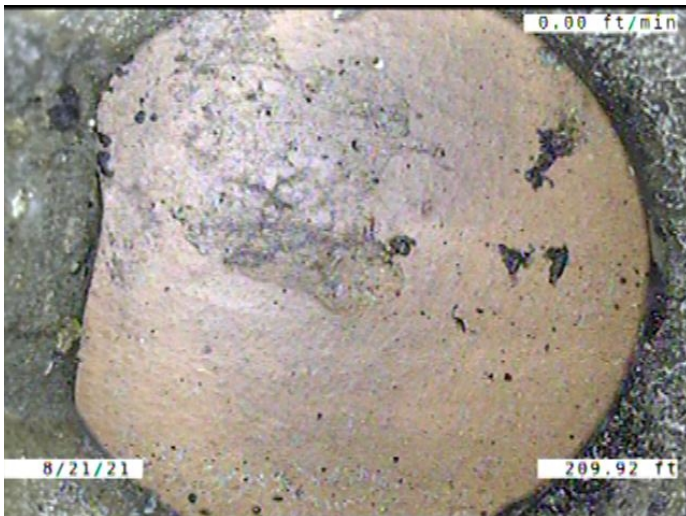
Code: **TFC**
 Description: **Tap Factory Capped**

Distance (ft): **209.9**
 Structural Grade: **0**
 O&M Grade: **0**
 Clock Start/From: **9**
 Clock To:
 1st Value: **6.000**
 2nd Value:
 Value Percent:
 Continuous Index:
 Within 8" of Joint: **YES**
 Remarks:

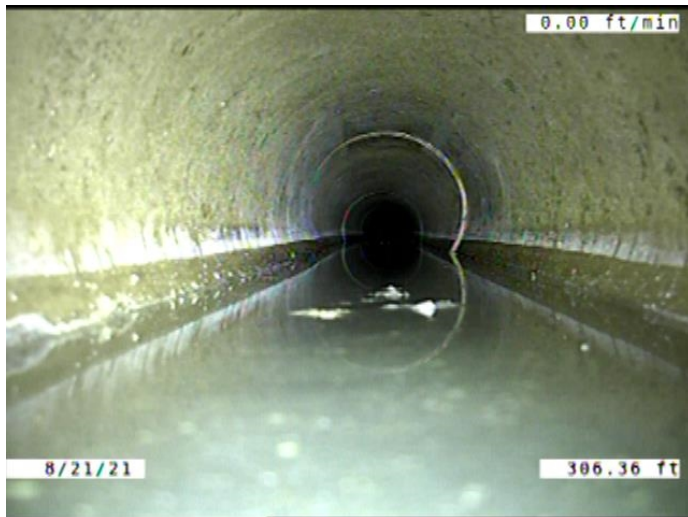
Code: **MWL**
 Description: **Miscellaneous Water Level**

Distance (ft): **306.4**
 Structural Grade: **0**
 O&M Grade: **0**
 Clock Start/From:
 Clock To:
 1st Value:
 2nd Value:
 Value Percent: **15.000**
 Continuous Index:
 Within 8" of Joint: **NO**
 Remarks:

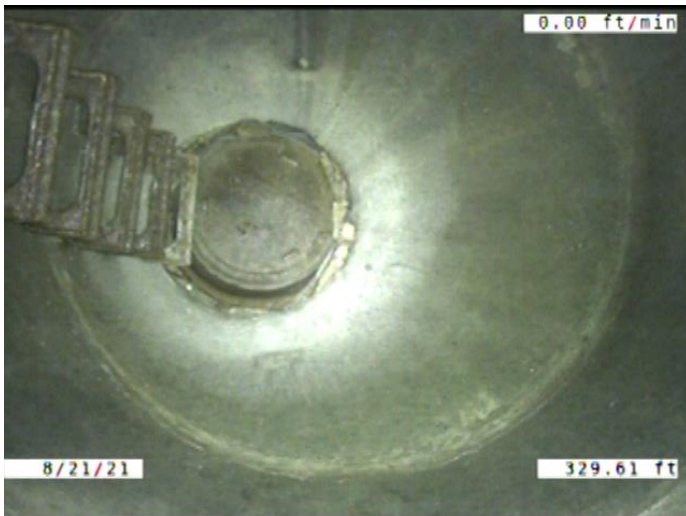
Code: **AMH**
 Description: **Manhole**

Distance (ft): **329.6**
 Structural Grade: **0**
 O&M Grade: **0**
 Clock Start/From:
 Clock To:
 1st Value:
 2nd Value:
 Value Percent:
 Continuous Index:
 Within 8" of Joint: **NO**
 Remarks: **M-503-078**
