RedZone  
ROBOTICS

Street:	North Guyer Street		Flow Control:	Not Controlled	
City:	Hobart, IN		Year Renewed:		
Location:	Alley		Tape/Media #:		
Purpose:	Routine Assessment		Dia/Height:	10"	
Use:	Sanitary Sewage Pipe		Material:	VCP	
Drain Area:			Lining:	None	
Category:	NA				
Comment:					
Location Details:			Direction of Survey:	Downstream	
US MH:	M-503-076	DS MH:	M-503-077	Total Length Surveyed (ft):	147.2

**Tuesday, April 25, 2023**

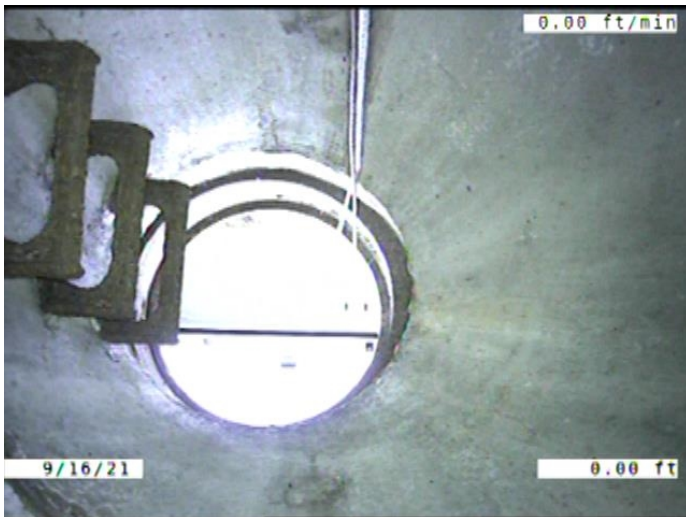
Code: **AMH**  
Description: **Manhole**

Distance (ft): **.0**  
Structural Grade: **0**  
O&M Grade: **0**  
Clock Start/From:  
Clock To:  
1st Value:  
2nd Value:  
Value Percent:  
Continuous Index:  
Within 8" of Joint: **NO**  
Remarks: **M-503-076**
