# Profile/Photo Observation Report

| Pipe Length (ft): | 231.8 | Owner: | City of Hobart | Pre Clean: | Heavy Cleaning |

| Street: | North Colorado Street | Flow Control: | Not Controlled |
| US MH: | M-503-078 | DS MH: | M-503-079 |

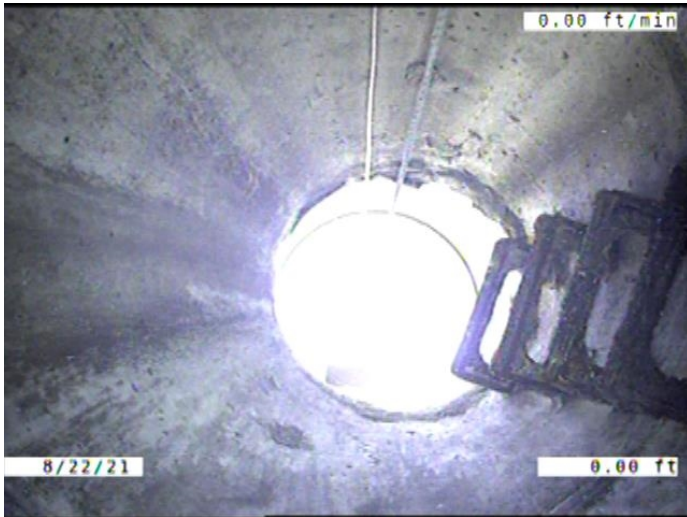
Code: **AMH**  
Description: **Manhole**

Distance (ft): **.0**  
Structural Grade: **0**  
O&M Grade: **0**  
Clock Start/From:  
Clock To:  
1st Value:  
2nd Value:  
Value Percent:  
Continuous Index:  
Within 8" of Joint: **NO**  
Remarks: **M-503-078**

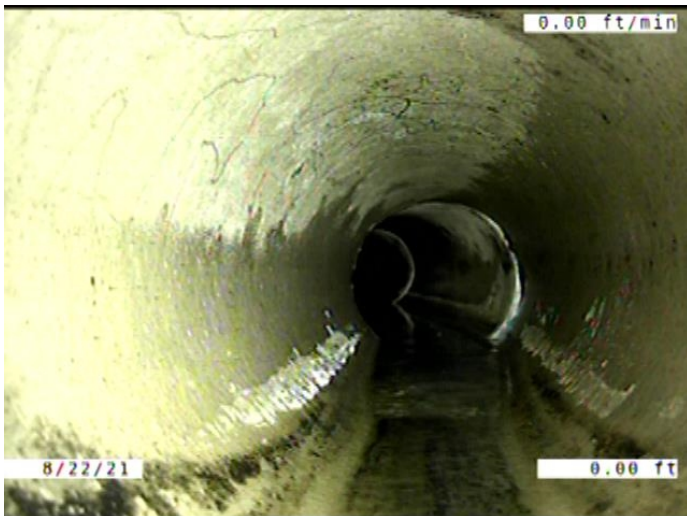
Code: **MWL**  
Description: **Miscellaneous Water Level**

Distance (ft): **.0**  
Structural Grade: **0**  
O&M Grade: **0**  
Clock Start/From:  
Clock To:  
1st Value:  
2nd Value:  
Value Percent: **5.000**  
Continuous Index:  
Within 8" of Joint: **NO**  
Remarks:

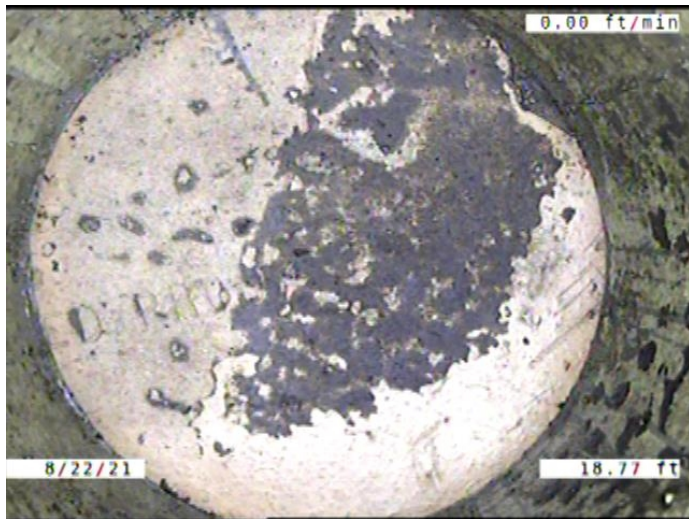
Code: **TFC**  
 Description: **Tap Factory Capped**

Distance (ft): **18.8**  
 Structural Grade: **0**  
 O&M Grade: **0**  
 Clock Start/From: **10**  
 Clock To:  
 1st Value: **4.000**  
 2nd Value:  
 Value Percent:  
 Continuous Index:  
 Within 8" of Joint: **YES**  
 Remarks:

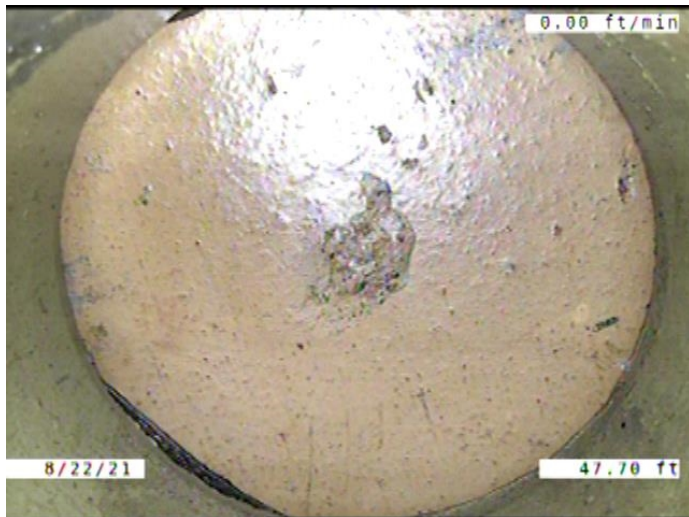
Code: **TFC**  
 Description: **Tap Factory Capped**

Distance (ft): **47.7**  
 Structural Grade: **0**  
 O&M Grade: **0**  
 Clock Start/From: **11**  
 Clock To:  
 1st Value: **4.000**  
 2nd Value:  
 Value Percent:  
 Continuous Index:  
 Within 8" of Joint: **YES**  
 Remarks:

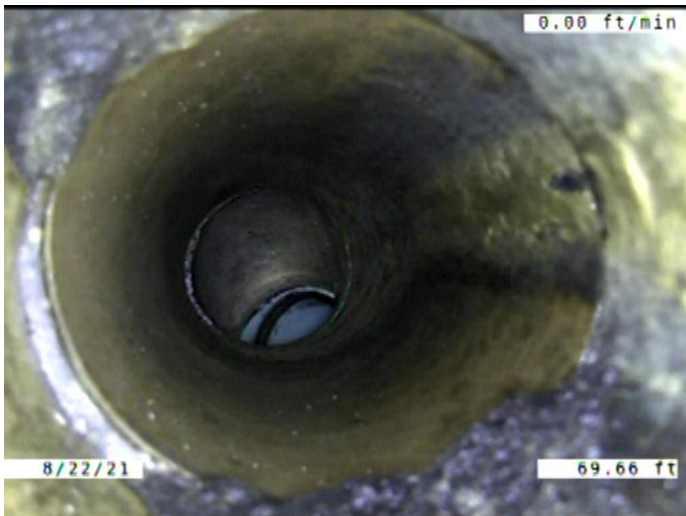
Code: **TF**  
 Description: **Tap Factory**

Distance (ft): **69.7**  
 Structural Grade: **0**  
 O&M Grade: **0**  
 Clock Start/From: **2**  
 Clock To:  
 1st Value: **4.000**  
 2nd Value:  
 Value Percent:  
 Continuous Index:  
 Within 8" of Joint: **YES**  
 Remarks:

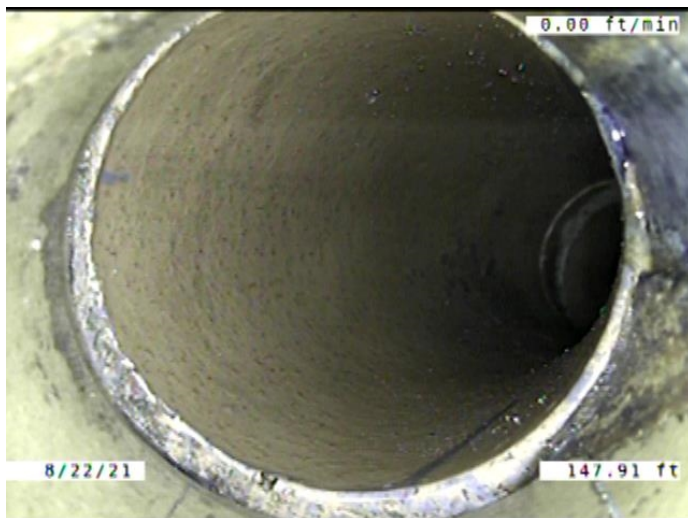
Code: **TF**  
Description: **Tap Factory**

Distance (ft): **147.9**  
Structural Grade: **0**  
O&M Grade: **0**  
Clock Start/From: **1**  
Clock To:  
1st Value: **4.000**  
2nd Value:  
Value Percent:  
Continuous Index:  
Within 8" of Joint: **YES**  
Remarks:

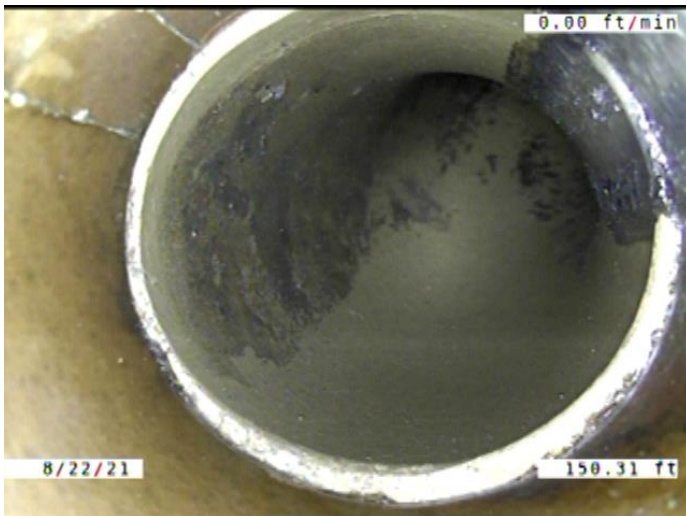
Code: **TF**  
 Description: **Tap Factory**

Distance (ft): **150.3**  
 Structural Grade: **0**  
 O&M Grade: **0**  
 Clock Start/From: **1**  
 Clock To:  
 1st Value: **4.000**  
 2nd Value:  
 Value Percent:  
 Continuous Index:  
 Within 8" of Joint: **YES**  
 Remarks:

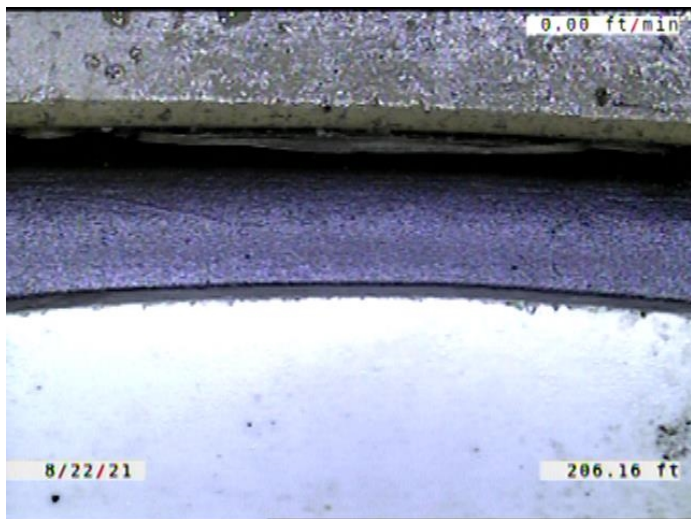
Code: **MMC**  
 Description: **Miscellaneous Material Change**

Distance (ft): **206.2**  
 Structural Grade: **0**  
 O&M Grade: **0**  
 Clock Start/From:  
 Clock To:  
 1st Value:  
 2nd Value:  
 Value Percent:  
 Continuous Index:  
 Within 8" of Joint: **NO**  
 Remarks: **VCP TO PVC**

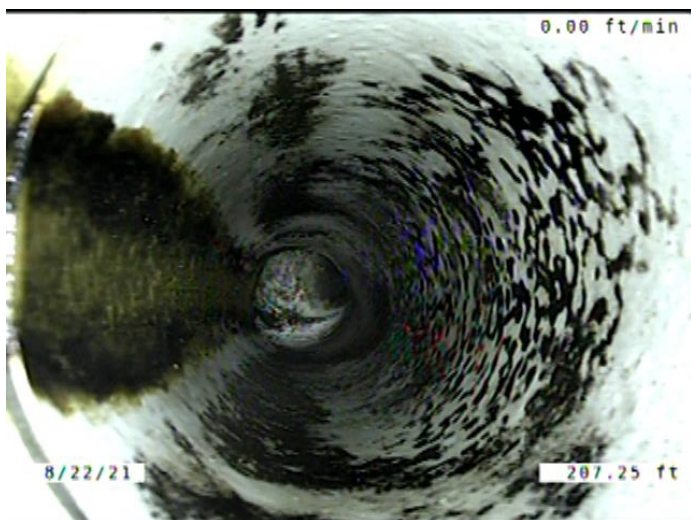
Code: **TF**  
 Description: **Tap Factory**

Distance (ft): **207.3**  
 Structural Grade: **0**  
 O&M Grade: **0**  
 Clock Start/From: **10**  
 Clock To:  
 1st Value: **6.000**  
 2nd Value:  
 Value Percent:  
 Continuous Index:  
 Within 8" of Joint: **YES**  
 Remarks:

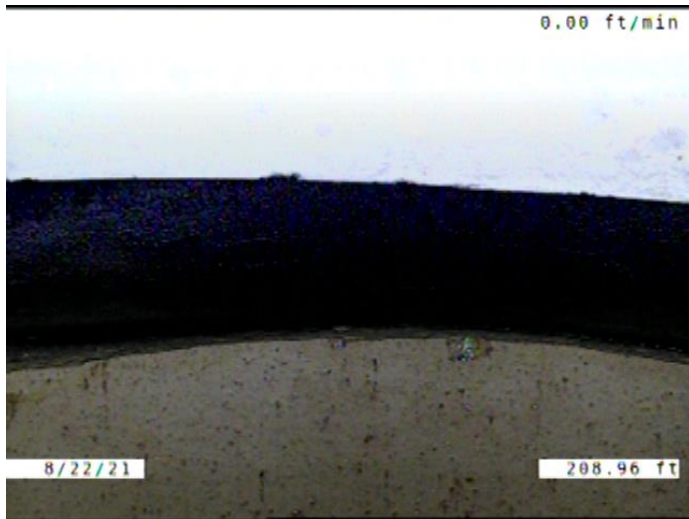
Code: **MMC**  
Description: **Miscellaneous Material Change**

Distance (ft): **209.0**  
Structural Grade: **0**  
O&M Grade: **0**  
Clock Start/From:  
Clock To:  
1st Value:  
2nd Value:  
Value Percent:  
Continuous Index:  
Within 8" of Joint: **NO**  
Remarks: **PVC TO VCP**

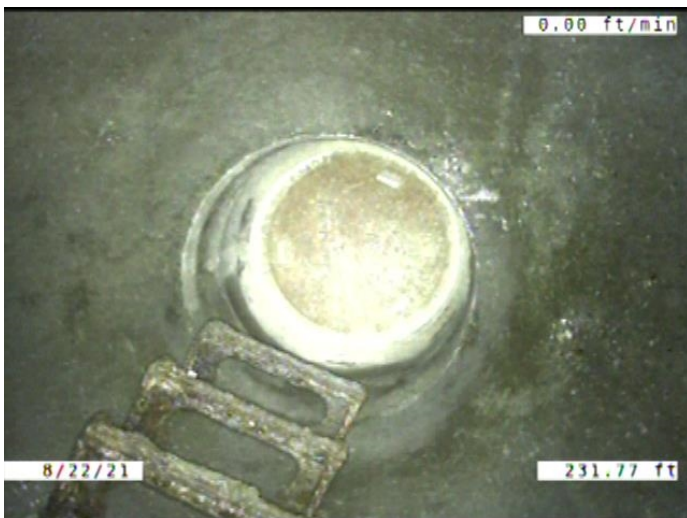
Code: **AMH**  
 Description: **Manhole**

Distance (ft): **231.8**  
 Structural Grade: **0**  
 O&M Grade: **0**  
 Clock Start/From:  
 Clock To:  
 1st Value:  
 2nd Value:  
 Value Percent:  
 Continuous Index:  
 Within 8" of Joint: **NO**  
 Remarks: **M-503-079**
