Profile/Photo Observation Report

Street:	ALLEY BETWEEN N WILSON ST & N G	Flow Control:	Not Controlled
City:	Hobart, IN	Year Renewed:	
Location:	Other	Tape/Media #:	
Purpose:	Not Known	Dia/Height:	10"
Use:	Sanitary	Material:	VCP
Drain Area:	NA	Lining:	
Category:	NA		
Comment:

Location Details:		Direction of Survey:	Downstream
US MH:	M-503-086	DS MH:	M-503-085
		Total Length Surveyed (ft):	109.6

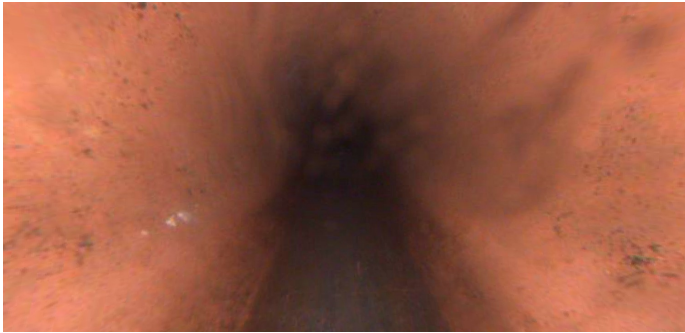
Code:	MWL
Description:	Water Level

Distance (ft):	.0
Structural Grade:	0
O&M Grade:	0
Clock Start/From:	
Clock To:	
1st Value:	
2nd Value:	
Value Percent:	5.000
Continuous Index:	
Within 8" of Joint:	NO
Remarks:

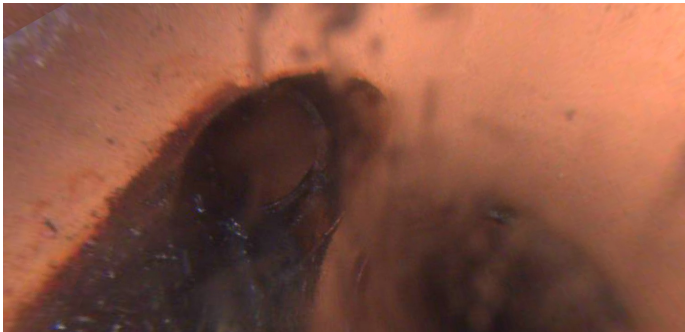
Code: **TFA**
Description: **Tap Factory Active**

Distance (ft): **41.7**
Structural Grade: **0**
O&M Grade: **0**
Clock Start/From: **10**
Clock To:
1st Value: **4.000**
2nd Value:
Value Percent:
Continuous Index:
Within 8" of Joint:
Remarks:

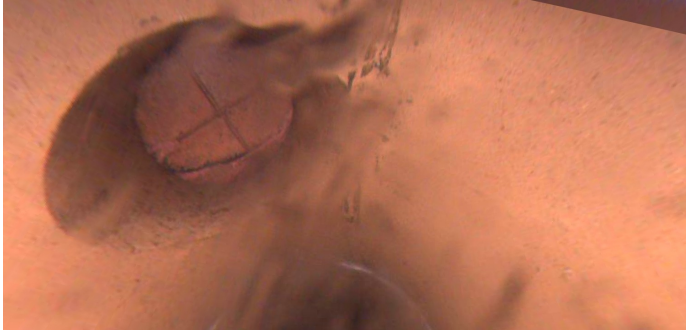
Code: **TFC**
Description: **Tap Factory Capped**

Distance (ft): **89.0**
Structural Grade: **0**
O&M Grade: **0**
Clock Start/From: **11**
Clock To:
1st Value: **4.000**
2nd Value:
Value Percent:
Continuous Index:
Within 8" of Joint:
Remarks:

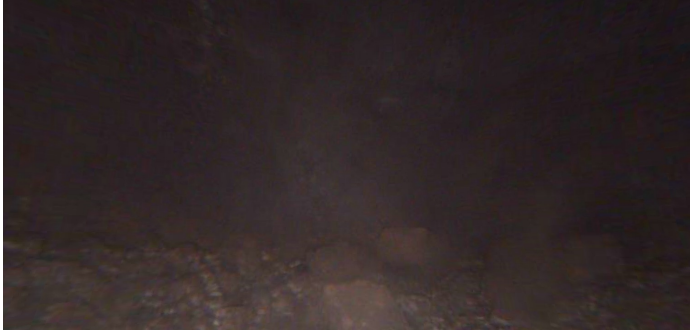
Code:	AMH
Description:	Manhole
Distance (ft):	109.6
Structural Grade:	0
O&M Grade:	0
Clock Start/From:	
Clock To:	
1st Value:	
2nd Value:	
Value Percent:	
Continuous Index:	
Within 8" of Joint:	NO
Remarks:	M-503-085
