Profile/Photo Observation Report

Date:	04/25/2018	Weather:		Coding:	PACP 6.0
Pipe Length (ft):	193.4	Owner:	NA	Pre Clean:	Not Known
P.O.#:		Surveyor:	Jen Costello	PSR:	P-504-007-006
Customer:		Clean Date:	01/01/1900	Shape:	C

Street:	N CALIFORNIA ST	Flow Control:	Not Controlled
City:	Hobart, IN	Year Renewed:	
Location:	Light Highway	Tape/Media #:	
Purpose:	Not Known	Dia/Height:	10"
Use:	Sanitary	Material:	VCP
Drain Area:	NA	Lining:	
Category:	NA		
Comment:

Location Details:		Direction of Survey:	Downstream
US MH:	M-504-006	DS MH:	M-504-007
		Total Length Surveyed (ft):	82.8

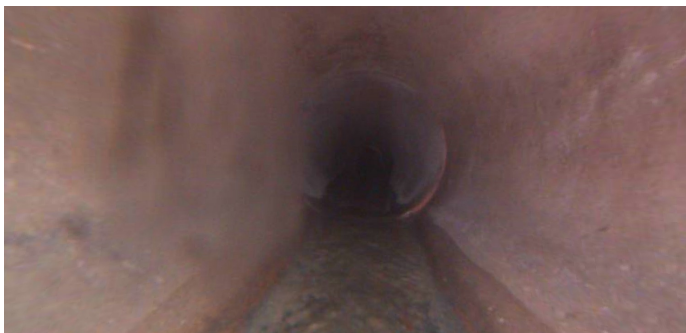
Code: **AMH**
Description: **Manhole**

Distance (ft): **.0**
Structural Grade: **0**
O&M Grade: **0**
Clock Start/From:
Clock To:
1st Value:
2nd Value:
Value Percent:
Continuous Index:
Within 8" of Joint: **NO**
Remarks: **M-504-006**

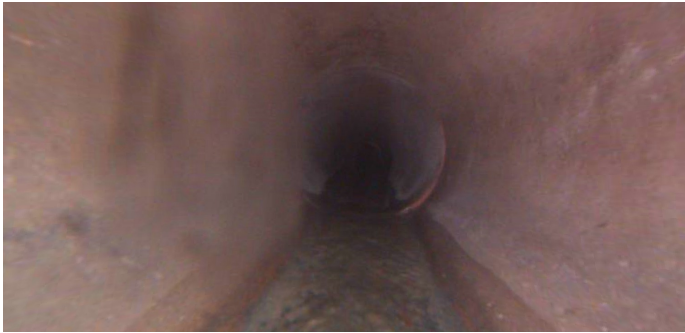
Code:	MWL
Description:	Water Level

Distance (ft):	.0
Structural Grade:	0
O&M Grade:	0
Clock Start/From:	
Clock To:	
1st Value:	
2nd Value:	
Value Percent:	5.000
Continuous Index:	
Within 8" of Joint:	NO
Remarks:

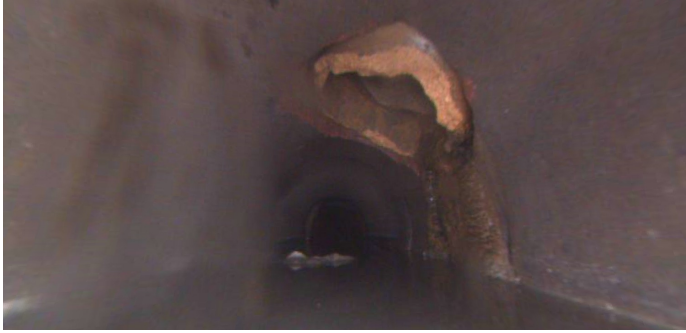
Code: **MWL**
Description: **Water Level**

Distance (ft): **5.8**
Structural Grade: **0**
O&M Grade: **0**
Clock Start/From:
Clock To:
1st Value:
2nd Value:
Value Percent: **40.000**
Continuous Index:
Within 8" of Joint: **NO**
Remarks:

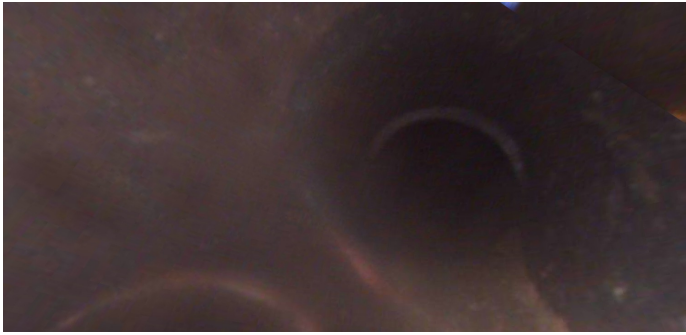
Code: **TF**
Description: **Tap Factory**

Distance (ft): **16.2**
Structural Grade: **0**
O&M Grade: **0**
Clock Start/From: **10**
Clock To:
1st Value: **4.000**
2nd Value:
Value Percent:
Continuous Index:
Within 8" of Joint:
Remarks:

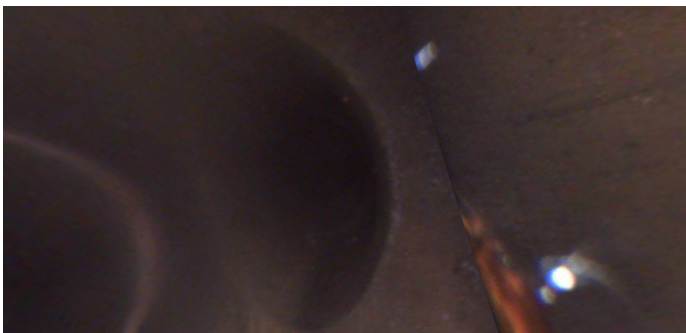
Code: **TF**
Description: **Tap Factory**

Distance (ft): **55.1**
Structural Grade: **0**
O&M Grade: **0**
Clock Start/From: **10**
Clock To:
1st Value: **4.000**
2nd Value:
Value Percent:
Continuous Index:
Within 8" of Joint:
Remarks:
