Profile/Photo Observation Report

Date:	04/25/2018	Weather:		Coding:	PACP 6.0
Pipe Length (ft):	193.4	Owner:	NA	Pre Clean:	Not Known
P.O.#:		Surveyor:	Jen Costello	PSR:	P-504-007-006
Customer:		Clean Date:	01/01/1900	Shape:	C

Street:	Summerlin	Flow Control:	Not Controlled
City:	Hobart, IN	Year Renewed:	
Location:	Light Highway	Tape/Media #:	
Purpose:	Not Known	Dia/Height:	10"
Use:	Sanitary	Material:	VCP
Drain Area:	NA	Lining:	
Category:	NA		
Comment:

Location Details:		Direction of Survey:	Downstream
US MH:	M-504-006	DS MH:	M-504-007
		Total Length Surveyed (ft):	82.8

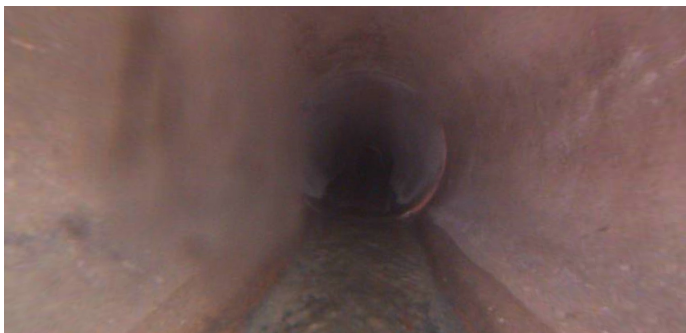
Code: **AMH**
Description: **Manhole**

Distance (ft): **.0**
Structural Grade: **0**
O&M Grade: **0**
Clock Start/From:
Clock To:
1st Value:
2nd Value:
Value Percent:
Continuous Index:
Within 8" of Joint: **NO**
Remarks: **M-504-006**

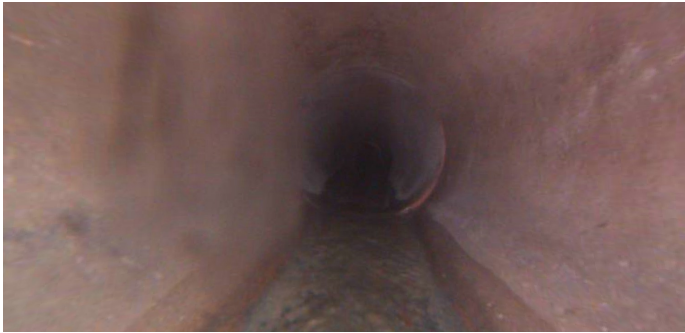
Code:	MWL
Description:	Water Level

Distance (ft):	.0
Structural Grade:	0
O&M Grade:	0
Clock Start/From:	
Clock To:	
1st Value:	
2nd Value:	
Value Percent:	5.000
Continuous Index:	
Within 8" of Joint:	NO
Remarks:

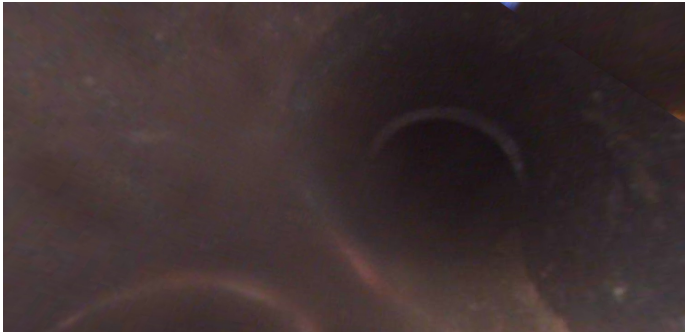
Code: **TF**
Description: **Tap Factory**

Distance (ft): **16.2**
Structural Grade: **0**
O&M Grade: **0**
Clock Start/From: **10**
Clock To:
1st Value: **4.000**
2nd Value:
Value Percent:
Continuous Index:
Within 8" of Joint:
Remarks:

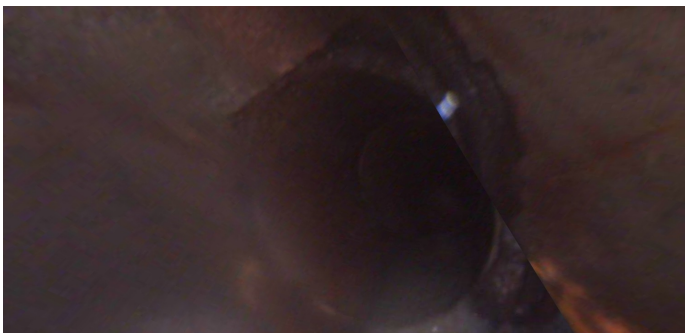
Code: **TBA**
Description: **Tap Break-in Active**

Distance (ft): **27.3**
Structural Grade: **0**
O&M Grade: **0**
Clock Start/From: **10**
Clock To:
1st Value: **4.000**
2nd Value:
Value Percent:
Continuous Index:
Within 8" of Joint:
Remarks:

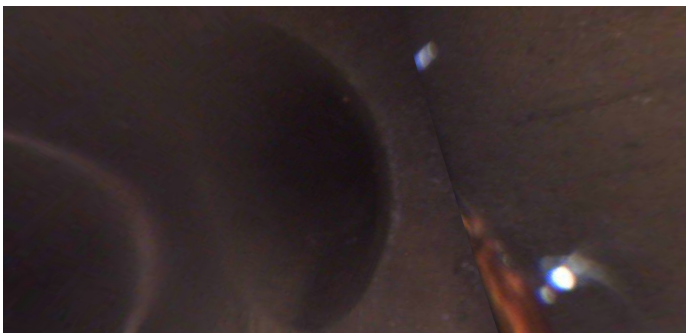
Code: **TF**
Description: **Tap Factory**

Distance (ft): **55.1**
Structural Grade: **0**
O&M Grade: **0**
Clock Start/From: **10**
Clock To:
1st Value: **4.000**
2nd Value:
Value Percent:
Continuous Index:
Within 8" of Joint:
Remarks:
