## Profile/Photo Observation Report

Street:	<b>Summerlin</b>	Flow Control:	<b>Not Controlled</b>
City:	<b>Hobart, IN</b>	Year Renewed:	
Location:	<b>Light Highway</b>	Tape/Media #:	
Purpose:	<b>Not Known</b>	Dia/Height:	<b>12"</b>
Use:	<b>Sanitary</b>	Material:	<b>VCP</b>
Drain Area:	<b>NA</b>	Lining:	
Category:	<b>NA</b>		
Comment:

Location Details:		Direction of Survey:	<b>Downstream</b>
US MH:	<b>M-504-006</b>	DS MH:	<b>M-504-010</b>
		Total Length Surveyed (ft):	<b>14.1</b>

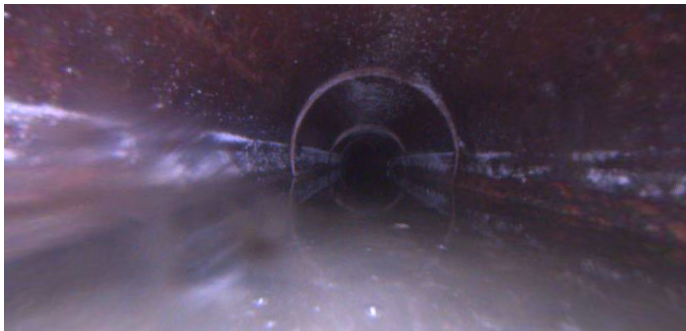
Code: **AMH**  
Description: **Manhole**

Distance (ft): **.0**  
Structural Grade: **0**  
O&M Grade: **0**  
Clock Start/From:  
Clock To:  
1st Value:  
2nd Value:  
Value Percent:  
Continuous Index:  
Within 8" of Joint: **NO**  
Remarks: **M-504-006**
