Profile/Photo Observation Report

Date:	04/20/2018	Weather:		Coding:	PACP 6.0
Pipe Length (ft):	188.8	Owner:	NA	Pre Clean:	Not Known
P.O.#:		Surveyor:	Byrd Fitzgerald	PSR:	P-504-008-007
Customer:		Clean Date:	01/01/1900	Shape:	C

Street:	N CALIFORNIA ST	Flow Control:	Not Controlled
City:	Hobart, IN	Year Renewed:	
Location:	Light Highway	Tape/Media #:	
Purpose:	Not Known	Dia/Height:	10"
Use:	Sanitary	Material:	VCP
Drain Area:	NA	Lining:	
Category:	NA		
Comment:

Location Details:		Direction of Survey:	Upstream
US MH:	M-504-007	DS MH:	M-504-008
		Total Length Surveyed (ft):	49.1

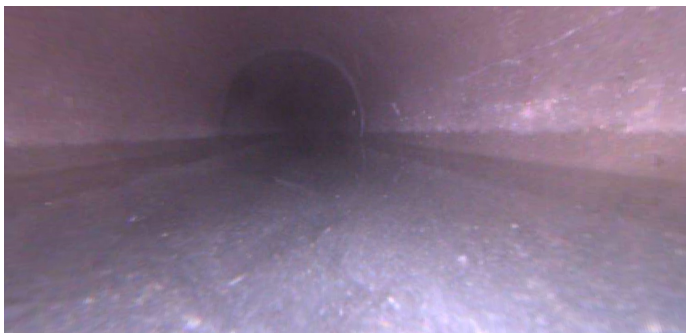
Code: **AMH**
Description: **Manhole**

Distance (ft): **.0**
Structural Grade: **0**
O&M Grade: **0**
Clock Start/From:
Clock To:
1st Value:
2nd Value:
Value Percent:
Continuous Index:
Within 8" of Joint: **NO**
Remarks: **M-504-007**

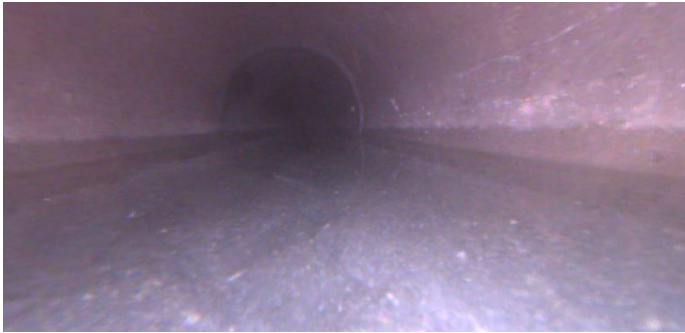
Code:	MWL
Description:	Water Level

Distance (ft):	.0
Structural Grade:	0
O&M Grade:	0
Clock Start/From:	
Clock To:	
1st Value:	
2nd Value:	
Value Percent:	10.000
Continuous Index:	
Within 8" of Joint:	NO
Remarks:

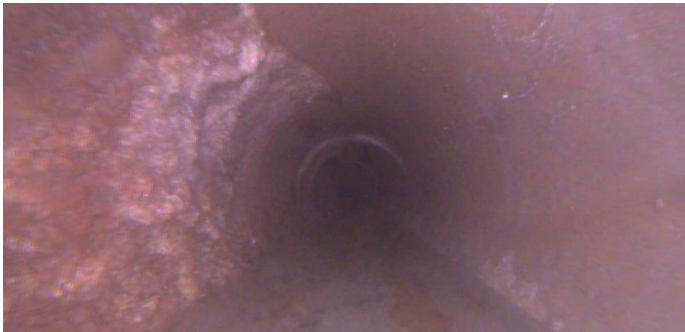
Code: **MWL**
Description: **Water Level**

Distance (ft): **32.4**
Structural Grade: **0**
O&M Grade: **0**
Clock Start/From:
Clock To:
1st Value:
2nd Value:
Value Percent: **5.000**
Continuous Index:
Within 8" of Joint: **NO**
Remarks:
