# Profile/Photo Observation Report

Date:	02/14/2024	Weather:		Coding:	PACP 7.0
Pipe Length (ft):	189.0	Owner:	City of Hobart	Pre Clean:	Heavy Cleaning
P.O.#:	YES502259	Surveyor:	S. Bucklin	PSR:	P-504-008-007
Customer:	City of Hobart	Clean Date:	10/08/2022	Shape:	C

Street:	N CALIFORNIA ST	Flow Control:	Not Controlled
City:	Hobart, IN	Year Renewed:	
Location:	Local rural streets with light traffic, t	Tape/Media #:	
Purpose:	Routine Assessment	Dia/Height:	10"
Use:	Sanitary Sewage Pipe	Material:	VCP
Drain Area:		Lining:	None
Category:	NA		
Comment:			
Location Details:		Direction of Survey:	Downstream
US MH:	M-504-007	DS MH:	M-504-008
		Total Length Surveyed (ft):	189.9

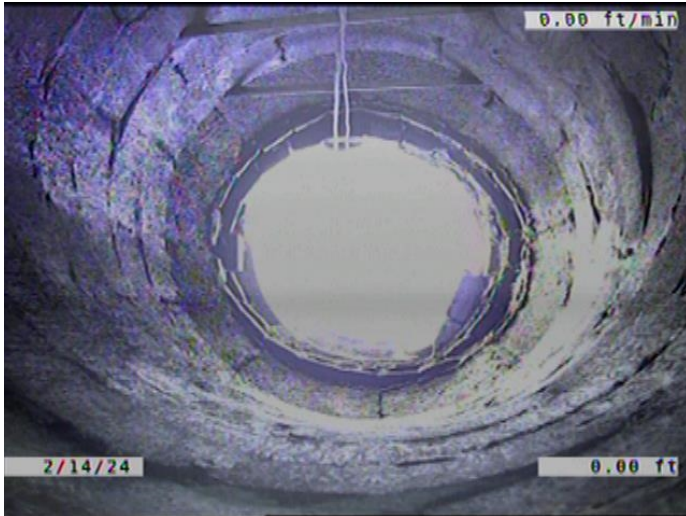
Code: **AMH**  
Description: **Manhole**

Distance (ft): **.0**  
Structural Grade: **0**  
O&M Grade: **0**  
Clock Start/From:  
Clock To:  
1st Value:  
2nd Value:  
Value Percent:  
Continuous Index:  
Within 8" of Joint: **NO**  
Remarks: **M-504-007**

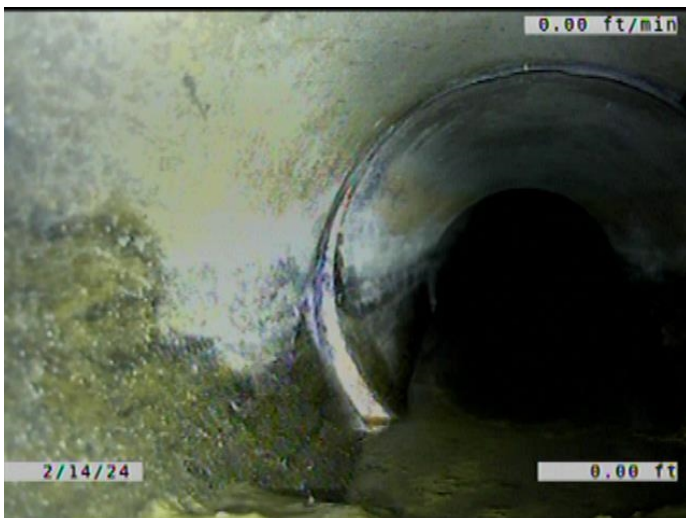
Code: **MWL**  
Description: **Miscellaneous Water Level**

Distance (ft): **.0**  
Structural Grade: **0**  
O&M Grade: **0**  
Clock Start/From:  
Clock To:  
1st Value:  
2nd Value:  
Value Percent: **5.000**  
Continuous Index:  
Within 8" of Joint: **NO**  
Remarks:

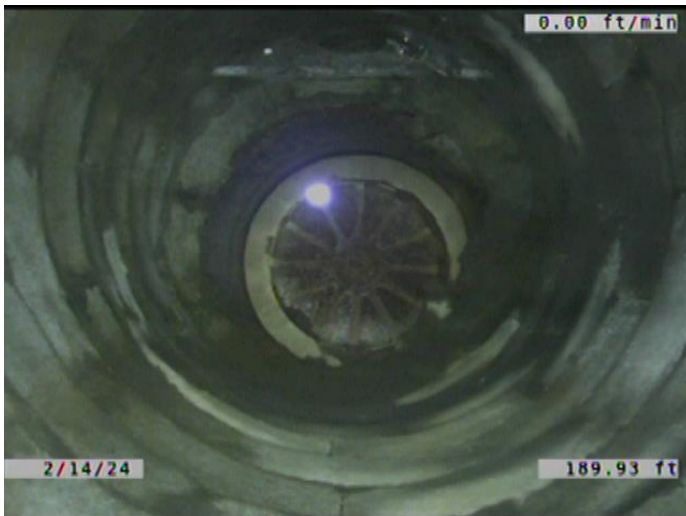
Code: **AMH**  
 Description: **Manhole**

Distance (ft): **189.9**  
 Structural Grade: **0**  
 O&M Grade: **0**  
 Clock Start/From:  
 Clock To:  
 1st Value:  
 2nd Value:  
 Value Percent:  
 Continuous Index:  
 Within 8" of Joint: **NO**  
 Remarks: **M-504-008**
