## Profile/Photo Observation Report

Date:	<b>04/24/2018</b>	Weather:		Coding:	<b>PACP 6.0</b>
Pipe Length (ft):	<b>165.8</b>	Owner:	<b>NA</b>	Pre Clean:	<b>No Pre-Cleaning</b>
P.O.#:		Surveyor:	<b>Jen Costello</b>	PSR:	<b>P-504-011-010</b>
Customer:		Clean Date:	<b>01/01/1900</b>	Shape:	<b>C</b>

Street:	<b>FOXCROFT STREET</b>	Flow Control:	<b>Not Controlled</b>
City:	<b>Hobart, IN</b>	Year Renewed:	
Location:	<b>Yard</b>	Tape/Media #:	
Purpose:	<b>Routine Assessment</b>	Dia/Height:	<b>12"</b>
Use:	<b>Sanitary</b>	Material:	<b>VCP</b>
Drain Area:	<b>NA</b>	Lining:	
Category:	<b>NA</b>		
Comment:	<b>P_C at 61 ft roots . FLOW direction wrong</b>		
Location Details:		Direction of Survey:	<b>Downstream</b>
US MH:	<b>M-504-010</b>	DS MH:	<b>M-504-011</b>
		Total Length Surveyed (ft):	<b>62.4</b>

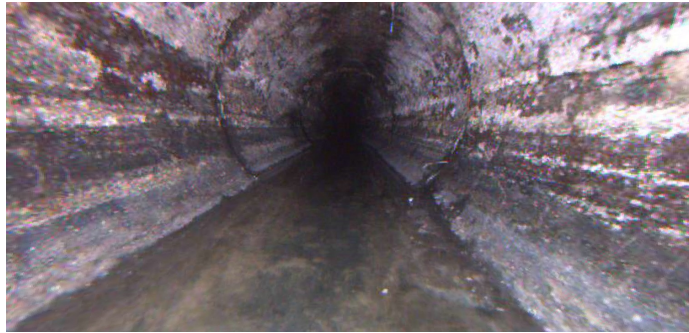
Code: **MWL**  
Description: **Water Level**

Distance (ft): **.0**  
Structural Grade: **0**  
O&M Grade: **0**  
Clock Start/From:  
Clock To:  
1st Value:  
2nd Value:  
Value Percent: **10.000**  
Continuous Index:  
Within 8" of Joint: **NO**  
Remarks:
