## Profile/Photo Observation Report

Date:	<b>04/24/2018</b>	Weather:		Coding:	<b>PACP 6.0</b>
Pipe Length (ft):	<b>146.2</b>	Owner:	<b>NA</b>	Pre Clean:	<b>No Pre-Cleaning</b>
P.O.#:		Surveyor:	<b>Jen Costello</b>	PSR:	<b>P-504-012-011</b>
Customer:		Clean Date:	<b>01/01/1900</b>	Shape:	<b>C</b>

Street:	<b>W HOME AVE</b>	Flow Control:	<b>Not Controlled</b>
City:	<b>Hobart, IN</b>	Year Renewed:	
Location:	<b>Yard</b>	Tape/Media #:	
Purpose:	<b>Routine Assessment</b>	Dia/Height:	<b>12"</b>
Use:	<b>Sanitary</b>	Material:	<b>VCP</b>
Drain Area:	<b>NA</b>	Lining:	
Category:	<b>NA</b>		
Comment:	<b>P_C at 38 ft root / debris. Flow direction wrong</b>		
Location Details:		Direction of Survey:	<b>Downstream</b>
US MH:	<b>M-504-011</b>	DS MH:	<b>M-504-012</b>
		Total Length Surveyed (ft):	<b>40.0</b>

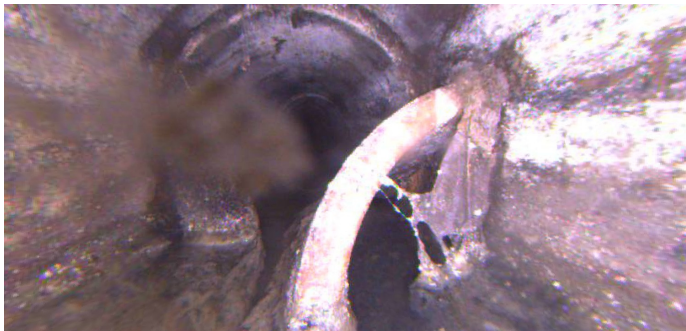
Code: **AMH**  
Description: **Manhole**

Distance (ft): **.0**  
Structural Grade: **0**  
O&M Grade: **0**  
Clock Start/From:  
Clock To:  
1st Value:  
2nd Value:  
Value Percent:  
Continuous Index:  
Within 8" of Joint: **NO**  
Remarks: **M-504-011**

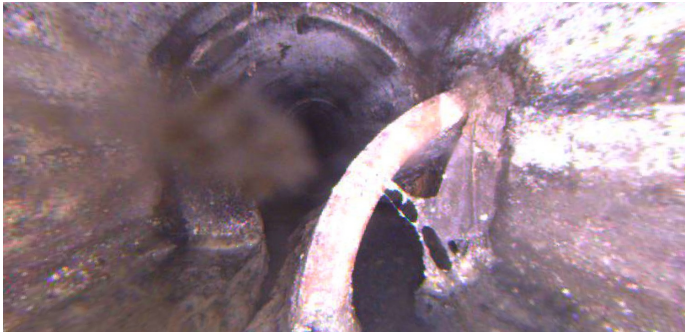
Code: **MWL**  
Description: **Water Level**

Distance (ft): **.0**  
Structural Grade: **0**  
O&M Grade: **0**  
Clock Start/From:  
Clock To:  
1st Value:  
2nd Value:  
Value Percent: **10.000**  
Continuous Index:  
Within 8" of Joint: **NO**  
Remarks:
