RedZone
ROBOTICS

Street:	South California Street		Flow Control:	Not Controlled	
City:	Hobart, IN		Year Renewed:		
Location:	Alley		Tape/Media #:		
Purpose:	Routine Assessment		Dia/Height:	12"	
Use:	Sanitary Sewage Pipe		Material:	VCP	
Drain Area:			Lining:	None	
Category:	NA				
Comment:					
Location Details:			Direction of Survey:	Downstream	
US MH:	M-504-011	DS MH:	M-504-012	Total Length Surveyed (ft):	143.3

O&M Index:	1.77	O&M Quick:	2J1B	O&M Rating:	131.00
Structural Index:	2.75	Structural Quick:	4C34	Structural Rating:	162.00
Overall Index:	2.20	Overall Quick:	4C34	Overall Rating:	293.00

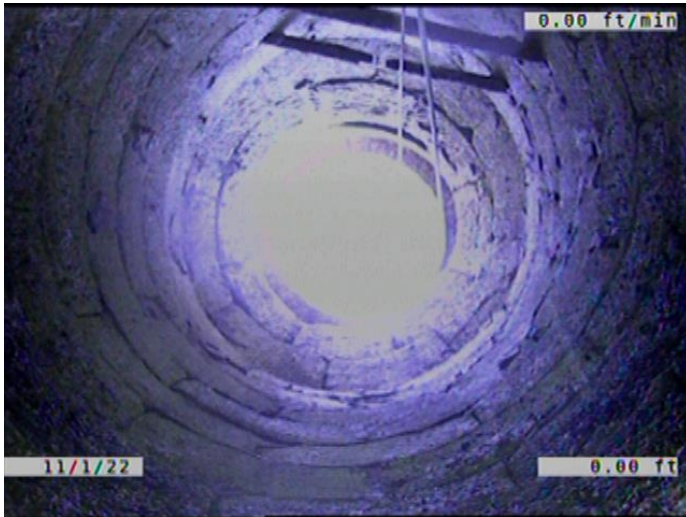
Code: **AMH**
 Description: **Manhole**

Distance (ft): **.0**
 Structural Grade: **0**
 O&M Grade: **0**
 Clock Start/From:
 Clock To:
 1st Value:
 2nd Value:
 Value Percent:
 Continuous Index:
 Within 8" of Joint: **NO**
 Remarks: **M-504-011**

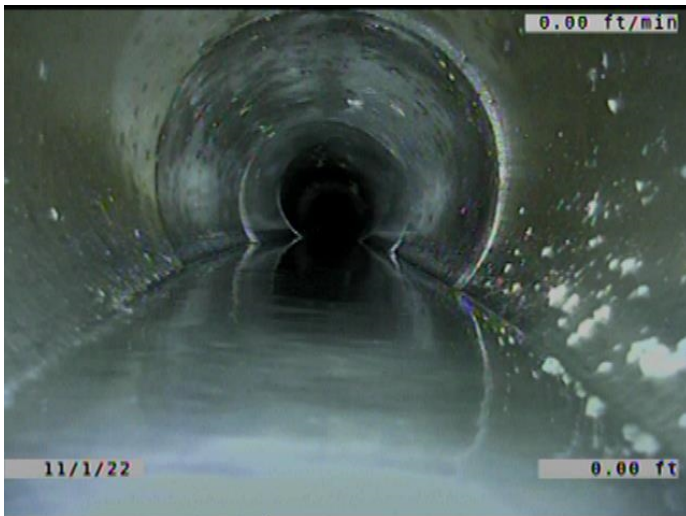
Code: **MWL**
 Description: **Miscellaneous Water Level**

Distance (ft): **.0**
 Structural Grade: **0**
 O&M Grade: **0**
 Clock Start/From:
 Clock To:
 1st Value:
 2nd Value:
 Value Percent: **5.000**
 Continuous Index:
 Within 8" of Joint: **NO**
 Remarks:

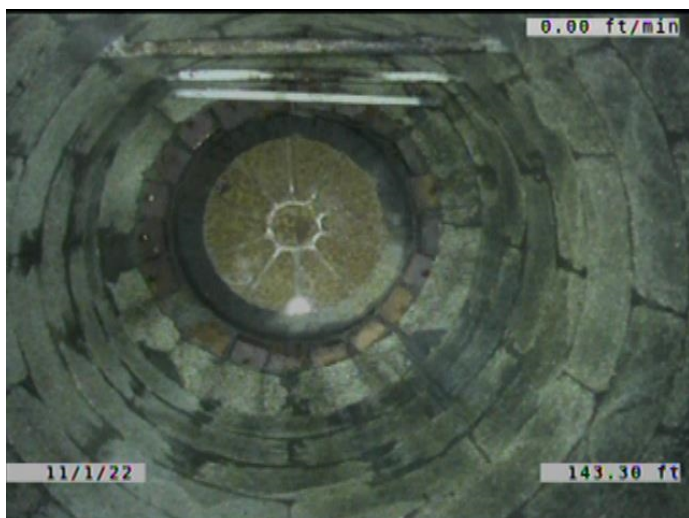
Code: **AMH**
 Description: **Manhole**

Distance (ft): **143.3**
 Structural Grade: **0**
 O&M Grade: **0**
 Clock Start/From:
 Clock To:
 1st Value:
 2nd Value:
 Value Percent:
 Continuous Index:
 Within 8" of Joint: **NO**
 Remarks: **M-504-012**
