## Profile/Photo Observation Report

Street:	<b>W HOME AVE</b>	Flow Control:	<b>Not Controlled</b>
City:	<b>Hobart, IN</b>	Year Renewed:	
Location:	<b>Light Highway</b>	Tape/Media #:	
Purpose:	<b>Not Known</b>	Dia/Height:	<b>12"</b>
Use:	<b>Sanitary</b>	Material:	<b>VCP</b>
Drain Area:	<b>NA</b>	Lining:	
Category:	<b>NA</b>		
Comment:

Location Details:		Direction of Survey:	<b>Upstream</b>
US MH:	<b>M-504-012</b>	DS MH:	<b>M-504-013</b>
		Total Length Surveyed (ft):	<b>40.9</b>

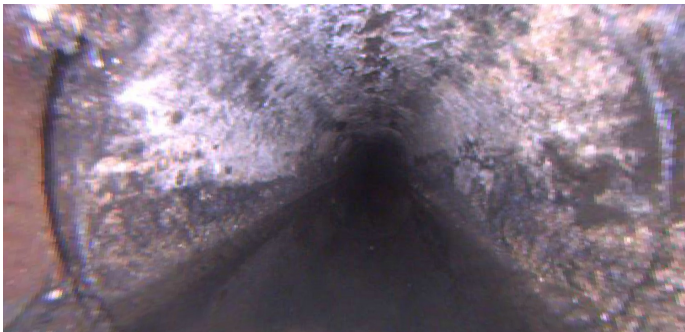
Code:	<b>AMH</b>
Description:	<b>Manhole</b>

Distance (ft):	<b>.0</b>
Structural Grade:	<b>0</b>
O&M Grade:	<b>0</b>
Clock Start/From:	
Clock To:	
1st Value:	
2nd Value:	
Value Percent:	
Continuous Index:	
Within 8" of Joint:	<b>NO</b>
Remarks:	<b>M-504-012</b>

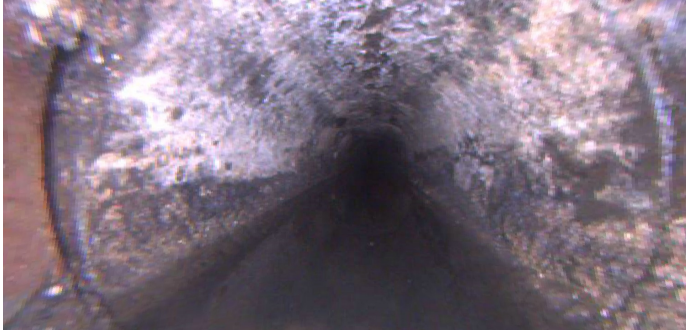
Code: **MWL**  
Description: **Water Level**

Distance (ft): **.0**  
Structural Grade: **0**  
O&M Grade: **0**  
Clock Start/From:  
Clock To:  
1st Value:  
2nd Value:  
Value Percent: **5.000**  
Continuous Index:  
Within 8" of Joint: **NO**  
Remarks:
