Profile/Photo Observation Report

Date:	11/01/2022	Weather:		Coding:	PACP 7.0
Pipe Length (ft):	150.0	Owner:	City of Hobart	Pre Clean:	Heavy Cleaning
P.O.#:	YES502259	Surveyor:	S. Bucklin	PSR:	P-504-013-012
Customer:	City of Hobart, IN (Red	Clean Date:	10/19/2022	Shape:	C

Street:	South Delaware Street	Flow Control:	Not Controlled
City:	Hobart, IN	Year Renewed:	
Location:	Alley	Tape/Media #:	
Purpose:	Routine Assessment	Dia/Height:	12"
Use:	Sanitary Sewage Pipe	Material:	VCP
Drain Area:		Lining:	None
Category:	NA		
Comment:			
Location Details:		Direction of Survey:	Upstream
US MH:	M-504-012	DS MH:	M-504-013
		Total Length Surveyed (ft):	149.0

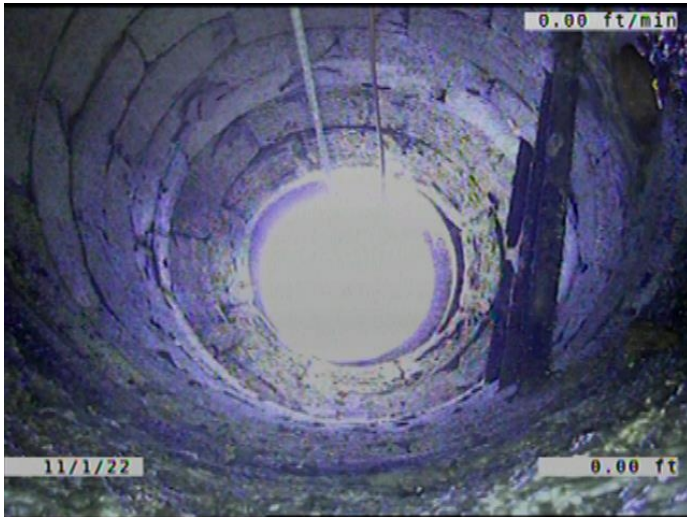
Code: **AMH**
 Description: **Manhole**

Distance (ft): **.0**
 Structural Grade: **0**
 O&M Grade: **0**
 Clock Start/From:
 Clock To:
 1st Value:
 2nd Value:
 Value Percent:
 Continuous Index:
 Within 8" of Joint: **NO**
 Remarks: **M-504-013**

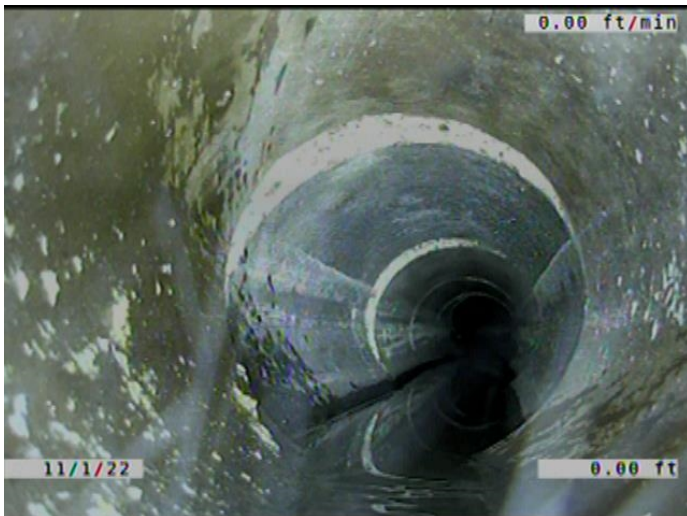
Code: **MWL**
 Description: **Miscellaneous Water Level**

Distance (ft): **.0**
 Structural Grade: **0**
 O&M Grade: **0**
 Clock Start/From:
 Clock To:
 1st Value:
 2nd Value:
 Value Percent: **5.000**
 Continuous Index:
 Within 8" of Joint: **NO**
 Remarks:

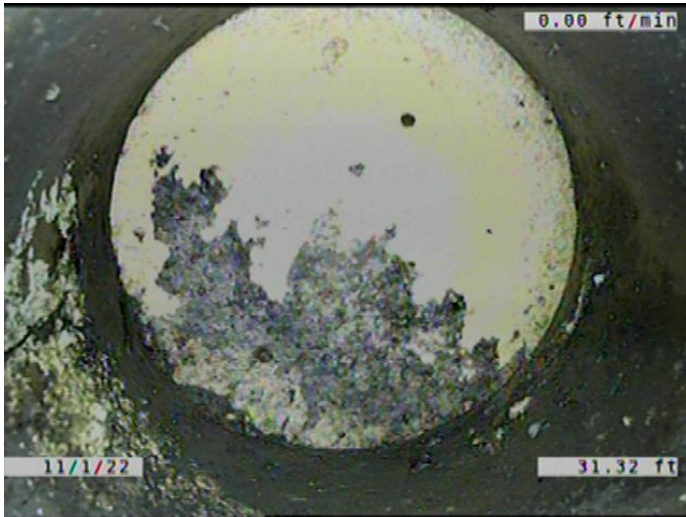
Code: **TFC**
 Description: **Tap Factory Capped**

Distance (ft): **31.3**
 Structural Grade: **0**
 O&M Grade: **0**
 Clock Start/From: **11**
 Clock To:
 1st Value: **4.000**
 2nd Value:
 Value Percent:
 Continuous Index:
 Within 8" of Joint: **YES**
 Remarks:

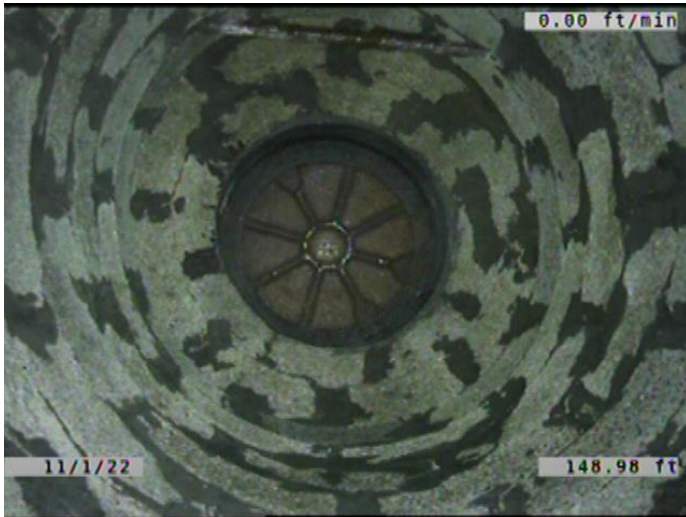
Code:	AMH
Description:	Manhole
Distance (ft):	149.0
Structural Grade:	0
O&M Grade:	0
Clock Start/From:	
Clock To:	
1st Value:	
2nd Value:	
Value Percent:	
Continuous Index:	
Within 8" of Joint:	NO
Remarks:	M-504-012
