## Profile/Photo Observation Report

Date:	<b>04/18/2018</b>	Weather:		Coding:	<b>PACP 6.0</b>
Pipe Length (ft):	<b>112.7</b>	Owner:	<b>NA</b>	Pre Clean:	<b>Not Known</b>
P.O.#:		Surveyor:	<b>Byrd Fitzgerald</b>	PSR:	<b>P-504-014-013</b>
Customer:		Clean Date:	<b>01/01/1900</b>	Shape:	<b>C</b>

Location Details:		Direction of Survey:	<b>Downstream</b>
US MH:	<b>M-504-013</b>	DS MH:	<b>M-504-014</b>
		Total Length Surveyed (ft):	<b>20.0</b>

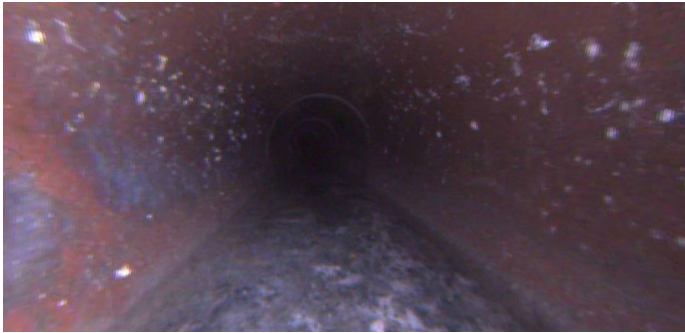
Code:	<b>AMH</b>
Description:	<b>Manhole</b>

Distance (ft):	<b>.0</b>
Structural Grade:	<b>0</b>
O&M Grade:	<b>0</b>
Clock Start/From:	
Clock To:	
1st Value:	
2nd Value:	
Value Percent:	
Continuous Index:	
Within 8" of Joint:	<b>NO</b>
Remarks:	<b>M-504-013</b>

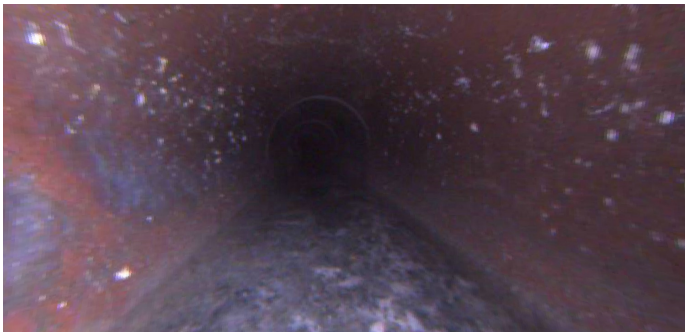
Code:	<b>MWL</b>
Description:	<b>Water Level</b>

Distance (ft):	<b>.0</b>
Structural Grade:	<b>0</b>
O&M Grade:	<b>0</b>
Clock Start/From:	
Clock To:	
1st Value:	
2nd Value:	
Value Percent:	<b>5.000</b>
Continuous Index:	
Within 8" of Joint:	<b>NO</b>
Remarks:
