Profile/Photo Observation Report

Date:	11/01/2022	Weather:		Coding:	PACP 7.0
Pipe Length (ft):	113.0	Owner:	City of Hobart	Pre Clean:	Heavy Cleaning
P.O.#:	YES502259	Surveyor:	S. Bucklin	PSR:	P-504-014-013
Customer:	City of Hobart, IN (Red	Clean Date:	10/19/2022	Shape:	C

Street:	South Delaware Street	Flow Control:	Not Controlled
City:	Hobart, IN	Year Renewed:	
Location:	Alley	Tape/Media #:	
Purpose:	Routine Assessment	Dia/Height:	12"
Use:	Sanitary Sewage Pipe	Material:	VCP
Drain Area:		Lining:	None
Category:	NA		
Comment:			
Location Details:		Direction of Survey:	Upstream
US MH:	M-504-013	DS MH:	M-504-014
		Total Length Surveyed (ft):	105.2

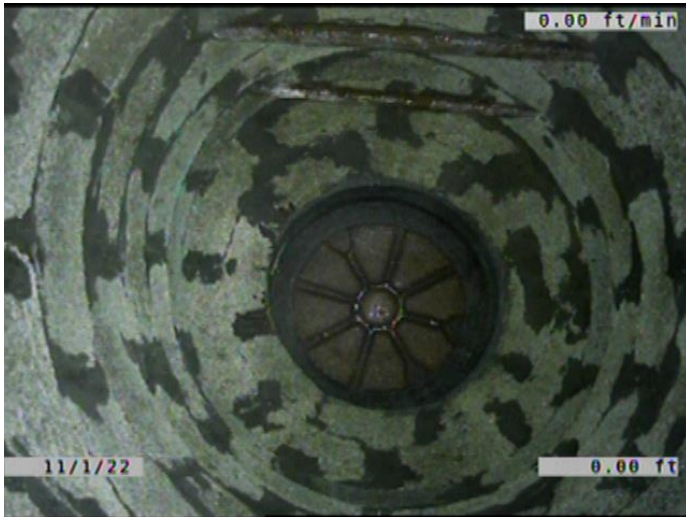
Code: **AMH**
Description: **Manhole**

Distance (ft): **.0**
Structural Grade: **0**
O&M Grade: **0**
Clock Start/From:
Clock To:
1st Value:
2nd Value:
Value Percent:
Continuous Index:
Within 8" of Joint: **NO**
Remarks: **M-504-014**

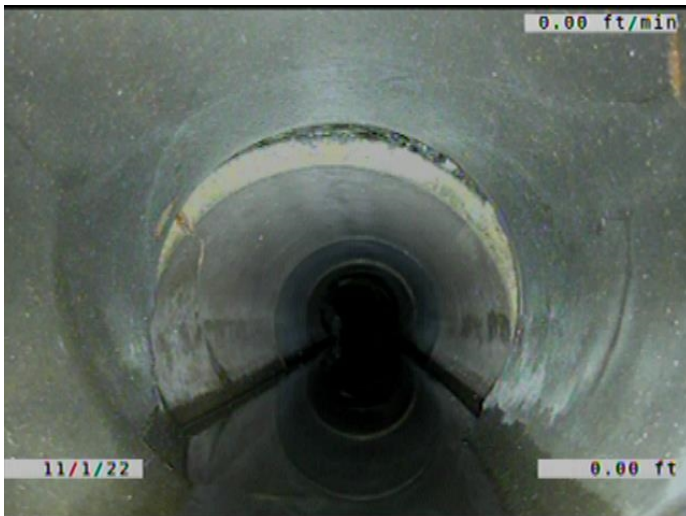
Code: **MWL**
Description: **Miscellaneous Water Level**

Distance (ft): **.0**
Structural Grade: **0**
O&M Grade: **0**
Clock Start/From:
Clock To:
1st Value:
2nd Value:
Value Percent: **5.000**
Continuous Index:
Within 8" of Joint: **NO**
Remarks:

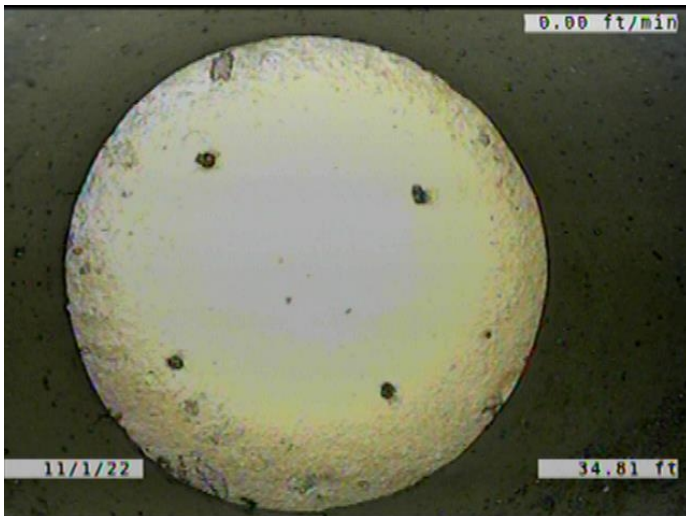
Code: **TFC**
Description: **Tap Factory Capped**

Distance (ft): **34.8**
Structural Grade: **0**
O&M Grade: **0**
Clock Start/From: **11**
Clock To:
1st Value: **4.000**
2nd Value:
Value Percent:
Continuous Index:
Within 8" of Joint: **YES**
Remarks:

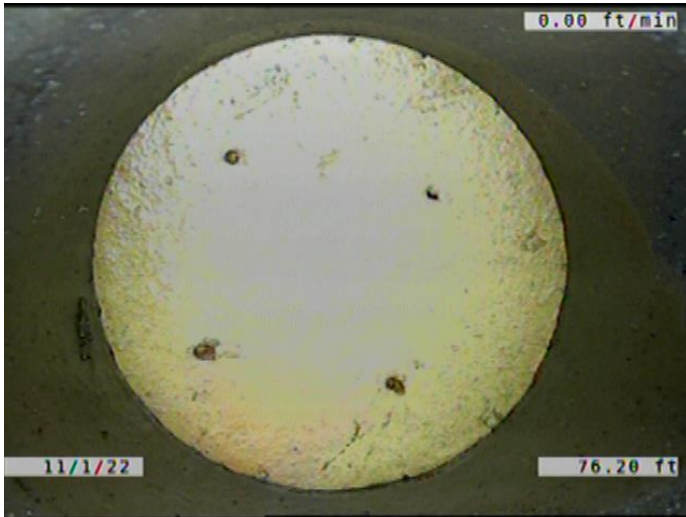
Code: **TFC**
 Description: **Tap Factory Capped**

Distance (ft): **76.2**
 Structural Grade: **0**
 O&M Grade: **0**
 Clock Start/From: **11**
 Clock To:
 1st Value: **6.000**
 2nd Value:
 Value Percent:
 Continuous Index:
 Within 8" of Joint: **YES**
 Remarks:

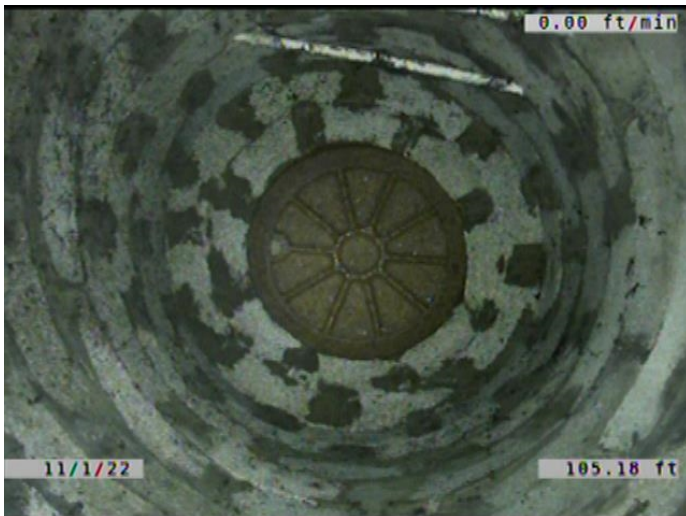
Code: **AMH**
 Description: **Manhole**

Distance (ft): **105.2**
 Structural Grade: **0**
 O&M Grade: **0**
 Clock Start/From:
 Clock To:
 1st Value:
 2nd Value:
 Value Percent:
 Continuous Index:
 Within 8" of Joint: **NO**
 Remarks: **M-504-013**
