Profile/Photo Observation Report

Date:	02/15/2024	Weather:		Coding:	PACP 7.0
Pipe Length (ft):	142.0	Owner:	City of Hobart	Pre Clean:	Heavy Cleaning
P.O.#:	YES502259	Surveyor:	S. Bucklin	PSR:	P-504-017-015
Customer:	City of Hobart	Clean Date:	10/17/2022	Shape:	C

Street:	N DELAWARE ST	Flow Control:	Not Controlled
City:	Hobart, IN	Year Renewed:	
Location:	Alley	Tape/Media #:	
Purpose:	Routine Assessment	Dia/Height:	10"
Use:	Sanitary Sewage Pipe	Material:	VCP
Drain Area:		Lining:	None
Category:	NA		
Comment:			
Location Details:		Direction of Survey:	Downstream
US MH:	M-504-015	DS MH:	M-504-017
		Total Length Surveyed (ft):	141.6

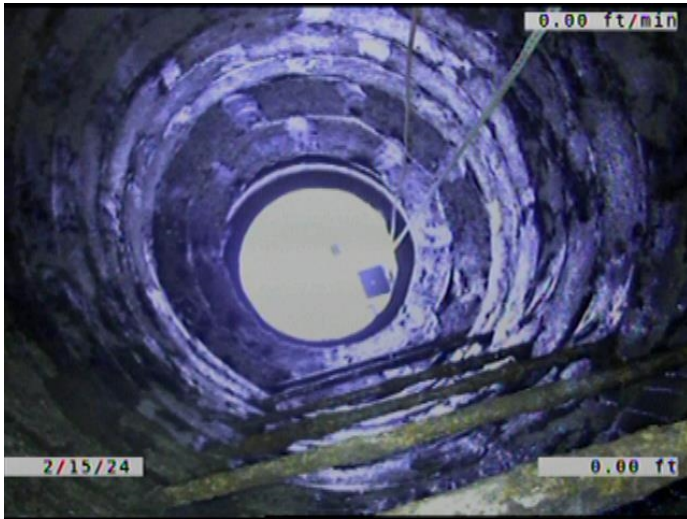
Code: **AMH**
Description: **Manhole**

Distance (ft): **.0**
Structural Grade: **0**
O&M Grade: **0**
Clock Start/From:
Clock To:
1st Value:
2nd Value:
Value Percent:
Continuous Index:
Within 8" of Joint: **NO**
Remarks: **M-504-015**

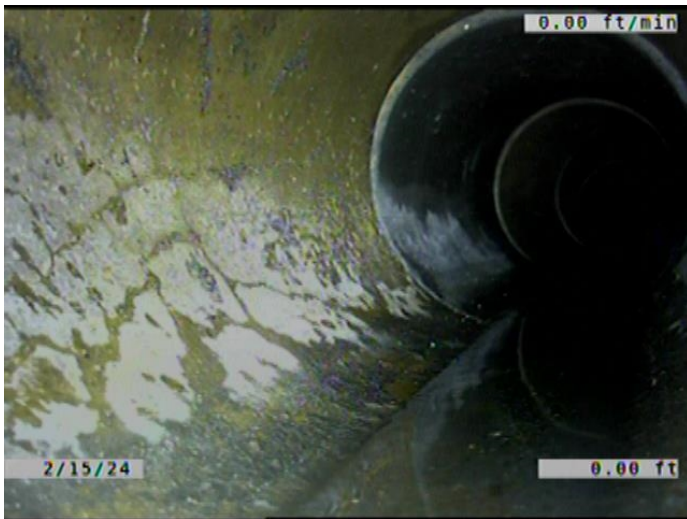
Code: **MWL**
Description: **Miscellaneous Water Level**

Distance (ft): **.0**
Structural Grade: **0**
O&M Grade: **0**
Clock Start/From:
Clock To:
1st Value:
2nd Value:
Value Percent: **5.000**
Continuous Index:
Within 8" of Joint: **NO**
Remarks:

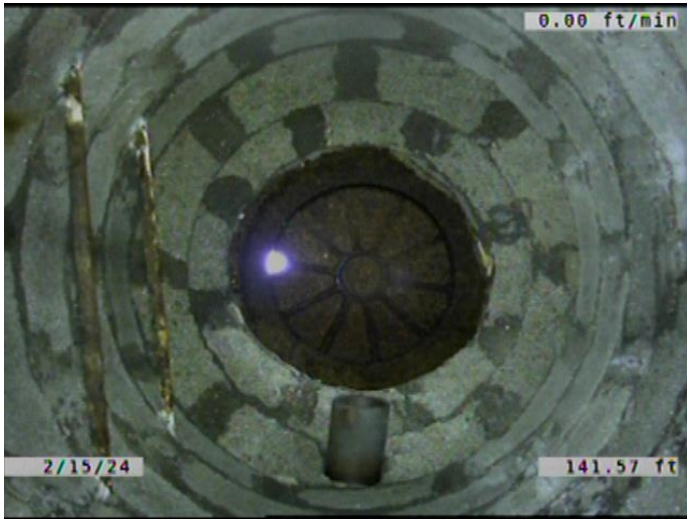
Code:	AMH
Description:	Manhole
Distance (ft):	141.6
Structural Grade:	0
O&M Grade:	0
Clock Start/From:	
Clock To:	
1st Value:	
2nd Value:	
Value Percent:	
Continuous Index:	
Within 8" of Joint:	NO
Remarks:	M-504-017
